PB90-916301  
NTSB/RAR-90/01

## **RAILROAD ACCIDENT REPORT**

**REAR-END COLLISION OF TWO  
NEW YORK CITY TRANSIT AUTHORITY TRAINS  
103RD STREET STATION  
NEW YORK, NEW YORK  
MARCH 10, 1989**

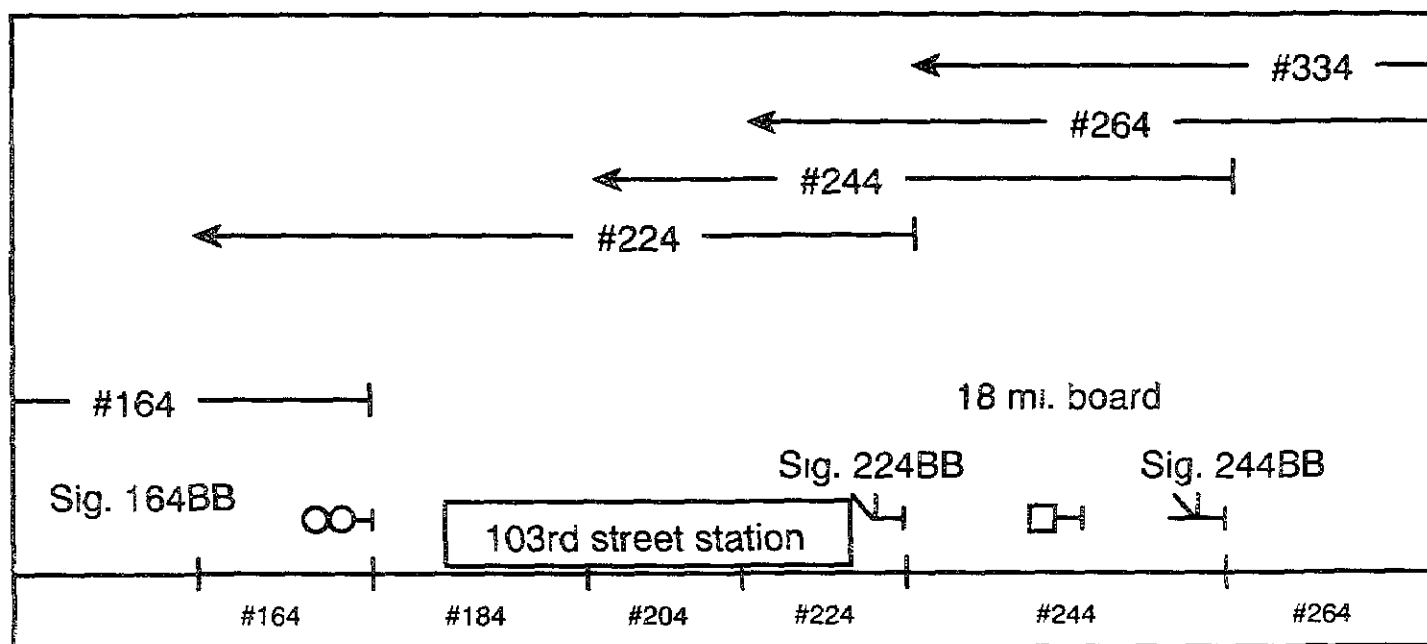
Figure 4.-- Track Circuits in 103rd Street Station.

The NYCTA uses a train control system with an automatic block signal system to direct the movements of trains. The signal system includes a three-color light displaying green, which indicates clear; or yellow, which indicates approach; or red, which indicates stop. The signal system constructed in 1912 is designed so that generally, the two signals immediately behind a train display red and the third signal behind a train displays yellow (see figure 3). There are three track circuits for track 1 in the 103rd Street Station; track circuit 184, which is 157 feet long, track circuit 204, which is 214 feet in length, and track circuit 224 which is 196 feet long. The station platform is about 500 feet in length. At the 103rd Street Station, the three block protection (two red signals and one yellow signal) is not always provided. When a train enters the 103rd Street Station, track circuit 224 will provide the three block protection as described and if the train proceeds into the track circuit 204 or overlaps from 204 into 244 the system is designed to still provide the three block protection. However, if the train moves into track circuit 184 and does not overlap into 204 the system is designed so that signal 224 at the entrance to the station will remain red, but signal 244 will be yellow, providing only a two block protection (see figure 4). Train 3A was completely within track circuit 204 at the time of the accident.

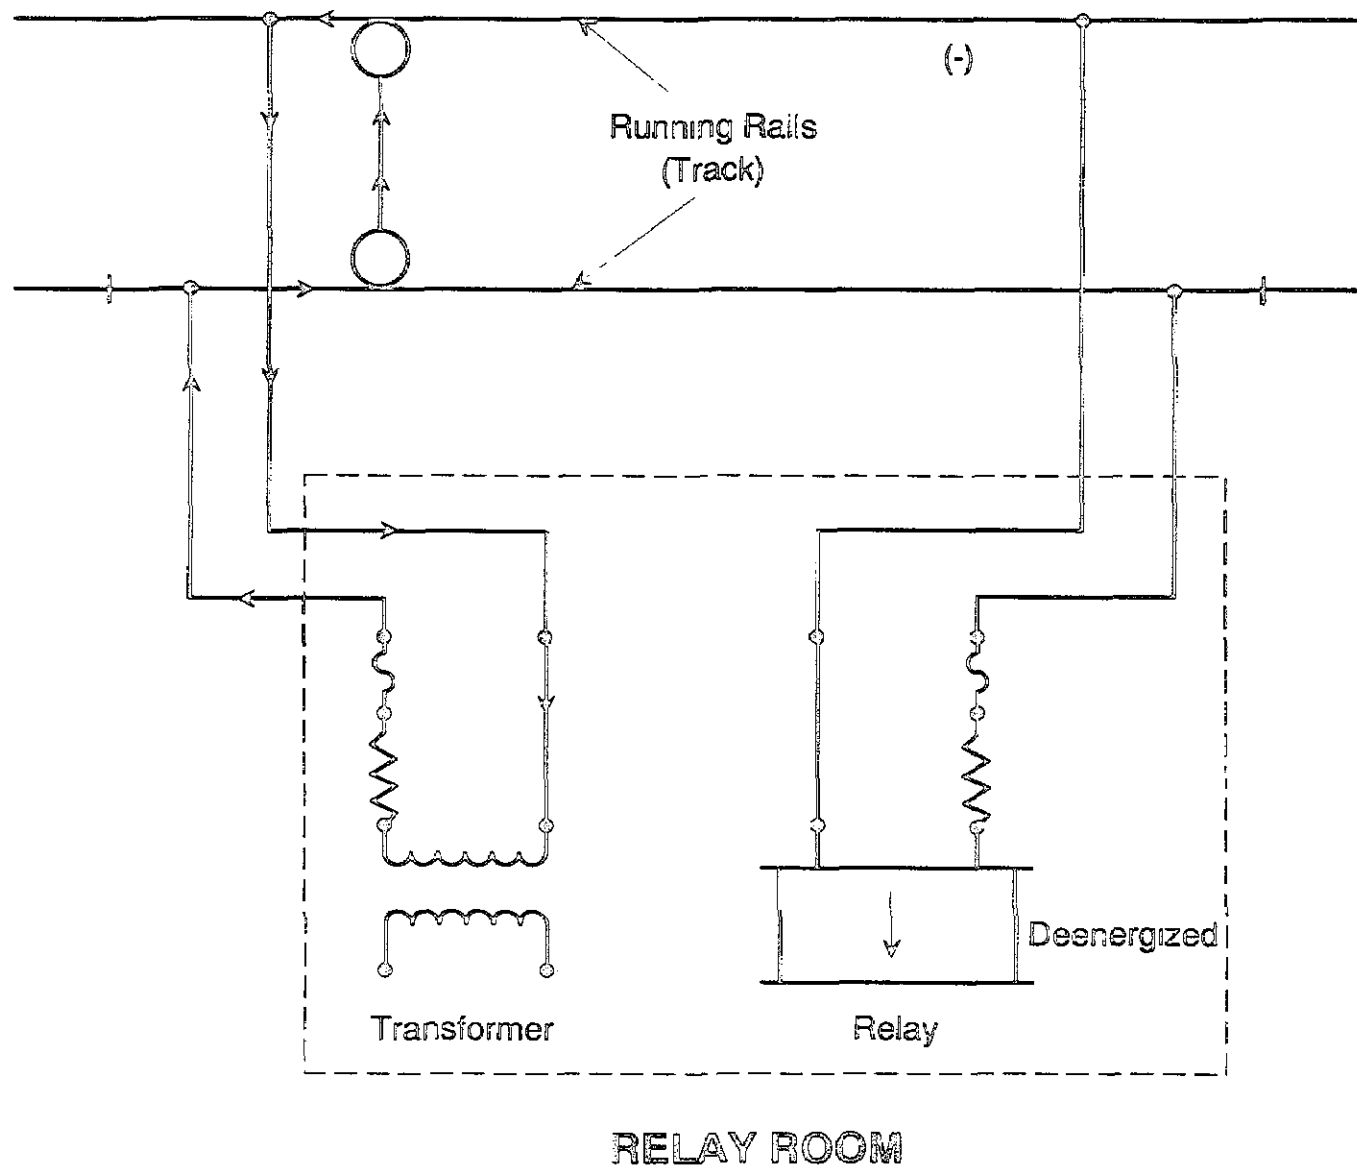
Figure 6.-- Track Circuit Shunting.

The track circuits are designed so that when a track circuit is unoccupied, current flows from the transformer through a resistor, a fuse and electrical wire to the positive (signal) rail, then through electrical wire, a fuse, a resistor, and a relay to the negative (propulsion) rail, and then again through electrical wire to the transformer; much of electrical wire is routed through the concrete inverts which support the tracks. When the relay is energized the signal system will display a clear indication (see figure 5). When a set of wheels are on the rail, the track circuit is shunted. Thus, current will not flow to energize the relay and the signal system will display a stop indication (see figure 6).

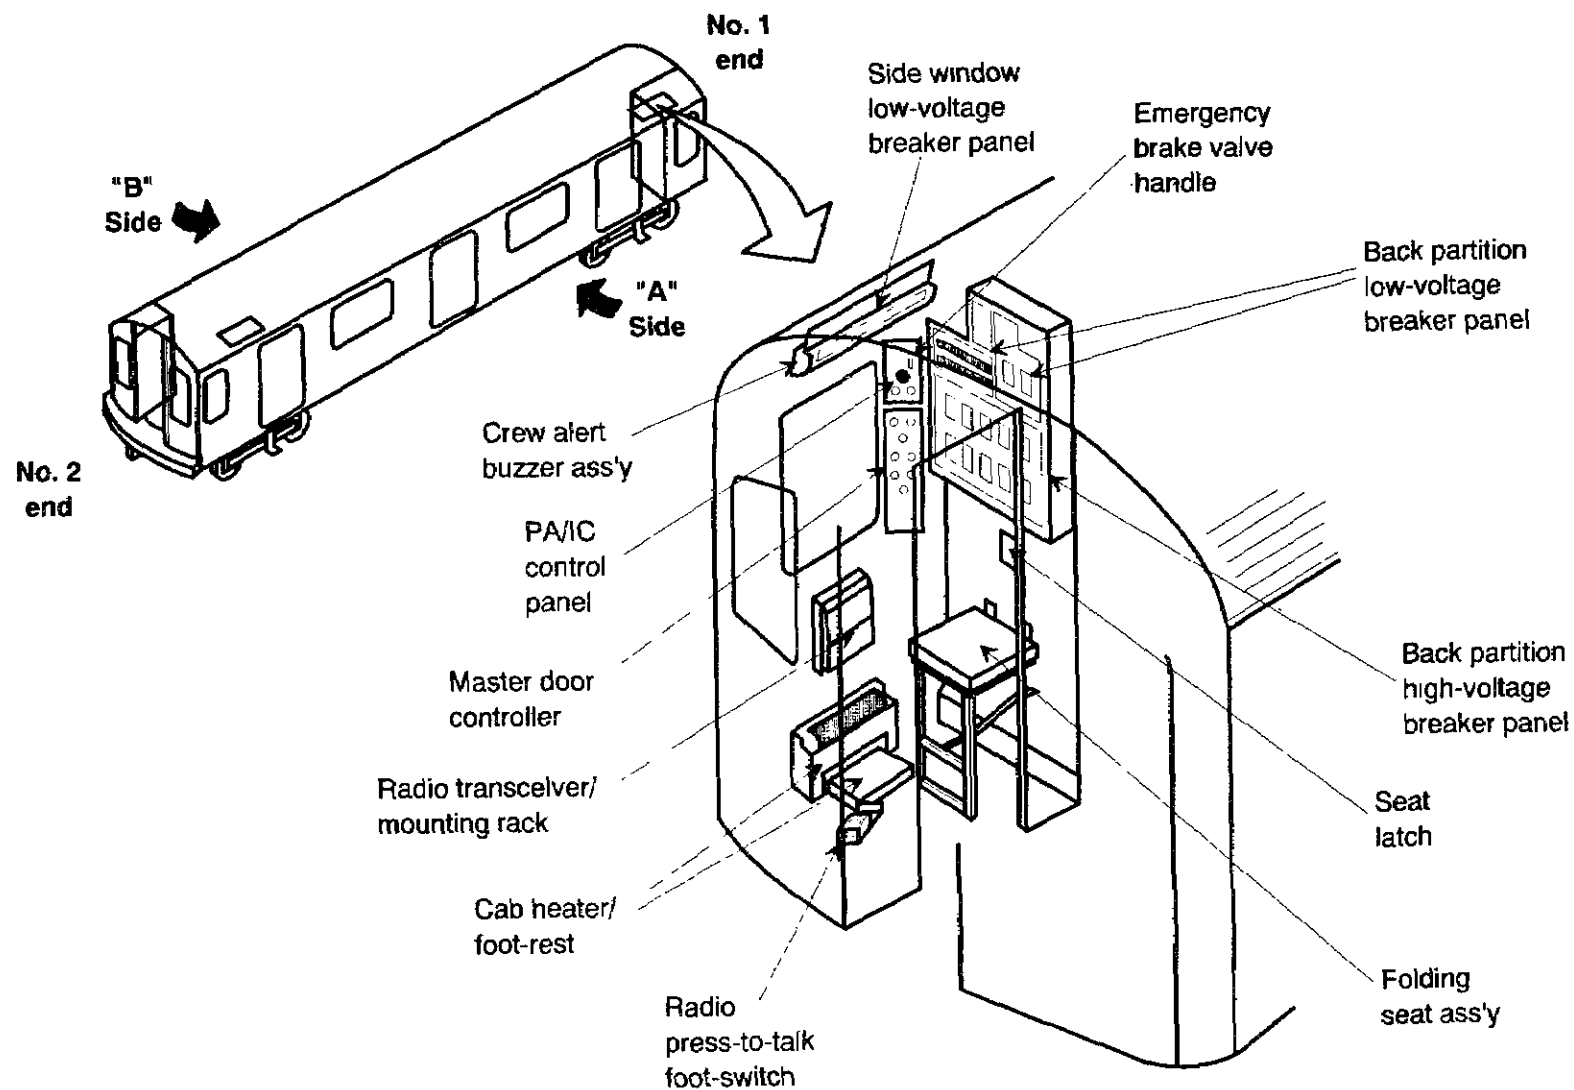
Figure 10.--Operating Cab Configuration.

Each car is equipped with an operating cab at each end. The R-62A car is designed with hinged doors and partitions so that the operator's compartment can extend across the entire width of the end of the car or across only the right portion of the end of the car (with the leading edge of the door forward and the full length door hinge at the trailing end). NYCTA does not operate the cars with the full front cab configuration but instead uses only the portion of the cab area on the right side of the car and requires that train operators close the cab door (see figure 10). This NYCTA arrangement allows more passenger seating in the area opposite the train operator's cab. The operating cab contains a brake valve and a master controller. The brake system uses both dynamic and electropneumatic blended braking and is controlled by the train operator with the brake handle. The propulsion master controller regulates the speed of the train and its handle must be kept depressed while the train is moving under power; otherwise, the "deadman" feature will apply the emergency brakes. The operating cab has a train operator's side door master controller; the opposite cab side is also equipped with a door master controller (see figure 10).

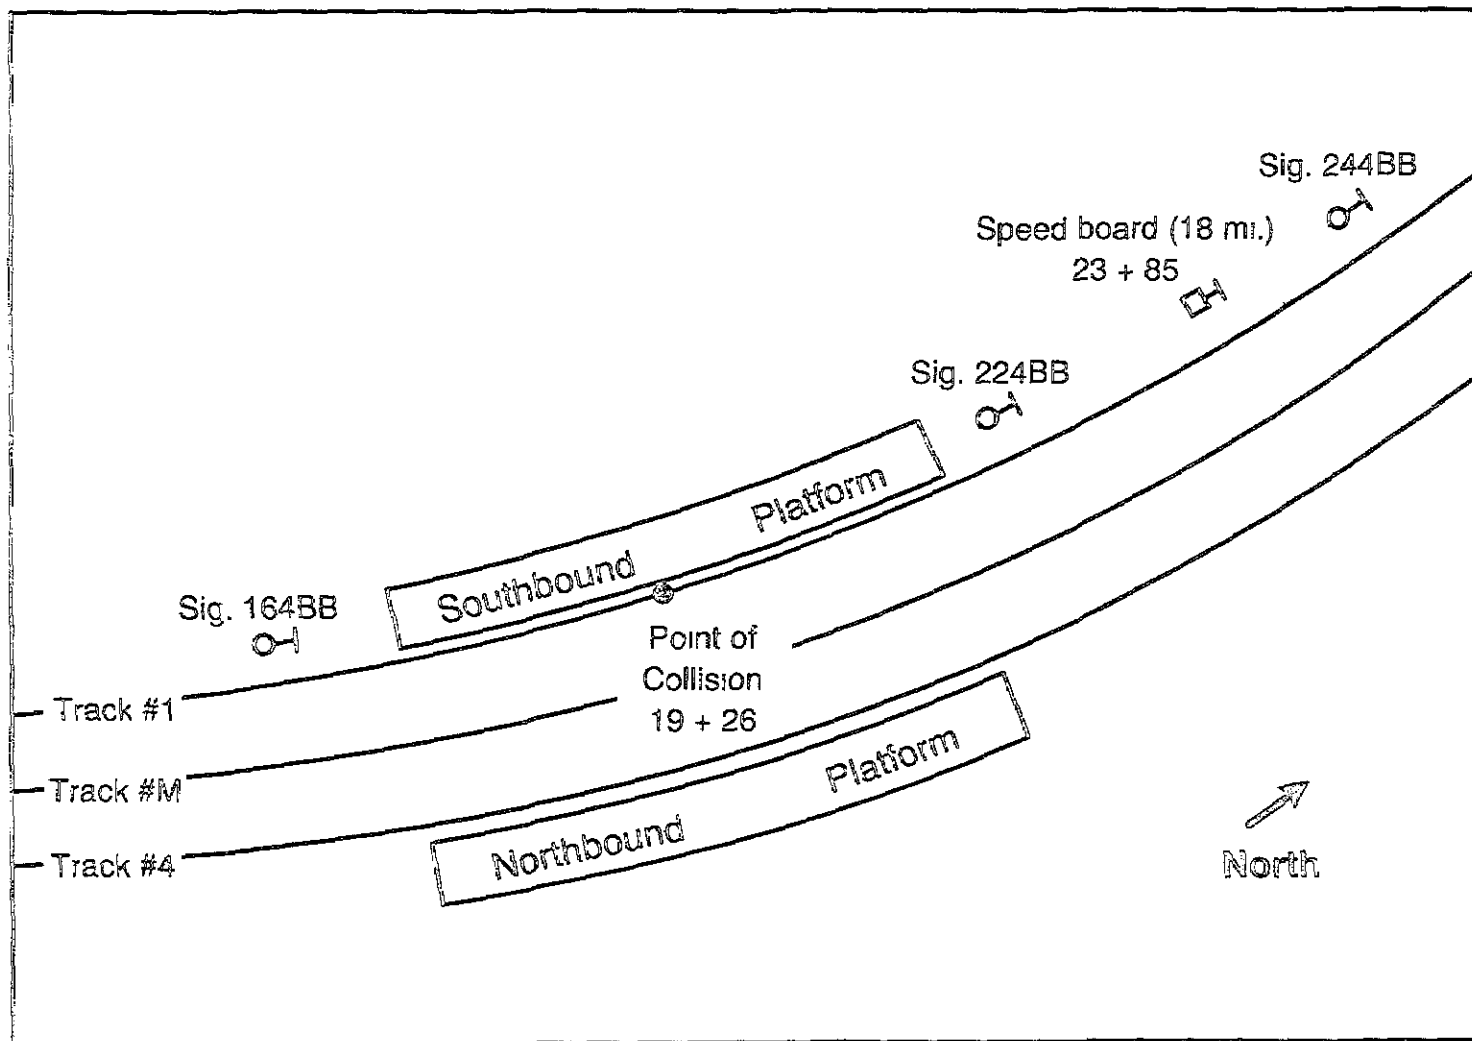
Figure 11.--103rd Street Station Track Layout.

In the area of the accident there are three tracks numbered from west to east. The track on which the accident occurred was the westerly track, designated as number 1 track. The middle track was designated as the middle track and the east side track was designated as number 4 track (see figure 11).

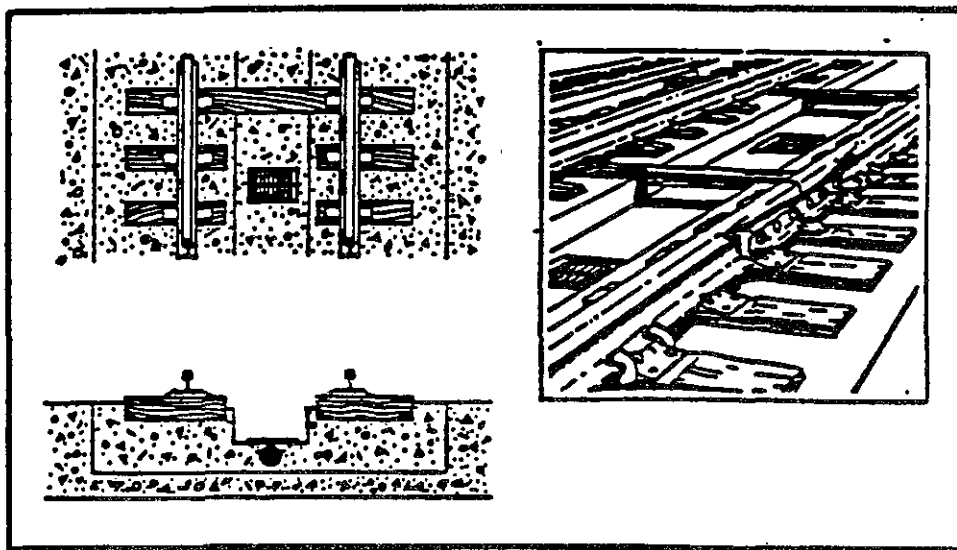
Figure 12.--Design Type 2 Track.

The tracks in the area of the accident were constructed with 100-pound ARA-B control cooled 39 foot rail sections. Rail sections were joined together with 36-inch, six-hole joint bars. The tracks were constructed on 12-foot 6-inch centers. The tracks in the area of the accident were classified by the NYCTA as design type II modified with 9 foot wood ties and 30 inch wood tie blocks embedded in a concrete invert (see figure 12).
