PB92-916301  
NTSB/RAR-92/01

## RAILROAD ACCIDENT REPORT

DERAILMENT AND COLLISION OF  
AMTRAK PASSENGER TRAIN 66 WITH  
MBTA COMMUTER TRAIN 906  
AT BACK BAY STATION  
BOSTON, MASSACHUSETTS  
DECEMBER 12, 1990

**Abstract:** At 8:23 a.m. on December 12, 1990, National Railroad Passenger Corporation (Amtrak) passenger train 66, consisting of a two-unit locomotive, two material handling cars, five passenger cars, one dining car, and two baggage cars, derailed and struck Massachusetts Bay Transit Authority (MBTA) commuter train 906, consisting of one locomotive, six passenger cars, and one control car, as both trains entered Back Bay station in Boston, Massachusetts.

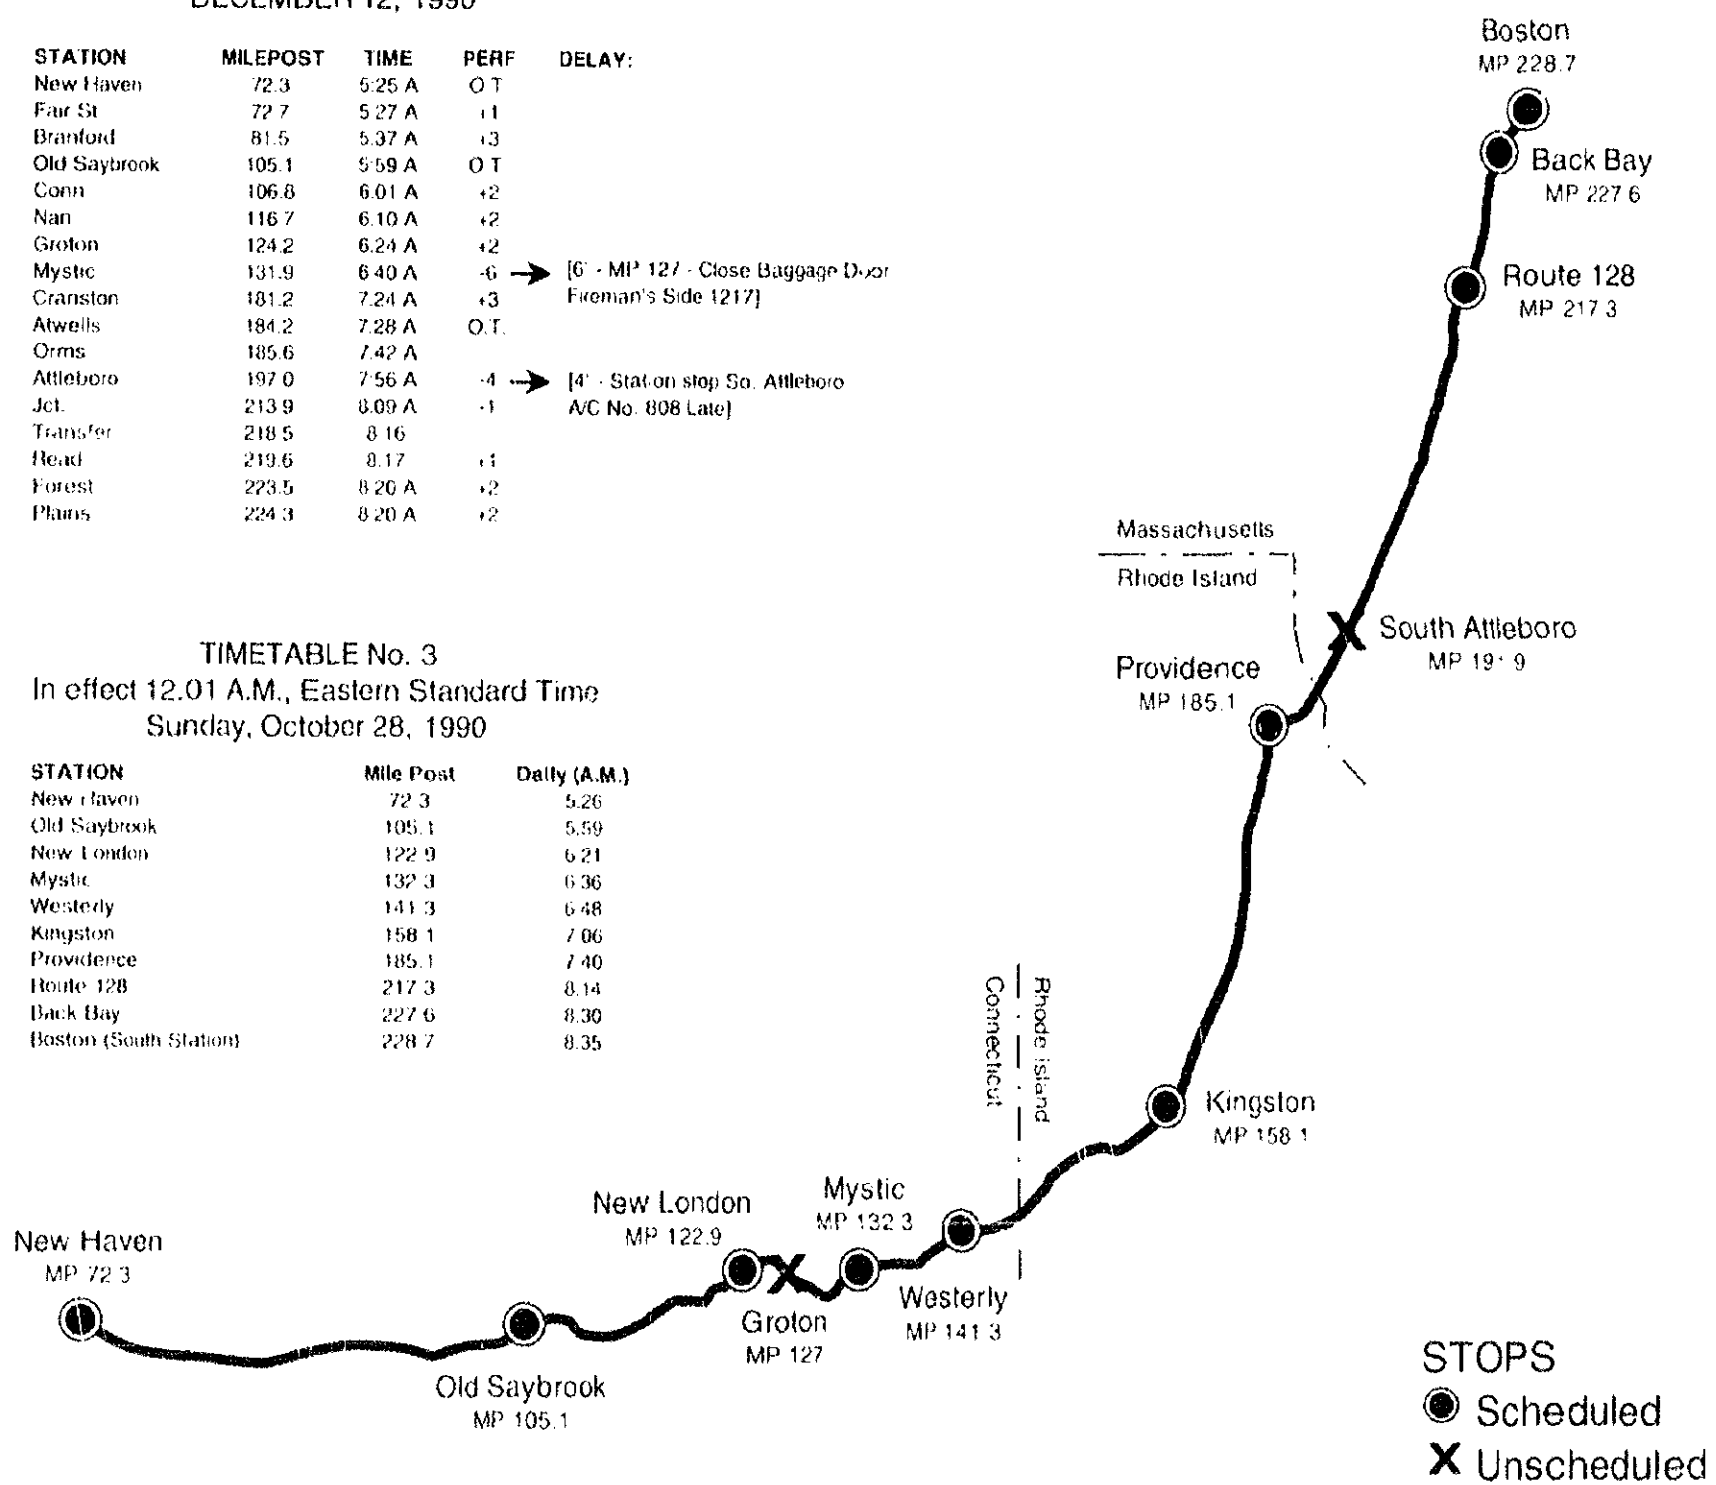
According to the Amtrak dispatcher's office train performance records, Amtrak train 66 was 6 minutes late at Mystic (MP 131.90) but was on schedule at Atwells (MP 184.2). The dispatcher notified the traincrew to stop at South Attleboro (MP 192) to board passengers. The stop at South Attleboro required about 4 minutes. Amtrak train 66 made its regular station stop at Route 128 (MP 217.3) on schedule. (For stopping information, see figure 1.)

Figure 1.--Amtrak train 66 route between New Haven and Boston, with train performance record and timetable schedule.
