# Chicago South Shore & South Bend Changes Signal Equipment

Union Model-R color-light signals replace upper-quadrant semaphores—High-speed spring switches installed at passing tracks

*By B. L. Smith*

Signal Supervisor, Chicago South Shore & South Bend

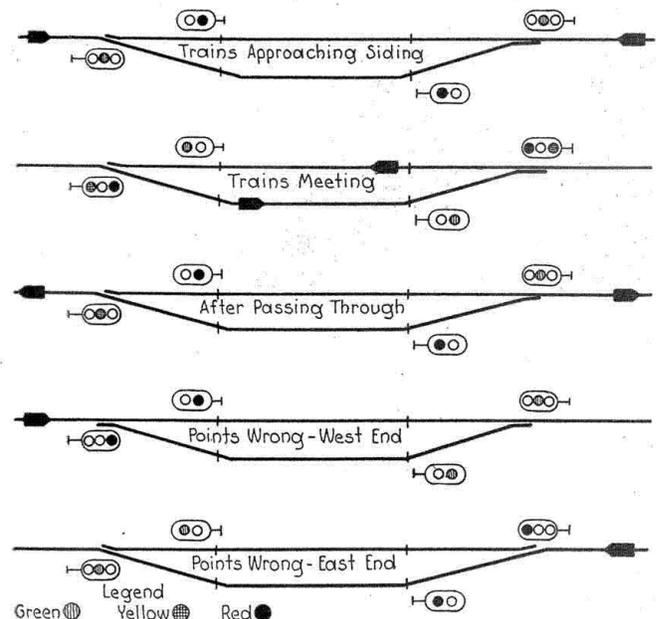
Signal indication diagram illustrating train movements through high-speed sidings and conditions existing when switches are not in proper position

One feature of this installation is the protection of the high-speed passing tracks, which employ a Morden high-speed spring switch protected by a three-position

home signal located 150 ft. in advance of the switch points on either end. Indications for these signals corresponding to the two positions of the switches are shown in the accompanying diagram. A special relay known as the Union light out Type-ANL is wired in series with the light to obtain these indications.
