Collision due to signal failure

A rear-end collision between two westbound Southern Pacific freight trains . . . "was caused by a false proceed signal indication due to an undesired electrical connection between control circuits of associated signals." In report No. 4035, the Interstate Commerce Commission's Railroad Safety and Service Board reported on its investigation of the accident which occurred at Emigrant Gap, Calif., on Jan. 7, 1965, about 5 pm, resulting in injuries to nine train-service employees.

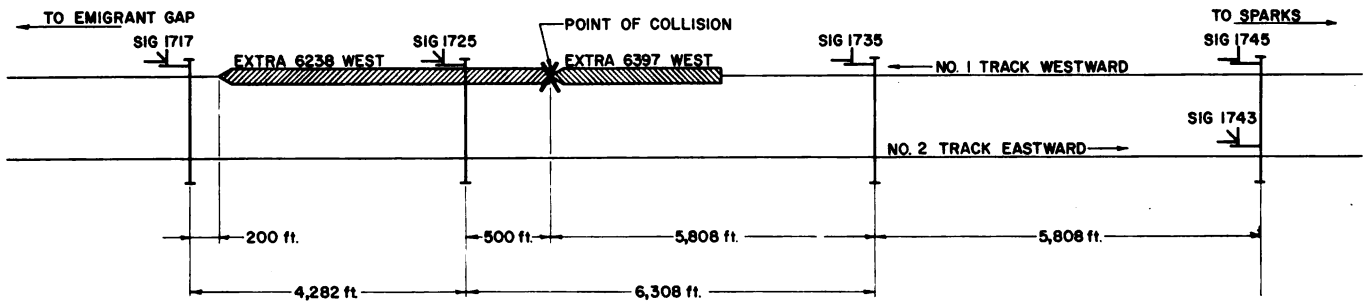
In the accident area this is a double-track line over which trains moving with the current of traffic operate by signal indications of an automatic block signal system, supplemented by an intermittent inductive train-stop system. The territory is in the Sierra Nevada mountains, between Sparks, Nev., and Sacramento, Calif. In the vicinity of the accident, there are a series of short tangents and curves in the track, and the average grade for westbound trains is 1.78% descending. Because of track curvature and sidehill cuts in the accident area, the range of vision between the collision point and an approaching westbound train is materially restricted. Automatic signals involved are shown on the diagram.

Just prior to the accident, Extra 6238 West, a westbound freight consisting of 5 diesel-electric units, 83 cars, a caboose and 2 helper diesel-electric units proceeded on track No. 1. The locomotive passed signal 1745 which indicated proceed; passed signal 1735, which indicated proceed; passed signal 1725 which displayed an approach aspect; and stopped 200 ft short of signal 1717 which indicated stop, because of snow removal equipment occupying

track No. 1 ahead. The rear of Extra 6238 West stopped in the block of signal 1735, 500 ft east of signal 1725.

According to the ICC report, the following train, Extra 6397 West, consisted of 4 diesel-electric locomotive units, 51 cars and a caboose. "Extra 6397 West passed signal 1745, which indicated proceed; passed signal 1735, which displayed a false proceed indication, and proceeded in the block on this signal at 31 mph, as indicated by the speed-recording tape. The engineer stated that as the train was moving on a curve, signal 1725 came into his view about 1,000 ft ahead and he saw it indicating stop. Immediately thereafter, he saw the rear end of Extra 6238 West standing on track No. 1 about 500 ft east of signal 1725 and also saw the flagman of that train giving stop signals with a red flag. Both the engineer and the front brakeman estimated that the flagman was approximately 50 ft to the rear of Extra 6238 West at this time [about 5 pm]. The engineer called a warning and applied the brakes in emergency, but the speed was not materially reduced before Extra 6397 West struck the helper locomotive at the rear of Extra 6238 West . . .

"Examination after the accident disclosed that snow on the ground in the area of the signal instrument housing at signal 1725 had accumulated to a height of 8 ft, leaving the ventilator at the top of the housing exposed. Snow had blown or drifted into the instrument housing through the ventilator and moistened the surfaces of the 19 lightning arresters carrying signal line circuits, includ-

"Tests and examinations revealed that current from the energized circuits apparently leaked over the damp surfaces of the 19 lightning arresters from their circuit terminals to their ground terminals. Because of this current leakage and the damp surfaces of the lightning arresters, electrolytic action occurred between the arrester circuit terminals and ground terminals. This caused a conductive substance to form on the surface of the arresters, bridging the arrester spark gaps and establishing an undesired circuit between the circuit terminals of adjacent arresters carrying the circuits for signal 1735 control relay and signal 1743 control relay.

"Since there was no train movement on track No. 2 in the Emigrant Gap area at the time involved, signal 1743 control relay circuit was energized as Extra 6397 West approached the accident point. It is apparent that because of the frozen ground condition that existed at the time of the accident, the ground resistance of the lightning arrester ground was increased to the extent that protection intended by the grounded negative battery common did not exist and there was enough current leakage from the energized signal 1743 control relay circuit to the signal 1735 control relay cir-

cuit to energize the signal 1735 control relay circuit. This caused signal 1735 to indicate proceed for Extra 6397 West although the block of that signal was occupied by the rear portion of Extra 6238 West.

"In this case, it is evident the damp condition of the surfaces of the lightning arresters in the signal instrument housing at signal 1725

caused an improper connection between the control circuits for signals 1743 and 1745, resulting in signal 1735 displaying a false proceed indication and causing the accident."
