G. R. S. Train Control Demonstrated on C. & N. W.

Actual Service Test Shows Practicability of Intermittent Tapered Speed Control and Stop Indications

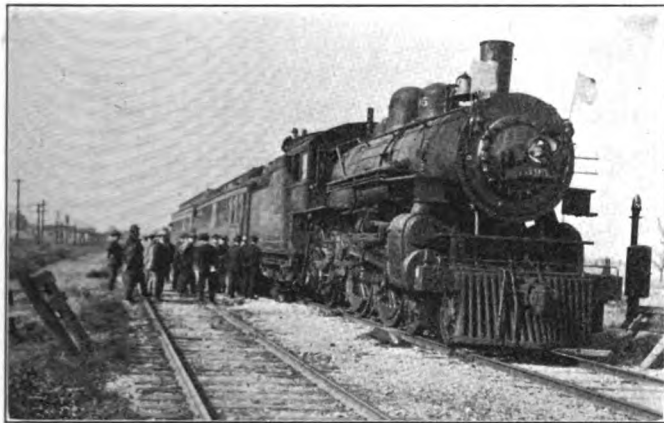
Making Low Speed Tests Over Pair of Track Inductors

With signal 908 at "stop" and 910 at "caution" an attempt was next made to operate the train at a low speed over the first two sets of speed control inductors and to pass the third set near signal 908 at a low speed so as to disregard the signal indication. However, the apparatus functioned as intended the train being stopped automatically within 600 ft. when

traveling at 23 m.p.h. although working steam until actually stopped. In repetition of this test at 25 m.p.h. the train was stopped at the signal. All of the foregoing tests were made with a brake pipe pressure of 70 lb. instead of 90 lb. which accounted for the engine and part of one car over-running the signal in one test.

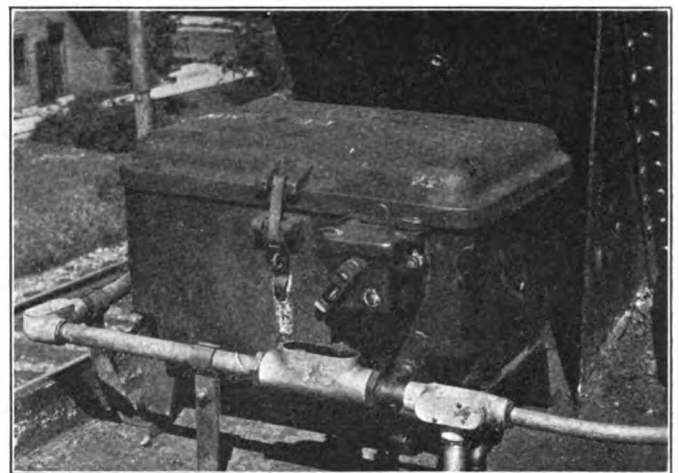
Relays and Timing Element Are Housed in a Cast-Iron Box on the Tender

The speed control and receiving apparatus for freight and passenger locomotives is identical except for the timing of the time element contactor. Locomotives that are, under certain circumstances, used in both passenger and freight service are equipped with time element contactors that may be automatically adjusted for either class of service. At present two passenger and two freight locomotives are equipped with receiver apparatus and mechanism for operating engineer's brake valve. A number of tests were made to demonstrate the operation of the system for both speed control and train stop features. Detailed description of the General Railway Signal Company's train control system was published on page 521 of the *Railway Age* for March 4, 1922.

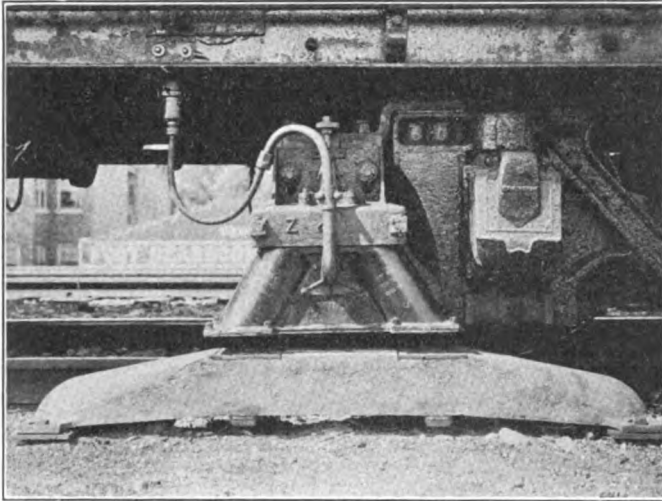
Receiving Element on Tender Truck Standing Over a Track Inductor

It will be noted in the table below that no impulse was received at a speed of approximately 2.4 miles an hour. The engine used in this test, however, was one of the first ones equipped in which the receiver was placed between the journal box and springs. Later engines are now being equipped
