Released in accordance with section 25 of the *Transport Safety Investigation Act 2003*

Safety summary

What happened

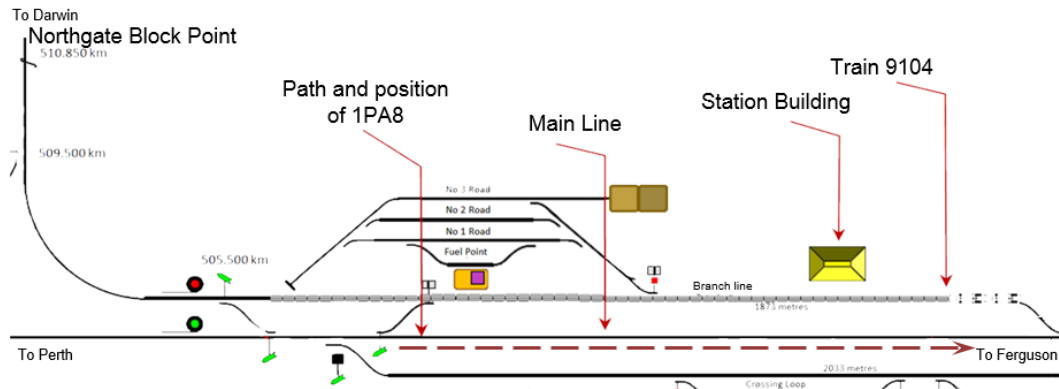
Figure 2: Tarcoola yard showing location of 9104 and path of 1PA8

Source: South Australia Track and Signal (G. Vincent) annotated by ATSB

Train 9104 proceeded to Tarcoola, stopping on the Branch Line at about 1935, adjacent to the Tarcoola Station building (Figure 2).

About 65 minutes later, at 2040, the NCO issued an authority for 1PA8 to enter Tarcoola and take the main line to pass train 9104. The NCO then issued an authority to 1PA8 that authorised it, after fulfilling the pass with 9104, to travel through to the next crossing loop at Ferguson, where it would cross with freight train 6WP2.
