**RAILROAD ACCIDENT INVESTIGATION**

REPORT No 4105

**TERMINAL RAILROAD ASSOCIATION OF ST. LOUIS**

**NOVEMBER 18, 1966**

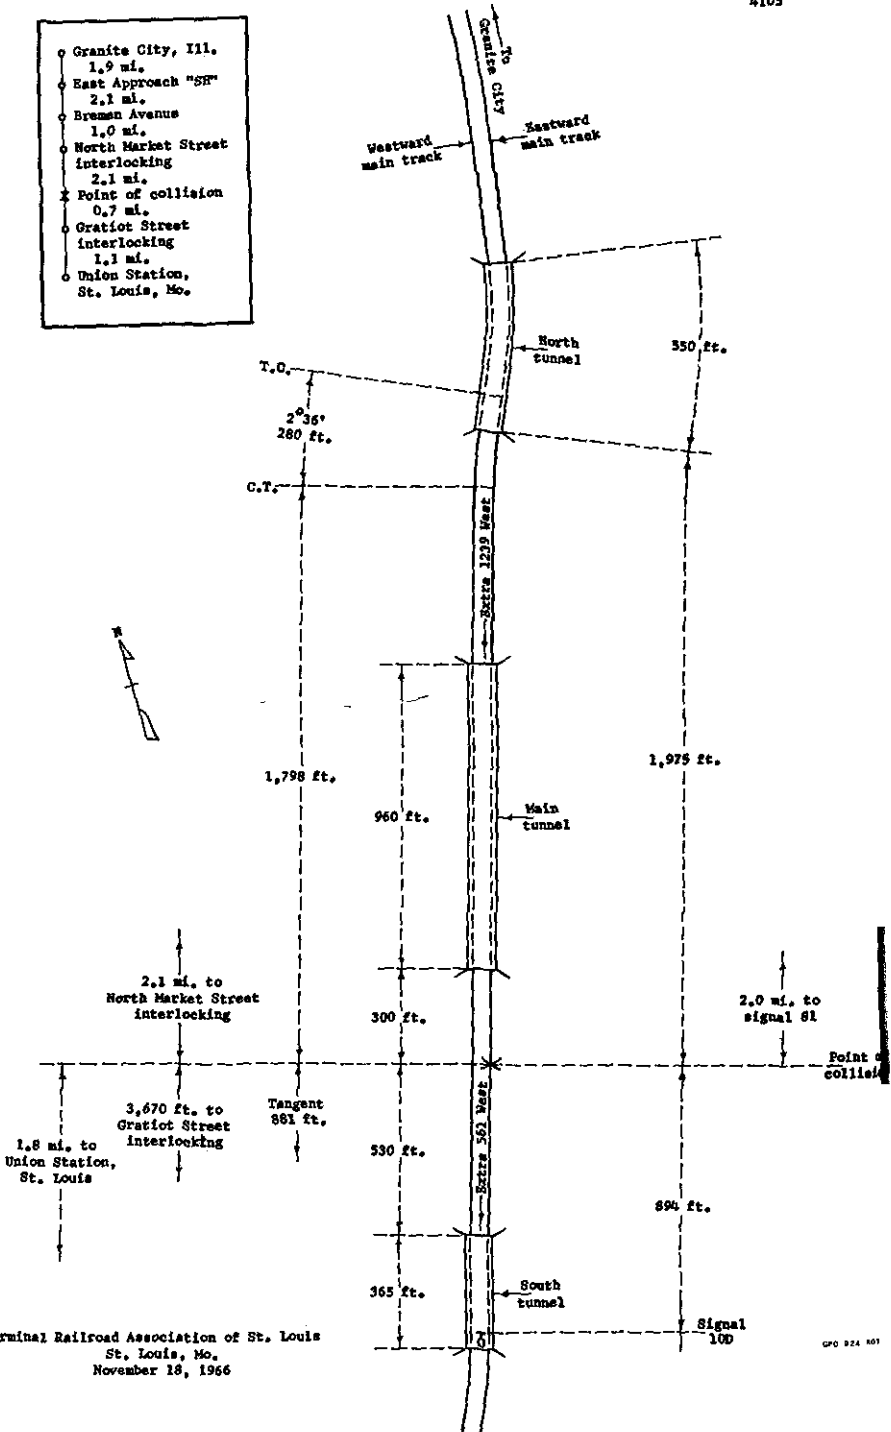
Terminal Railroad Association of St. Louis  
St. Louis, Mo.  
November 18, 1966

- Granite City, Ill.  
1.9 mi.
- East Approach "SR"  
2.1 mi.
- Bremen Avenue  
1.0 mi.
- North Market Street  
interlocking  
2.1 mi.
- ✕ Point of collision  
0.7 mi.
- Gratiot Street  
interlocking  
1.1 mi.
- Union Station,  
St. Louis, Mo.

The collision occurred on the eastward main track, 1.8 miles east of Union Station, St. Louis.
