REPORT OF THE DIRECTOR

PENNSYLVANIA RAILROAD

SPRINGDALE, PA.

INVESTIGATION NO. 2124

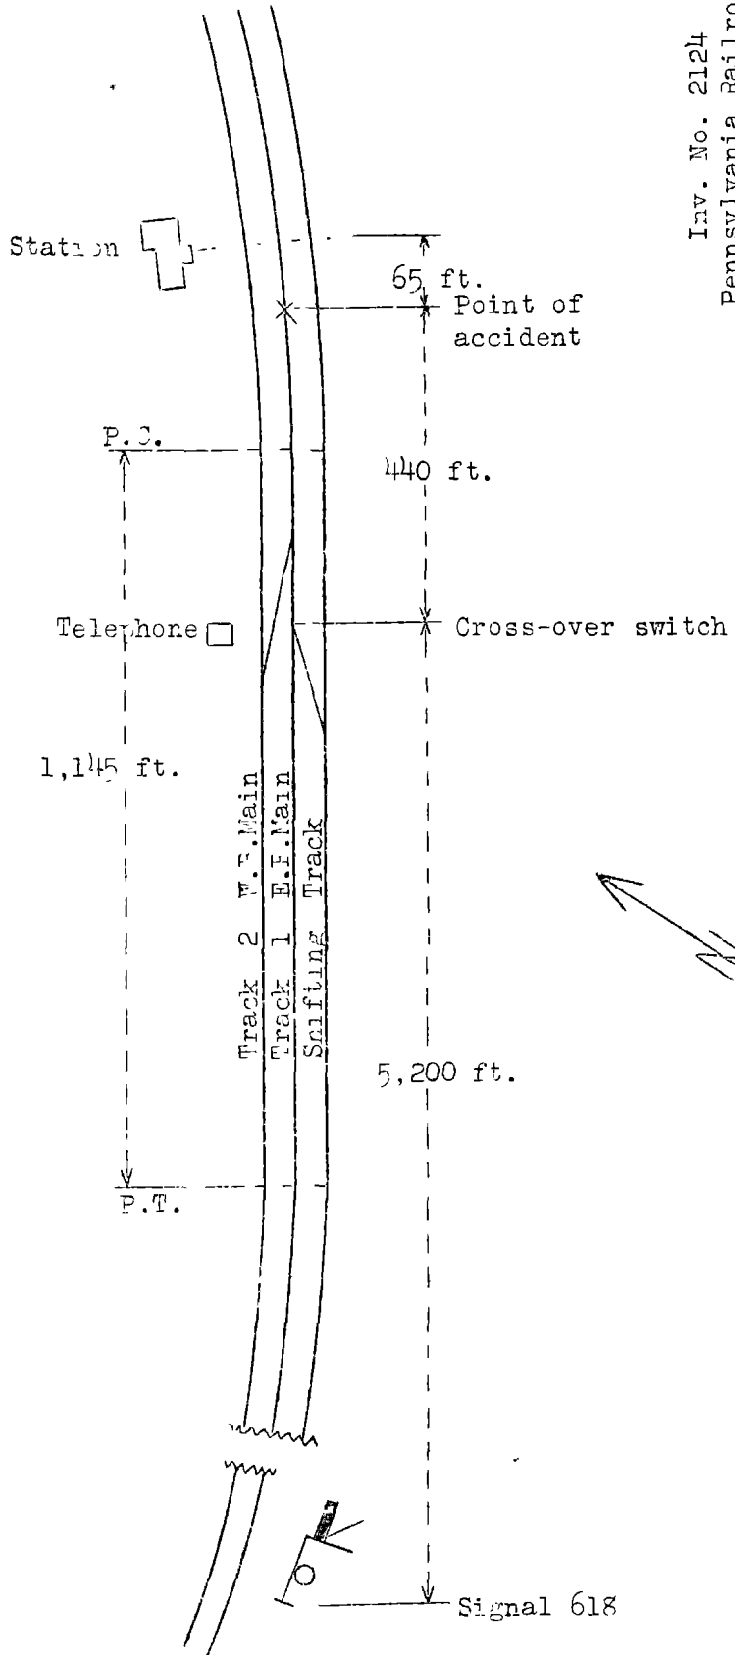
Inv. No. 2124
Pennsylvania Railroad
Springdale, Pa.
Dec. 2, 1936

○	Conpitt Jct., Pa.
	59.1 mi.
○	RA Block Station
	3.6 mi.
✱	Springdale (P.of A.)
	2.1 mi.
○	Cheswick
	1.0 mi.
○	Denny
	1.1 mi.
○	Harmarville
	3.4 mi.
○	Blawnox
	2.0 mi.
○	Aspinwall
	6.2 mi.
○	UY Block Station
	2.2 mi.
○	CM Block Station
	4.5 mi.
○	Federal Street (Pittsburgh, Pa.)

This accident occurred on that part of the Conemaugh Division extending between Conpitt Junction and Federal Street, Pittsburgh, Pa., a distance of 79.2 miles; in the vicinity of the point of accident this is a double-track line over which trains are operated by timetable, train orders and an automatic block-signal system. The accident occurred on the east-bound main track at a point 65 feet west of the station at Springdale; approaching this point from the west there is a compound curve to the left 4,740 feet in length, the curvature varying from $0^{\circ} 45'$ to 3° , then the track is tangent a distance of 1,145 feet, followed by a 3° curve to the left 1,030 feet in length, the accident occurring on the last mentioned curve at a point 135 feet from its western end. The grade is practically level.

At Springdale a shifting track, locally known as the glue track, parallels the main tracks on the south; the shifting track connects with the east-bound main track through a cross-over about 135 feet in length, the east or main track switch thereof being a trailing-point switch located 505 feet west of the station. A second trailing-point cross-over, about 200 feet in length, connects the two main tracks, the east switch of which is located 374 feet west of the station. The latter cross-over has a mechanical center-locking device operated from the ground and connected to the signal circuit on both main tracks; the cross-over between the shifting track and the east-bound main track is not equipped with such a locking device. All of the switches are hand-operated and so arranged that any movement of the switch levers from normal position, or a movement of the center locking device of the main track cross-overs, shunts the track circuit and causes east-bound automatic block signal 618 to assume stop position. This signal is located 5,200 feet west of the east switch of the shifting track.
