REPORT OF THE DIRECTOR
BUREAU OF SAFETY

ACCIDENT ON THE
MICHIGAN CENTRAL RAILROAD

MONROE, MICH.

INVESTIGATION NO. 2251

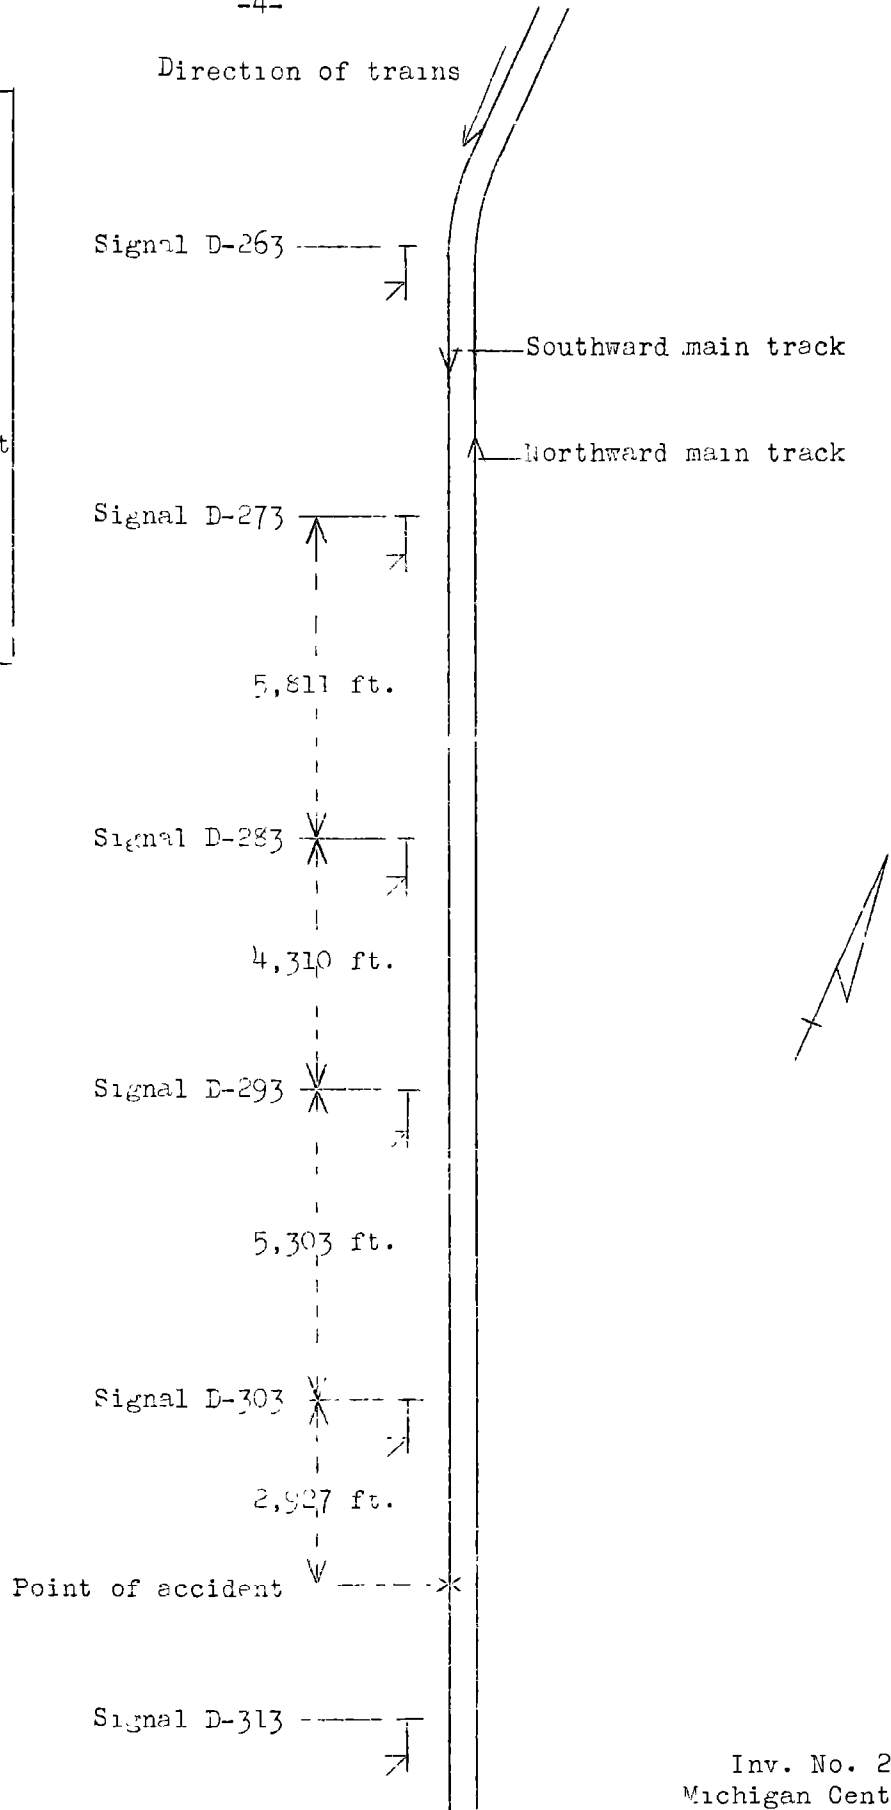
Inv. No. 2251
 Michigan Central RR
 Monroe, Mich.
 Feb. 13, 1938

o	Detroit, Mich.
	14.66 mi.
o	Trenton
	6.16 mi.
o	Rockwood
	5.62 mi.
o	Newport
	3.35 mi.
X	Point of accident
	4.03 mi.
o	Monroe
	23.75 mi.
o	Toledo, Ohio
