REPORT OF THE DIRECTOR
BUREAU OF SAFETY

:
ACCIDENT ON THE
:
CHICAGO, ROCK ISLAND AND PACIFIC RAILWAY

WASHBURN, IOWA

INVESTIGATION NO. 2300

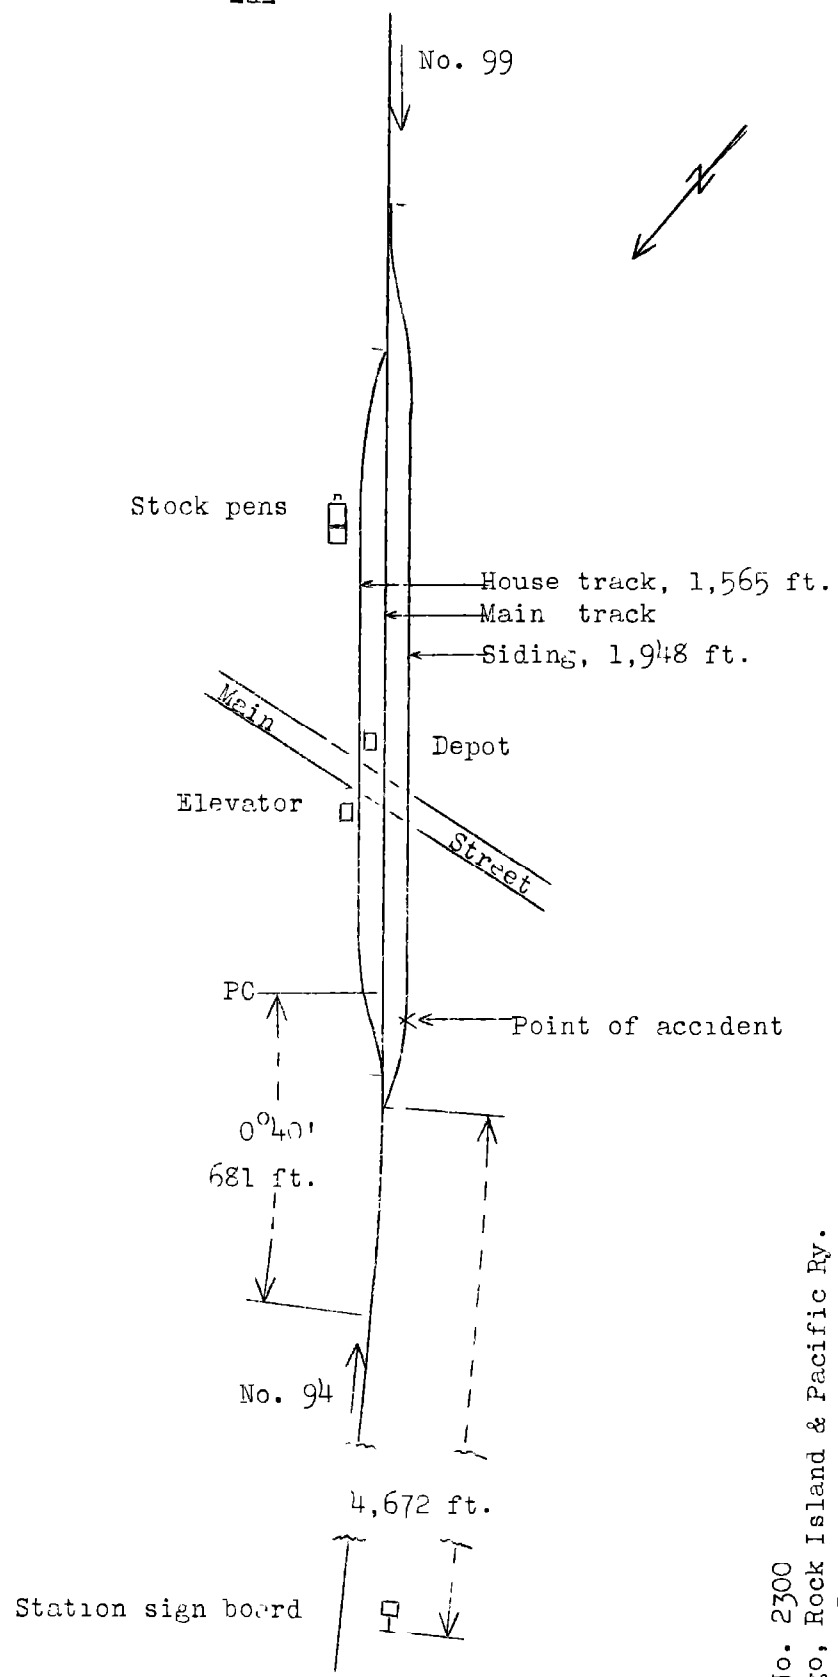
Inv. No. 2300
 Chicago, Rock Island & Pacific Ry.
 Washburn, Iowa
 October 15, 1938.

o Cedar Rapids, Iowa (Union Station)	0.8 mi.
o Cedar Rapids Yard	22.9 mi.
o Vinton	14.3 mi.
o LaPorte City	8.0 mi.
x Washburn (P of A)	4.9 mi.
o East Yard	2.0 mi.
o Waterloo	74.9 mi.
o Manly, Iowa

This accident occurred on that part of the Cedar Rapids Division designated as Sub-Division 16 which extends between Cedar Rapids and Manly, Iowa, a distance of 127.9 miles. In the vicinity of the point of accident this is a single-track line over which trains are operated by timetable and train orders, no block-signal system being in use. The accident occurred on the siding at Washburn at a point approximately 250 feet east of the west switch. Approaching this point from the west the track is tangent 9,170 feet followed by a $0^{\circ} 40'$ curve to the left 681 feet in length, the accident occurred on this curve at a point about 44 feet west of its east end. The grade for east-bound trains is slightly ascending a distance of 1,300 feet, and then descending 0.18 percent a distance of approximately 1,630 feet to the point of accident. Approaching from the east the track is tangent a distance of 4,995 feet followed by the curve on which the accident occurred. The siding at Washburn is 1,948 feet in length, has a capacity of 32 cars, and parallels the main track on the south. A house track, 1,565 feet in length, the west switch of which is located approximately 100 feet east of the west switch of the siding, parallels the main track on the north. Stock pens are located near the west end and to the north of the house track. The depot is located between the main track and the house track approximately 741 feet east of the west house-track switch. Immediately west of the depot Main Street extends across the three tracks at grade and at an angle of about 60 degrees. There is an elevator located just west of the crossing and to the north of the house track approximately 604 feet east of the west house-track switch. The switches at the west end of both the siding and the house track are equipped with high Star switch stands, each having an 18-inch, red-enameled, round-disc target, the center of which is 61 inches above the top of the ties. The station board for east-bound trains is located 4,672 feet west of the west switch of the siding.
