INTERSTATE COMMERCE COMMISSION
WASHINGTON

ACCIDENT ON THE
CHICAGO AND NORTHWESTERN RAILWAY

McHENRY, ILL.

INVESTIGATION NO. 2303

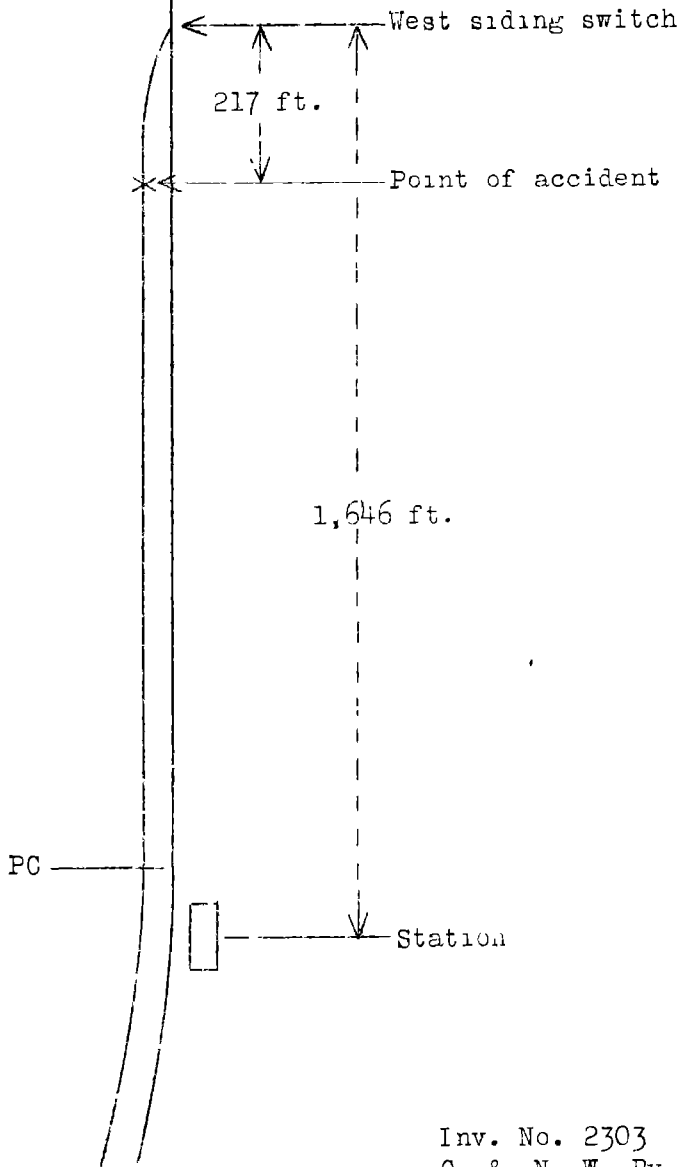
Direction
of train

o	Williams Bay, Wis.	
		26.0 mi.
X	Point of accident	
o	McHenry, Ill.	4.6 mi.
o	Terra Cotta	2.9 mi.
o	Crystal Lake	
		43.25 mi.
o	Chicago, Ill.
