REPORT OF THE DIRECTOR
BUREAU OF SAFETY

ACCIDENT ON THE
CHICAGO, BURLINGTON & QUINCY RAILROAD

BEVERLY, MO.

INVESTIGATION NO. 2337

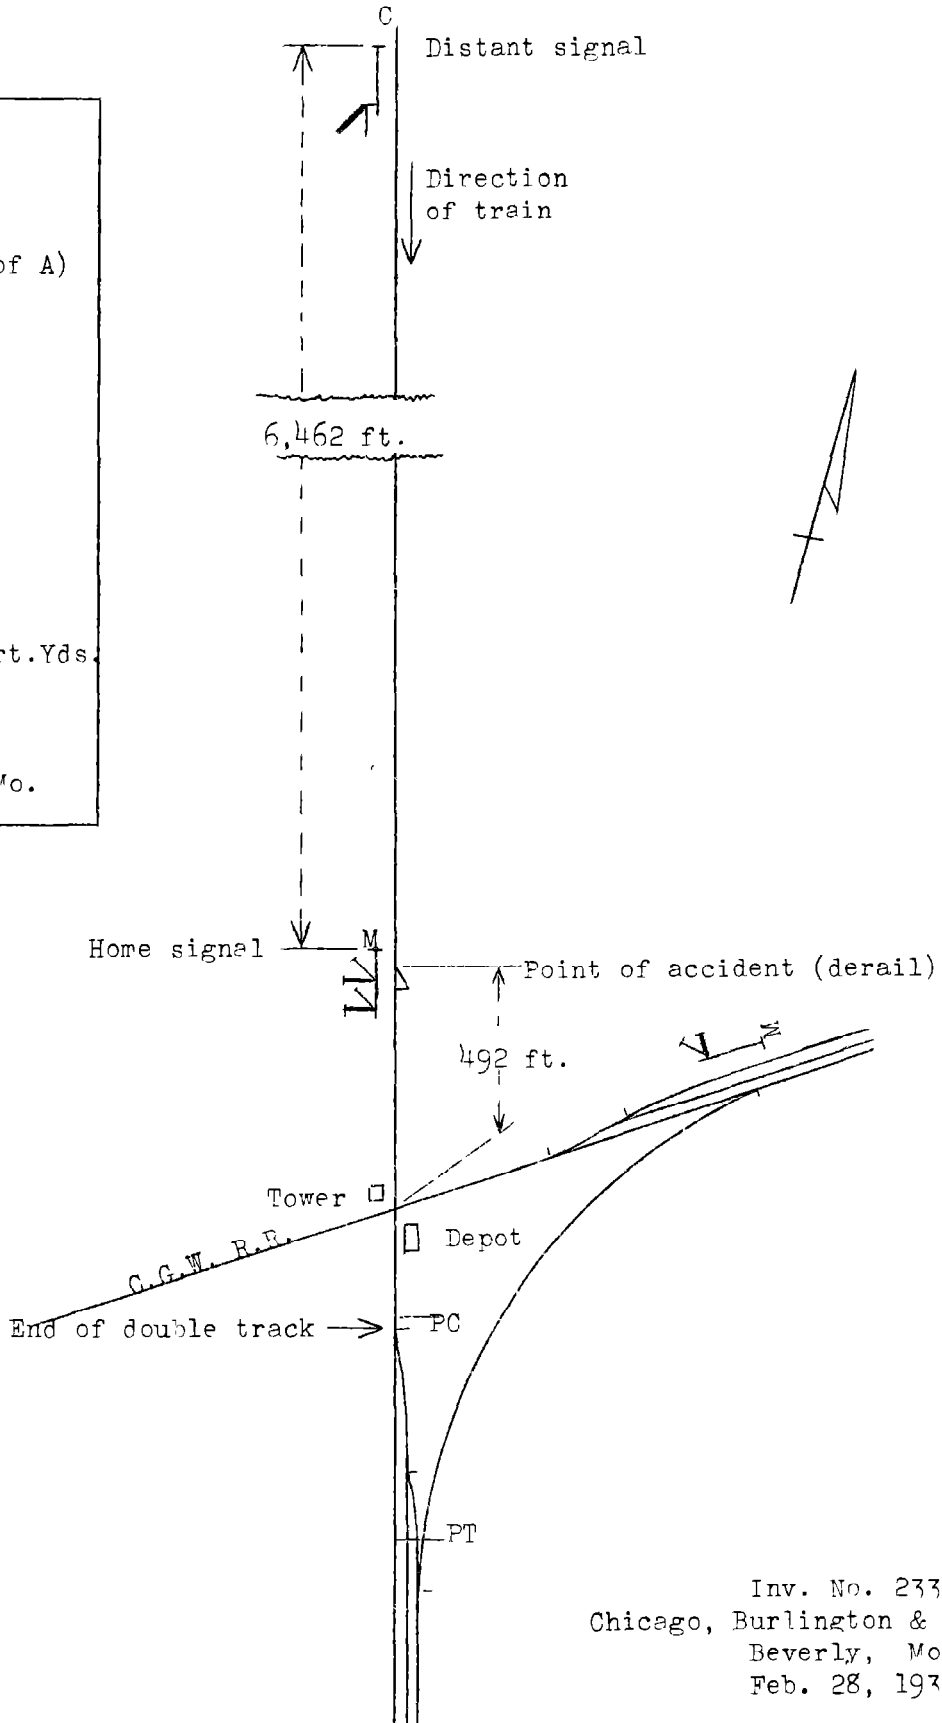
Inv. No. 2337
 Chicago, Burlington & Quincy R.R.
 Beverly, Mo.
 Feb. 28, 1939

o	Ustick, Mo.	
		25.8 mi.
X	Beverly (P of A)	
		3.3 mi.
o	Weston	
		12.8 mi.
o	Armour	
		16.6 mi.
o	St. Joseph Frt. Yds.	
		1.6 mi.
o	St. Joseph, Mo.

Approaching from the north there is a 1° curve to the right 990 feet long, followed by a tangent 2,655 feet long on which the accident occurred at a point 662 feet from its southern end. The grade is slightly descending southward at the point of accident.

The two-arm, two-position, mechanically operated home signal is of the lower-quadrant semaphore type. The top arm, which displays either a green or a red aspect, is longer than

the bottom arm, which displays either a yellow or a red aspect. A green-over-red aspect indicates a movement with the current of traffic on the southward main track. A red-over-yellow aspect indicates proceed-at-restricted speed for a movement against the current of traffic or a movement from the single track to the siding. Either a green-over-red or a red-over-yellow aspect permits a train to use the crossing. A red-over-red aspect indicates stop.
