ACCIDENT ON THE
PENNSYLVANIA RAILROAD

KENNY, PA.

APRIL 30, 1939

INVESTIGATION NO. 2347

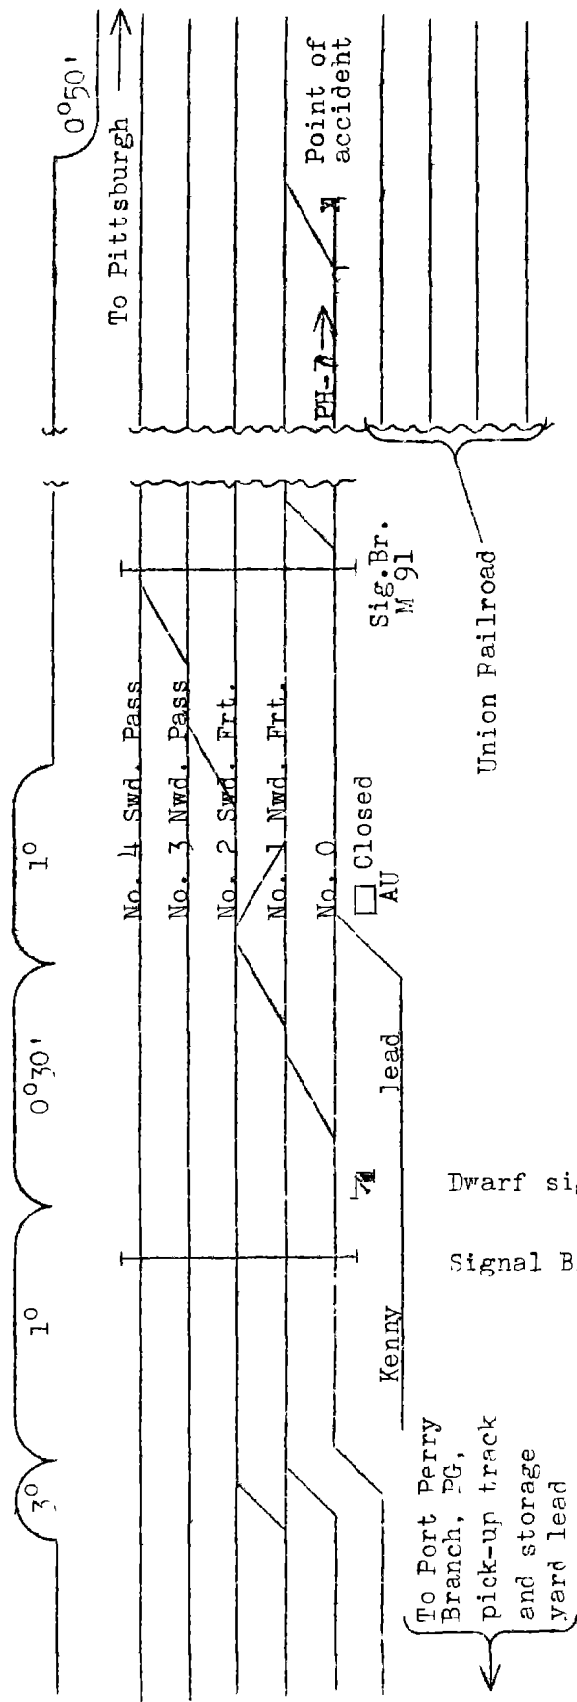
| (Pittsburgh, Pa.) |
| o Division Post |
| 9.1 mi. |
| X Kenny (P. of A.) |
| 0.8 mi. |
| o PG Block Station |
| 51.8 mi. |
| o Ten Mile Run Jct., Pa. |

This accident occurred on that part of the Monongahela Division which extends between Division Post, Pittsburgh, and Ten Mile Run Junction, Pa., a distance of 61.7 miles. In the vicinity of the point of accident this is a four-track line over which trains are operated by timetable, train orders, and an automatic block-signal system; these tracks from east to west are numbered 1, 2, 3, and 4, No. 1 being the northward freight track. The accident occurred at the north end or stub end of a yard track known as track No. 0; this track is 7,993 feet long, parallels the main tracks on the east, and extends northward from the Port Perry Branch at PG Block Station, located 0.8 mile south of Kenny. Four tracks of the Union Railroad, on which tracks there are numerous switch lights, parallel track No. 0 on the east, making nine parallel tracks in the vicinity of the point of accident. Track centers of all nine tracks are spaced approximately 13½ feet apart. Approaching from the south on track No. 0 there is a compound curve to the right a distance of 2,058 feet, the curvature of the eastern portion varying from 0° 30' to 1°, a tangent 1,284 feet long, a 1° 15' curve to the right 586 feet in length, a tangent a distance of 648 feet, a 4° curve to the left 144 feet long and then a tangent 763 feet in length to the north end of track No. 0. The grade is descending northward a distance of 6,505 feet, varying from 0.01 to 0.39 percent, then it is 0.05 percent ascending a distance of 1,488 feet to the end of the track.
