-----  
ACCIDENT ON THE  
CHICAGO, MILWAUKEE, ST. PAUL AND PACIFIC RAILROAD

-----  
AVEFY, IDAHO

-----  
SEPTEMBER 15, 1939

-----  
INVESTIGATION NO. 2379

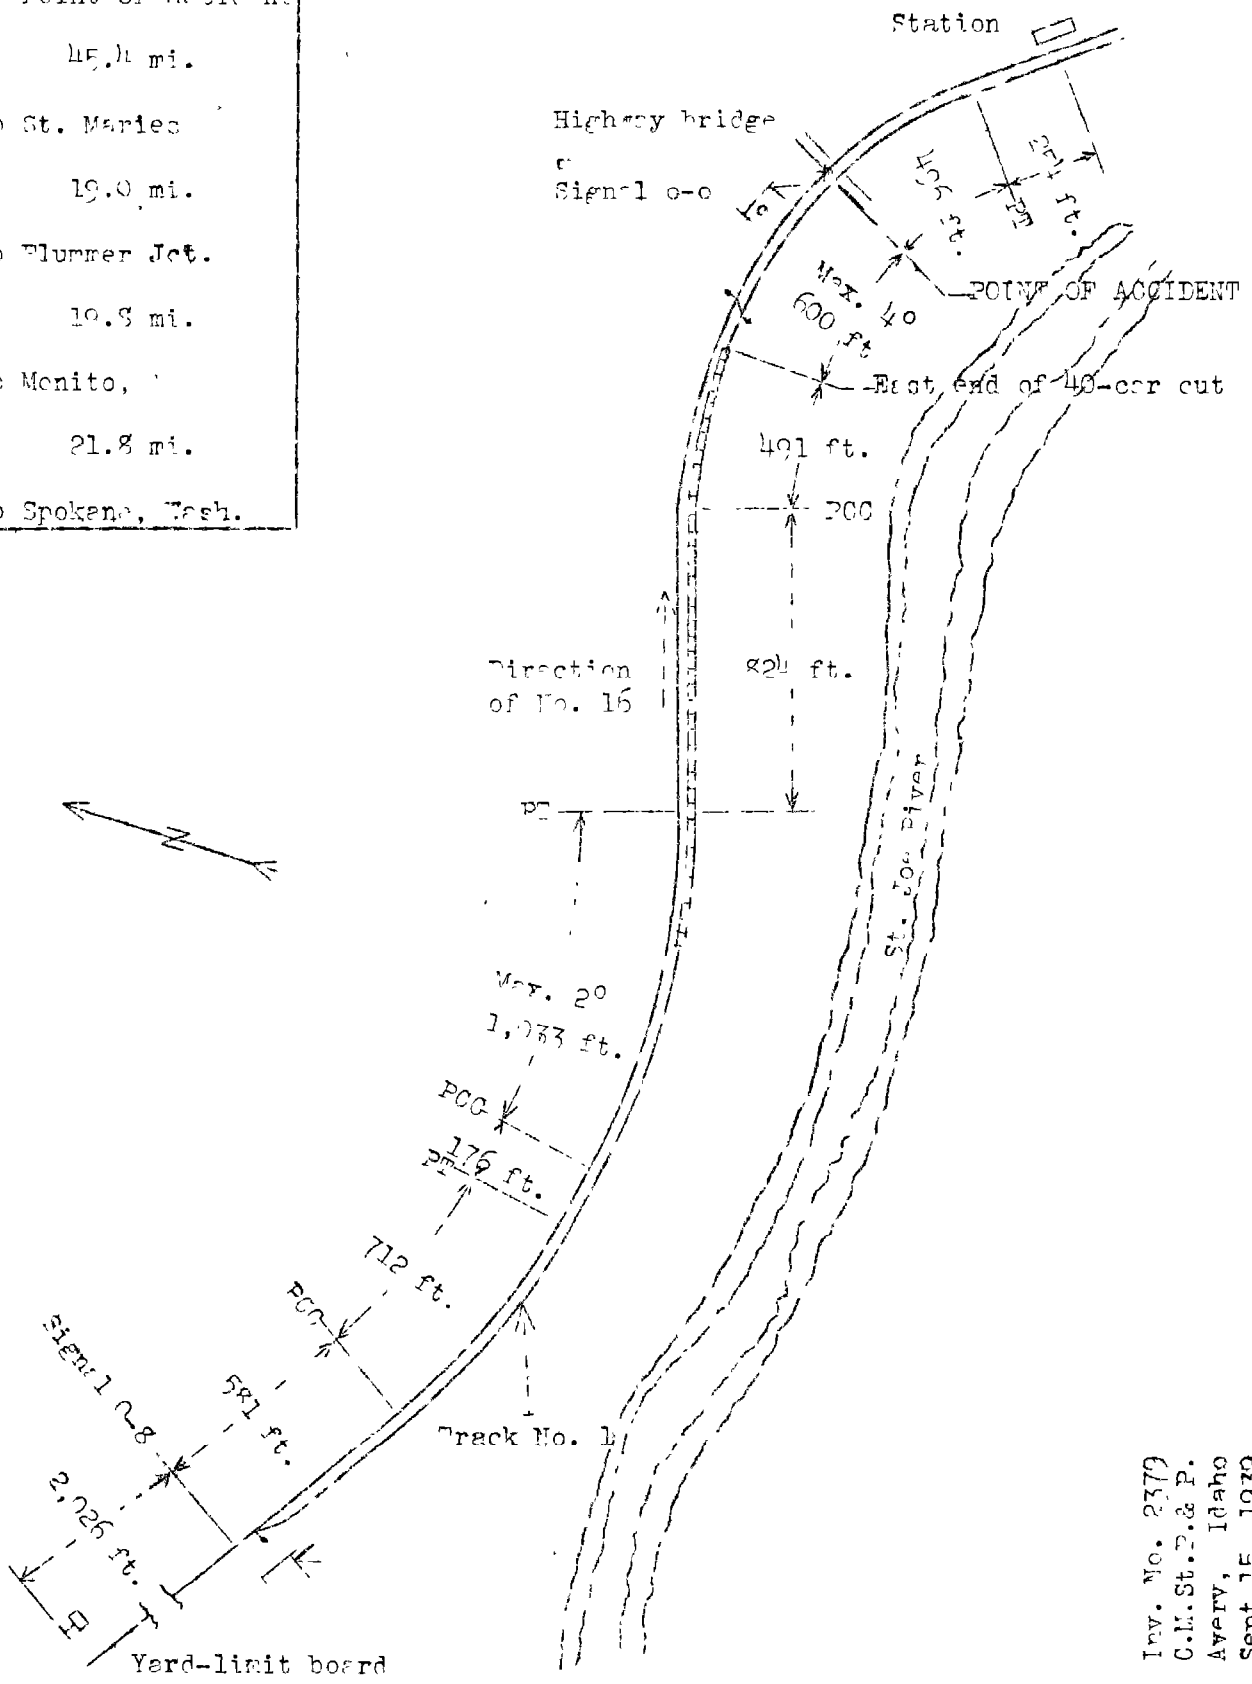
Inv. No. 2379  
 C.M. St. P. & P.  
 Avery, Idaho  
 Sept 15, 1929

o	Avery, Idaho
▼	Point of accident
	45.4 mi.
o	St. Maries
	19.0 mi.
o	Flummer Jct.
	10.8 mi.
o	Monito,
	21.8 mi.
o	Spokane, Wash.

This accident occurred on that part of the Rocky Mountain Division designated as the Fourth Subdivision which extends between Avery, Idaho, and Alberton, Montana, a distance of 100.3 miles. Trains arriving at Avery from the west are operated over that part of the Coast Division designated as the First Sub-division which extends between Plummer Jct. and Avery, Idaho, a distance of 64.4 miles. In the vicinity of the point of accident this is a single-track line over which trains are operated by timetable, train orders, and an automatic block system. The accident occurred within yard limits on the main track at a point 750 feet west of the station at Avery. Approaching from the west there is a series of tangents and curves, followed by a tangent 824 feet in length, and then a compound curve to the right with a maximum curvature of  $4^{\circ}$ , which extends 1,091 feet to the point of accident and 496 feet beyond. The grade for east-bound trains is generally ascending, being 0.24 percent at the point of accident. A yard track 3,800 feet long, designated as track No. 1, is located to the south of and parallel to the main track; its east switch is located 404 feet west of the point of accident; at the time of accident the east end of a cut of 40 box cars was located on this track at a point about 600 feet west of the point of accident. The tracks are laid on a hillside cut and generally parallel the north bank of the St. Joe River. The west yard-limit board is located 6,389 feet west of the point of accident.

Automatic signals O-8 and O-0 governing eastward movements are located 4,417 and 169 feet, respectively, west of the point of accident. Signal O-8 is located on the south side and signal O-0 is located on the north side of the main track. Signal O-8 is a 3-position, upper quadrant, semaphore signal, continuously lighted, and is controlled by a D. C. polarized relay; its indications are:
