INTERSTATE COMMERCE COMMISSION
WASHINGTON

REPORT OF THE DIRECTOR
BUREAU OF SAFETY

ACCIDENT ON THE
INDIANA HARBOR BELT RAILROAD

ALCO, INDIANA

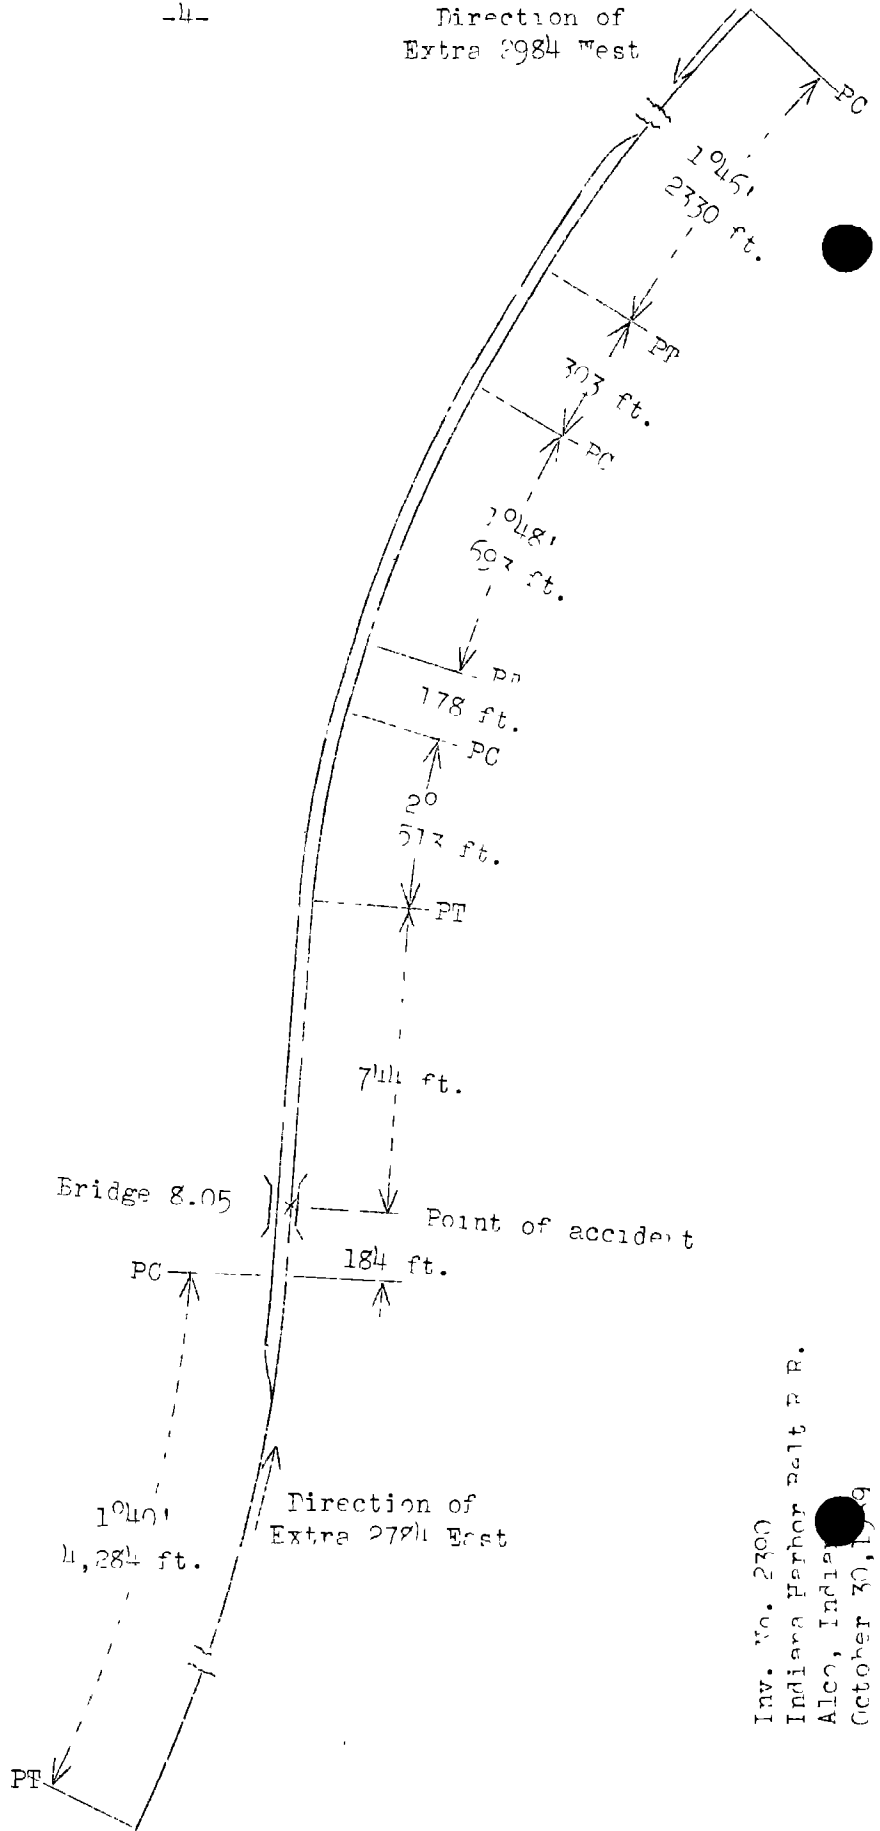
Inv. No. 2300
 Indiana Harbor Belt R.R.
 Alco, Ind.
 October 30, 1929

o	FN, Dure Park, Ind.	
		9.03 mi.
x	Point of accident	
o	Alco	
		1.2 mi.
o	Garv	
		4.5 mi.
o	Ivanhoe	
		2.2 mi.
o	Gibson, Ind.

This accident occurred on the Gary Branch which extends between Gibson and FN telegraph office, Dune Park, Indiana, a distance of 16.93 miles. In the vicinity of the point of accident this is a single-track line over which trains are operated by timetable and train orders; there is no block system in use. The accident occurred on the main track, on bridge 8.05, at a point 667 feet east of the west switch of the siding which parallels the main track on the north and is 4,815 feet in length.
