ACCIDENT ON THE
NEW YORK, CHICAGO & ST. LOUIS RAILROAD

BLUFFTON, OHIO

MAY 22, 1940

INVESTIGATION NO. 2428

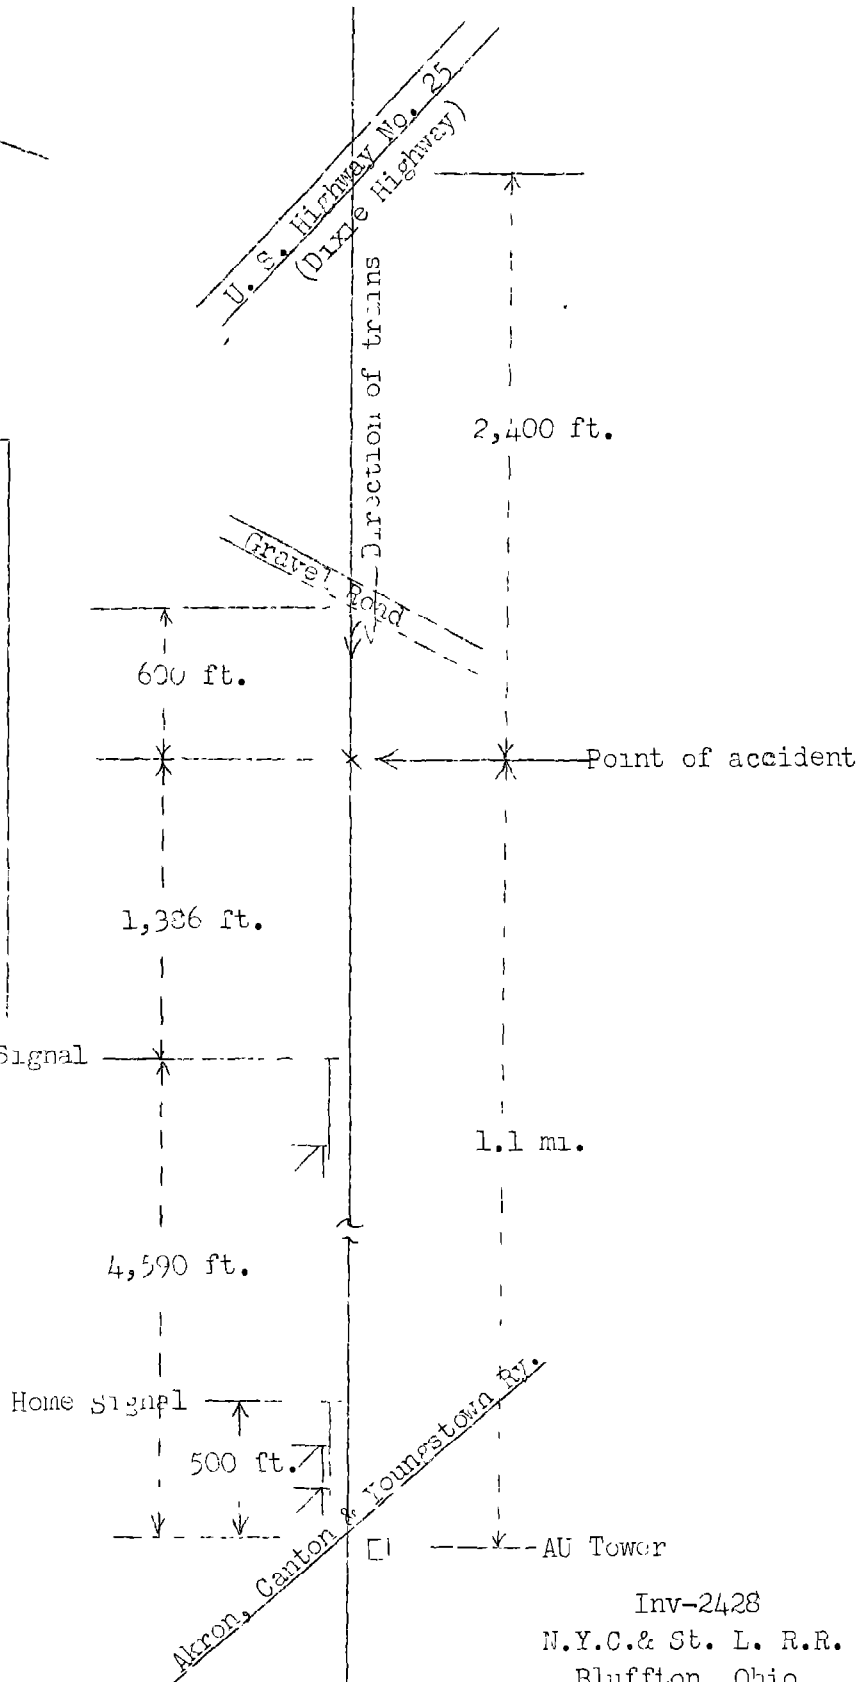
Inv-2428
 N.Y.C. & St. L. R.R.
 Bluffton, Ohio
 May 22, 1940

o Sandusky, Ohio	42.6 mi.
o Fostoria	5.8 mi.
o DA Tower	9.2 mi.
o Findlay	11.6 mi.
o Mt. Cory	2.7 mi.
X Point of accident	1.1 mi.
o AU Tower	0.6 mi.
o Bluffton	16.7 mi.
o South Lima, Ohio

Distant Signal
