REPORT OF THE DIRECTOR
BUREAU OF SAFETY

ACCIDENT ON THE
PENNSYLVANIA RAILROAD

CUYAHOGA FALLS, OHIO

INVESTIGATION NO. 2440

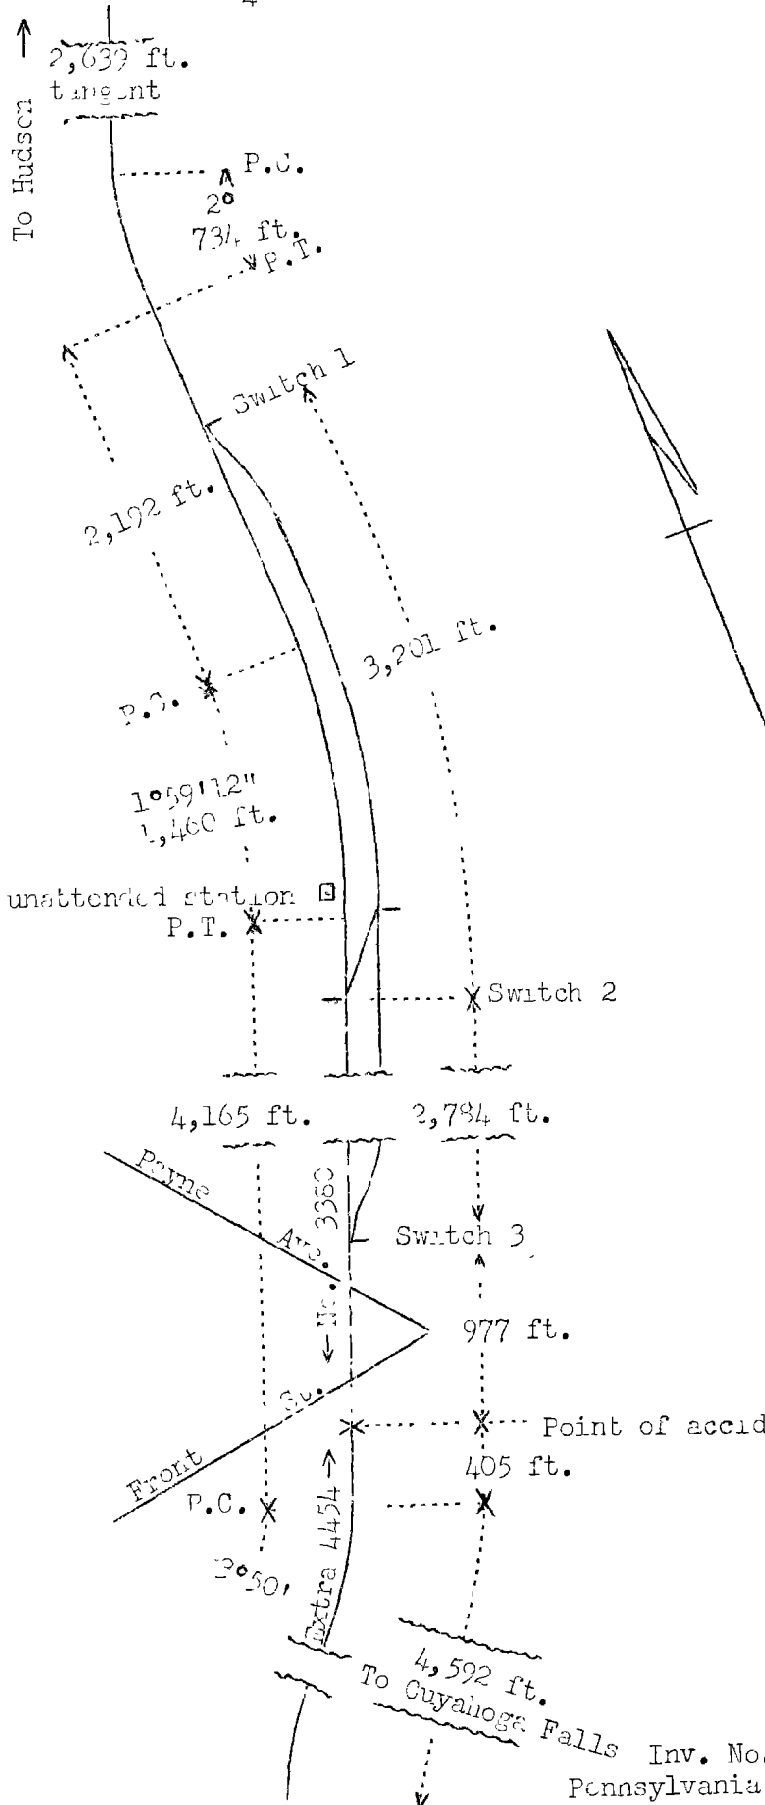
Inv. No. 2440
Pennsylvania Railroad
Cuyahoga Falls, Ohio
July 31, 1940

SI unattended station
P.T.

- Hudson, Ohio
6.3 mi.
- Silver Lake
4,165 ft.
- × Point of accident
4,592 ft.
- Cuyahoga Falls
5.0 mi.
- Akron
2.2 mi.
- Main Street
12 1/2 mi.
- Columbus, Ohio
(Joyce Ave.)

A siding 5,985 feet in length and designated as Silver Lake is north of the point of accident and parallels the main track on the east. The switches are numbered progressively from north to south; the most northerly is designated as switch one, the intermediate, switch two, and the most southerly, switch three; these switches are, respectively, 2.37, 1.58, and 1.05 miles north of the station at Cuyahoga Falls. The accident occurred at a point 977 feet south of switch three. Payne Avenue and Front Street cross the main track diagonally at points, respectively, 677 and 872 feet south of switch three.

An unattended block-station sign is located at a point 2,934 feet south of switch one, 267 feet north of switch two, and 3,050
