INVESTIGATION NO. 2485
THE BALTIMORE & OHIO RAILROAD COMPANY
REPORT IN RE ACCIDENT
AT TAKOMA PARK, D. C., ON
FEBRUARY 26, 1941.

Railroad: Baltimore & Ohio
Date: February 26, 1941
Location: Takoma Park, D. C.
Kind of accident: Rear-end collision
Trains involved: Freight : Freight
Train numbers: Extra 4804 : Extra 4444
Engine numbers: 4834 : 4444
Consist: 44 cars and : 53 cars and
caboose caboose
Speed: Standing : 5-10 m. p. h.
Operation: Automatic block-signal system
Track: Double; tangent; 0.78 percent
descending grade eastward
Weather: Clear
Time: About 2:55 p. m.
Casualties: 1 killed; 1 injured
Cause: Accident caused by failure to provide
adequate flag protection for preced-
ing train and by failure properly to
control speed of following train in
compliance with signal indications

Accident at Takoma Park, D. C., on February 26, 1941, caused
by failure to provide adequate flag protection for pre-
ceding train and by failure properly to control speed of
following train in compliance with signal indications.

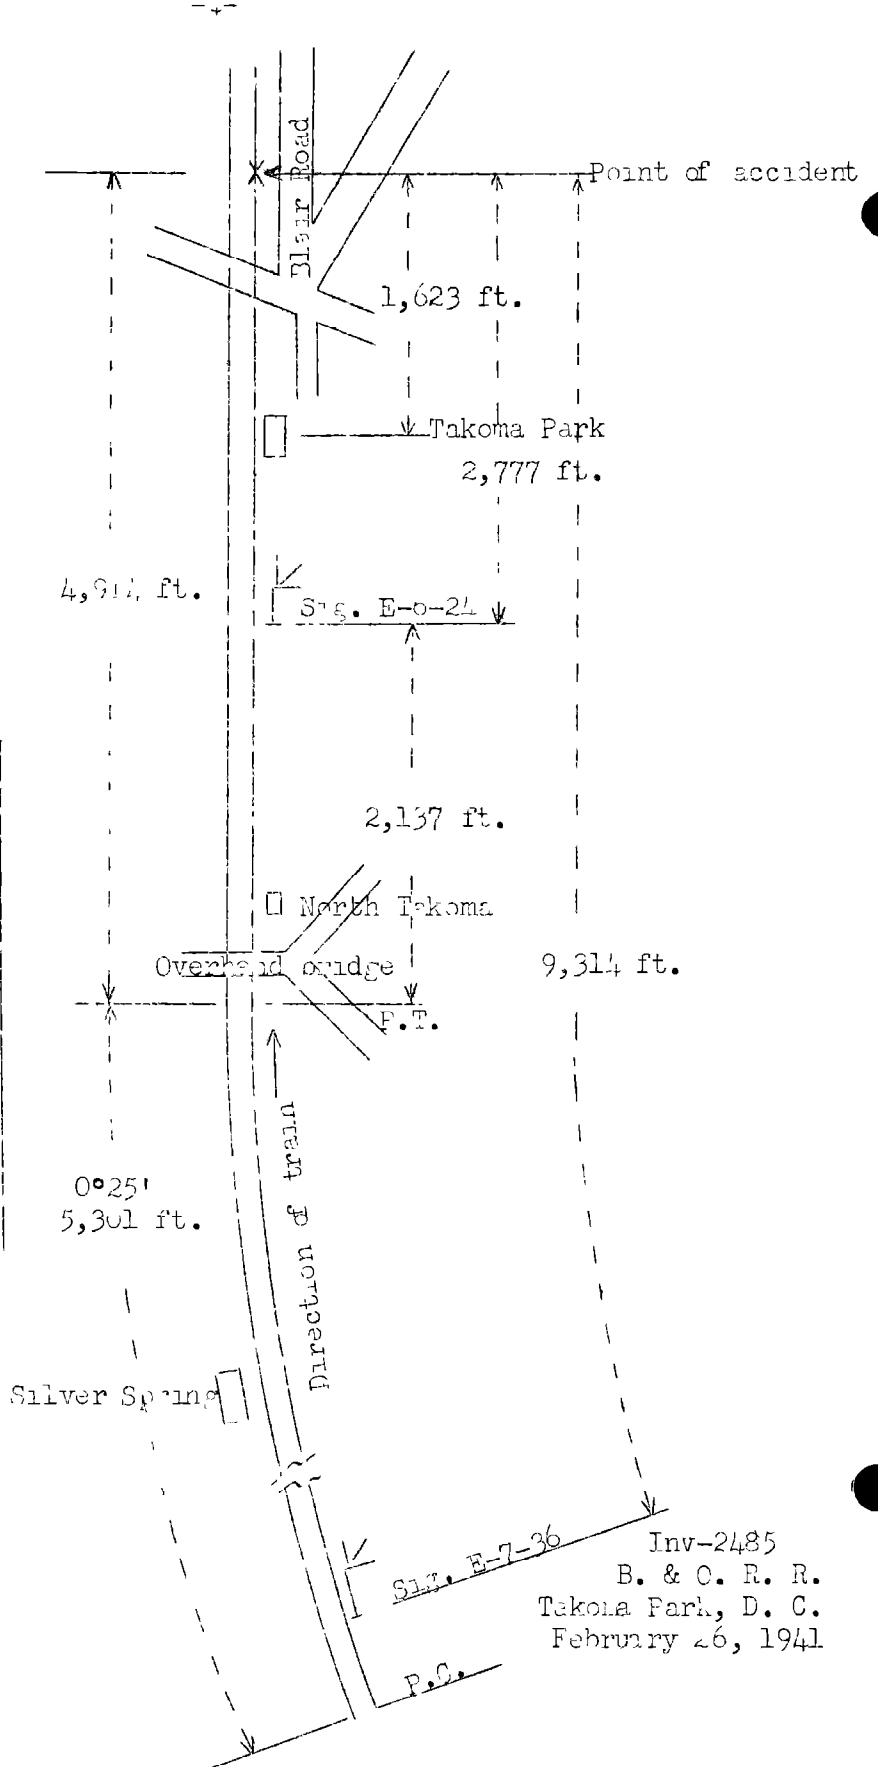
Inv-2485
 B. & O. R. R.
 Takoma Park, D. C.
 February 26, 1941

- o Washington, D. C. 5.2 mi.
- o Inwood 1,017 ft.
- X Point of accident 1,623 ft.
- o Takoma Park, D. C. 0.5 "
- o North Takoma, Md. 0.7 mi.
- o Silver Spring 31.3 mi.
- o Point of tracks 10.1 "
- o Overton, Md.

In the immediate vicinity of the point of accident the tracks are laid on a fill 20 feet in height. Blair Road parallels the tracks on the south at a distance of about 50 feet.

The caboose and the rear two cars became derailed to the right. The caboose stopped on Blair Road at the foot of the embankment, about 30 feet east of the point of collision and 50 feet from the track; it was destroyed by fire. The rear two cars stopped about halfway down the embankment and opposite their relative positions in the train. Engine 4444 became derailed, rolled down the embankment, stopped upright on Blair Road, practically parallel to the track and about 20 feet to the rear of the caboose. The engine was badly damaged; the cab was crushed. The tender stopped on its left side down the embankment at right angles to the track with its front end adjacent to the cab of the engine. The front truck of the first car of Extra 4444 was derailed; this car stopped with its front end about 60 feet east of the point of collision.
