INVESTIGATION NO. 2523
THE PENNSYLVANIA RAILROAD COMPANY
REPORT IN RE ACCIDENT
AT FORT WAYNE, IND., ON
SEPTEMBER 8, 1941

Accident at Fort Wayne, Ind., on September 8, 1941, caused by a train entering a crossover at a high rate of speed on account of a misunderstanding between the yardmaster and a switchtender.

Inv-2523
 Pennsylvania Railroad
 Wabash Tower, Ind.
 Sept. 8, 1941

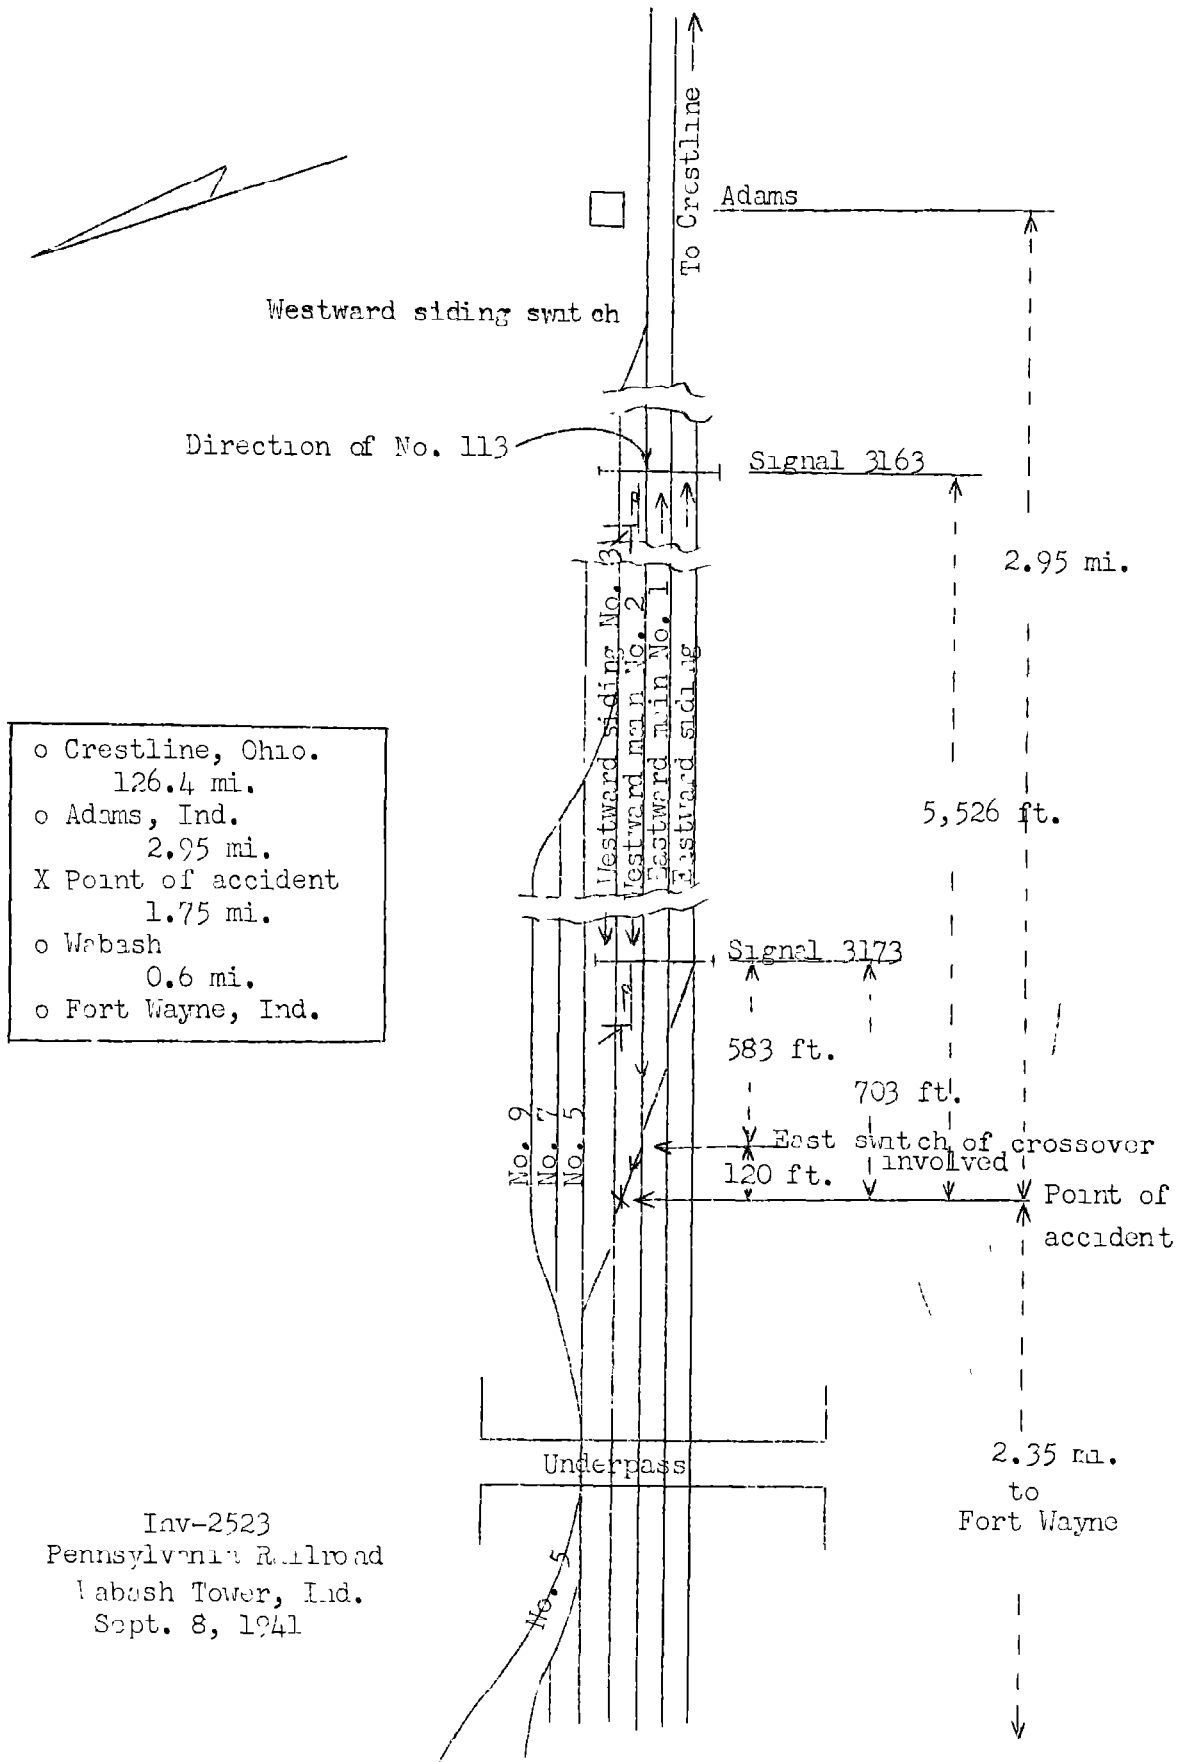
- o Crestline, Ohio. 126.4 mi.
- o Adams, Ind. 2.95 mi.
- X Point of accident 1.75 mi.
- o Wabash 0.6 mi.
- o Fort Wayne, Ind.

2.35 mi.
 to
 Fort Wayne

observed both the aspect of the switch-lamp and the indication of signal 3173 change. The train entered the east switch of the crossover at an estimated speed of 50 or 55 miles per hour and the engine became derailed at a point 120 feet west of this switch, at the west frog. At the point of derailment the curvature was 7027'37" to the left. The engine overturned to the right and slid on its right side a distance of 475 feet.
