INVESTIGATION NO. 2535
THE CLEVELAND, CINCINNATI, CHICAGO & ST. LOUIS
RAILWAY COMPANY

REPORT IN RE ACCIDENT
NEAR MORGANTOWN, IND., ON

OCTOBER 9, 1941

Accident near Morgantown, Ind., on October 9, 1941, caused by
a train order being accepted at a station after train to
which it was addressed had passed that station.

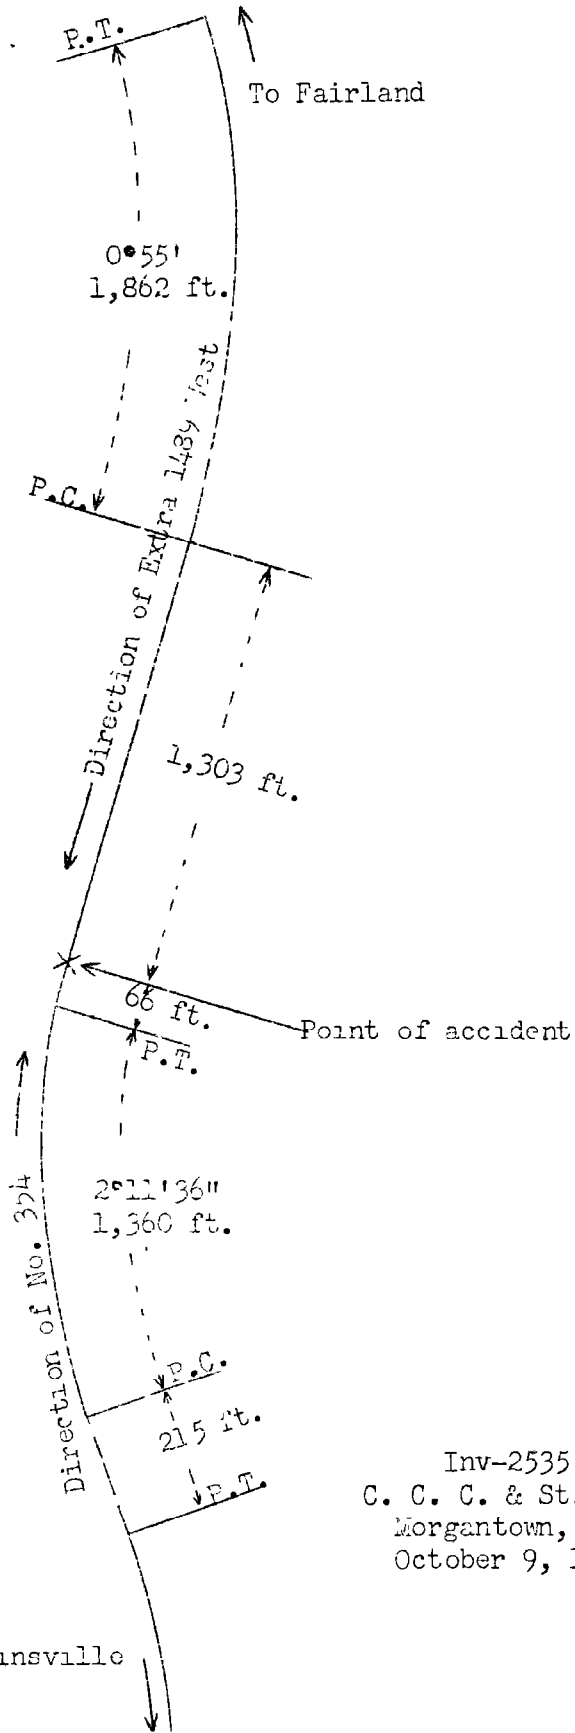
Inv-2535
 C. C. C. & St. L. Ry.
 Morgantown, Ind.
 October 9, 1941.

- o Fairland, Ind. 12.5 mi.
- o Franklin 7.2 mi.
- o Trafalgar 5.11 mi.
- X Point of accident 1.59 mi.
- o Morgantown 11.6 mi.
- o Martinsville, Ind.
