INVESTIGATION NO. 2692
THE MINNEAPOLIS & ST. LOUIS RAILROAD COMPANY
REPORT IN RE ACCIDENT
NEAR ST. LOUIS PARK, MINN., ON
APRIL 11, 1943

Accident near St. Louis Park, Minn., on April 11, 1943,
caused by failure of the preceding train to clear
the time of a following superior train and then by
failure to provide adequate flag protection.

Inv. No. 2692
 Minneapolis & St. Louis Railroad
 St. Louis Park, Minn.
 April 11, 1943

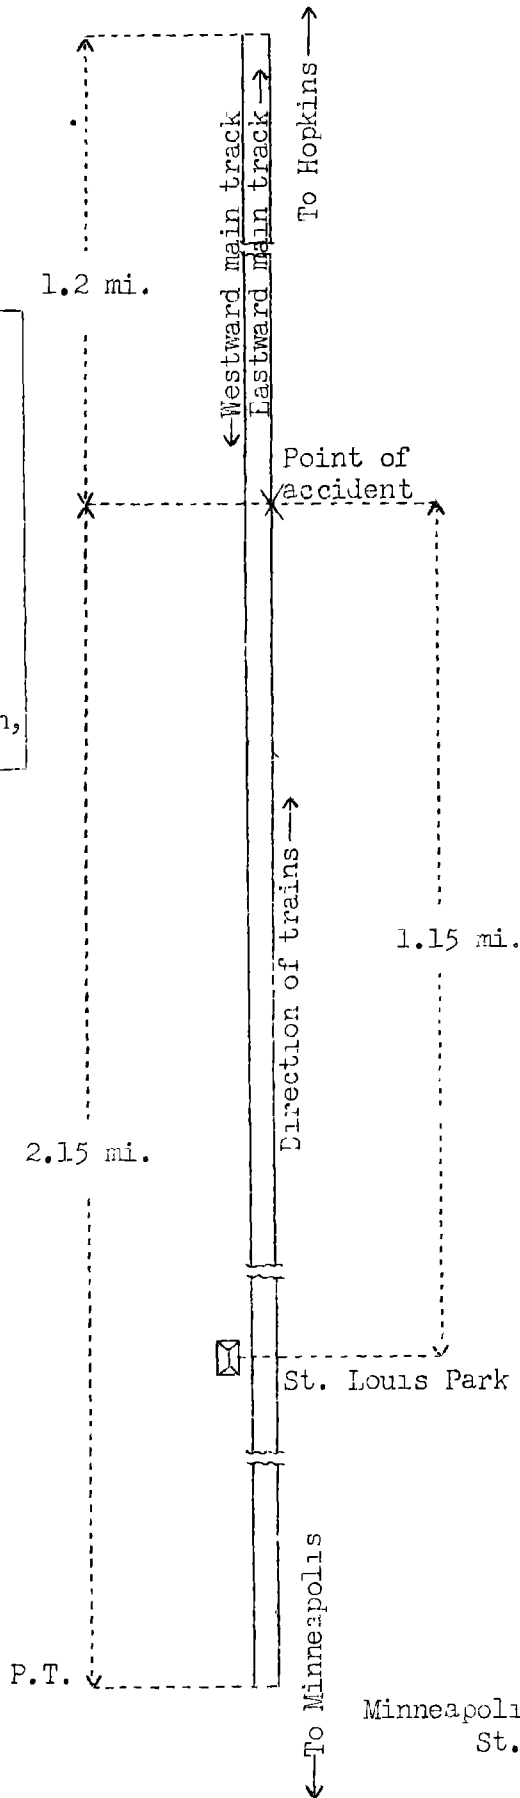
Location of Accident and Method of Operation

Trains of the Chicago, St. Paul, Minneapolis & Omaha Railway, hereinafter referred to as the C. St. P. M. & O., are operated over the Minneapolis & St. Louis Railroad, hereinafter referred to as the M. & St. L., between Holden Street, Minneapolis, and Merriam, Minn., 26.3 miles. This accident occurred on that part of the First District extending between Second Street North, Minneapolis, and Hopkins, Minn., 7.8 miles. This is a double-track line, within yard limits, over which trains moving with the current of traffic are operated by timetable and operating rules. There is no block system in use and there are no sidings between Minneapolis and Hopkins. The accident occurred on the eastward main track 6.75 miles east of Second Street North, Minneapolis, and 1.15 miles east of the station at St. Louis Park. Approaching from the west the track is tangent 2.15 miles to the point of accident and 1.2 miles beyond. In the vicinity of the point of accident the grade for east-bound trains is 0.12 percent ascending.
