INTERSTATE COMMERCE COMMISSION
WASHINGTON

INVESTIGATION NO. 2743
THE CHICAGO & EASTERN ILLINOIS RAILROAD COMPANY
REPORT IN RE ACCIDENT
NEAR CORY, ILL., ON
NOVEMBER 16, 1943

Accident near Cory, Ill., on November 16, 1943, caused by
failure properly to control the speed of the following
train moving within yard limits.

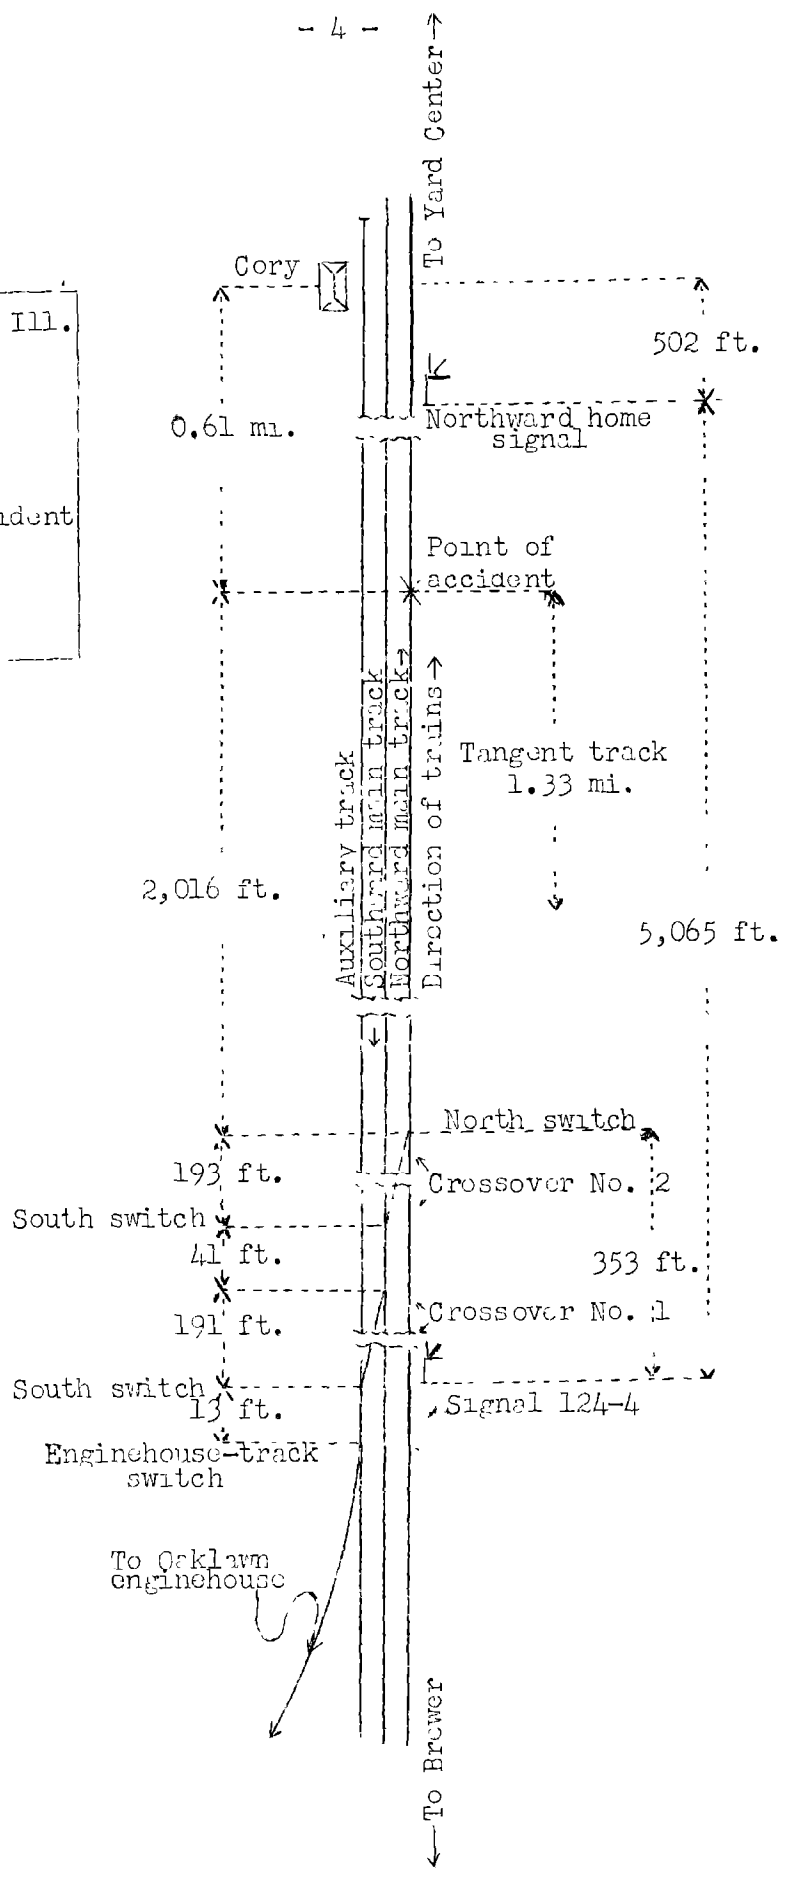
Inv. No. 2743
 Chicago & Eastern Illinois R. R.
 Cory, Ill.
 November 16, 1911

- o Yard Center, Ill. 105.20 mi.
- o Danville 0.20 mi.
- o Cory 0.61 mi.
- X Point of accident 0.79 mi.
- o Oaklawn 1.70 mi.
- o Brewer, Ill.

This accident occurred on that part of the railroad designated as the Danville District and extending between Brewer and Yard Center, Ill., 108.5 miles. Between Oaklawn and Cory, respectively, 1.7 miles and 3.1 miles north of Brewer, this was a double-track line, within yard limits, over which trains were operated by timetable, train orders and an automatic block system. The accident occurred within yard limits on the northward main track 0.61 mile south of the tower at Cory. From the south the main tracks were tangent throughout a distance of 1.33 miles to this point and a considerable distance northward. The grade was practically level.
