INVESTIGATION NO. 2747
THE CLEVELAND, CINCINNATI, CHICAGO & ST. LOUIS
RAILWAY COMPANY
REPORT IN RE ACCIDENT
AT LUDLOW FALLS, OHIO, ON
NOVEMBER 28, 1943

Accident at Ludlow Falls, Ohio, on November 28, 1943, caused
by lap of authority of two opposing trains.

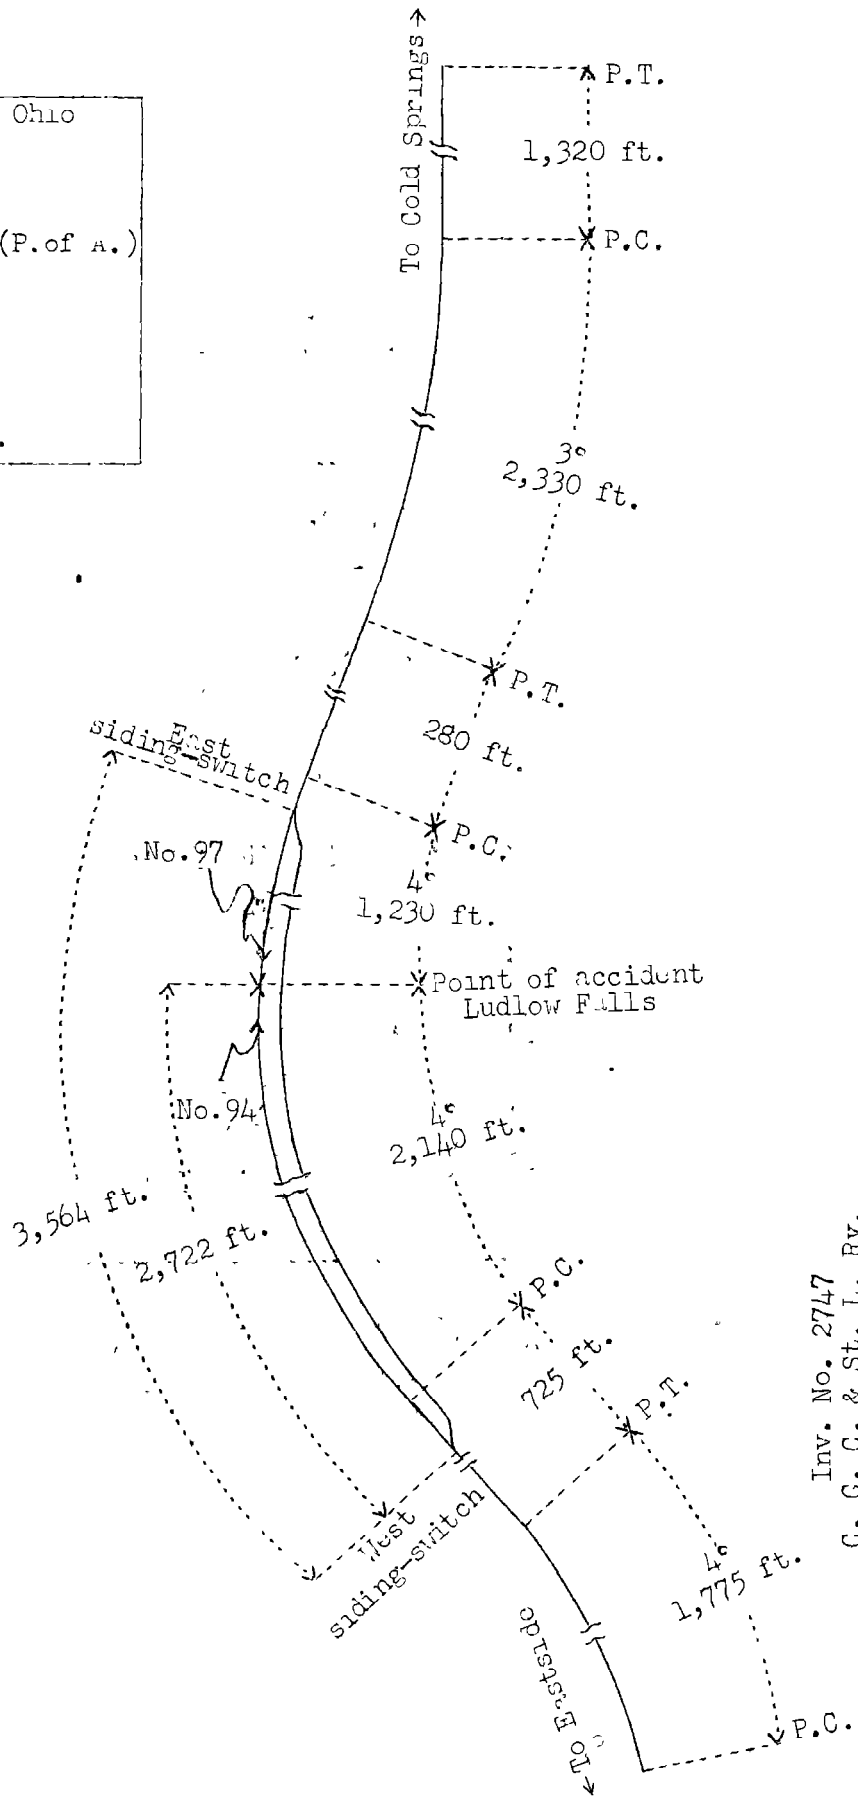
Location of Accident and Method of Operation

- o Cold Springs, Ohio
19.5 mi.
- o Troy
9.4 mi.
- X Ludlow Falls (P. of A.)
19.3 mi.
- o Hewitt, Ohio
15.8 mi.
- o Lynn, Ind.
60.2 mi.
- o Eastside, Ind.

Inv. No. 2747
 C. C. C. & St. L. Ry.
 Ludlow Falls, Ohio
 November 28, 1943
