INVESTIGATION NO 2763
THE NEW YORK, NEW HAVEN AND HARTFORD
RAILROAD COMPANY
REPORT IN RE ACCIDENT
AT DARIEN, CONN., ON
JANUARY 14, 1944

Accident at Darien, Conn., on January 14, 1944, caused by
failure properly to control the speed of the following
train in accordance with signal indications.

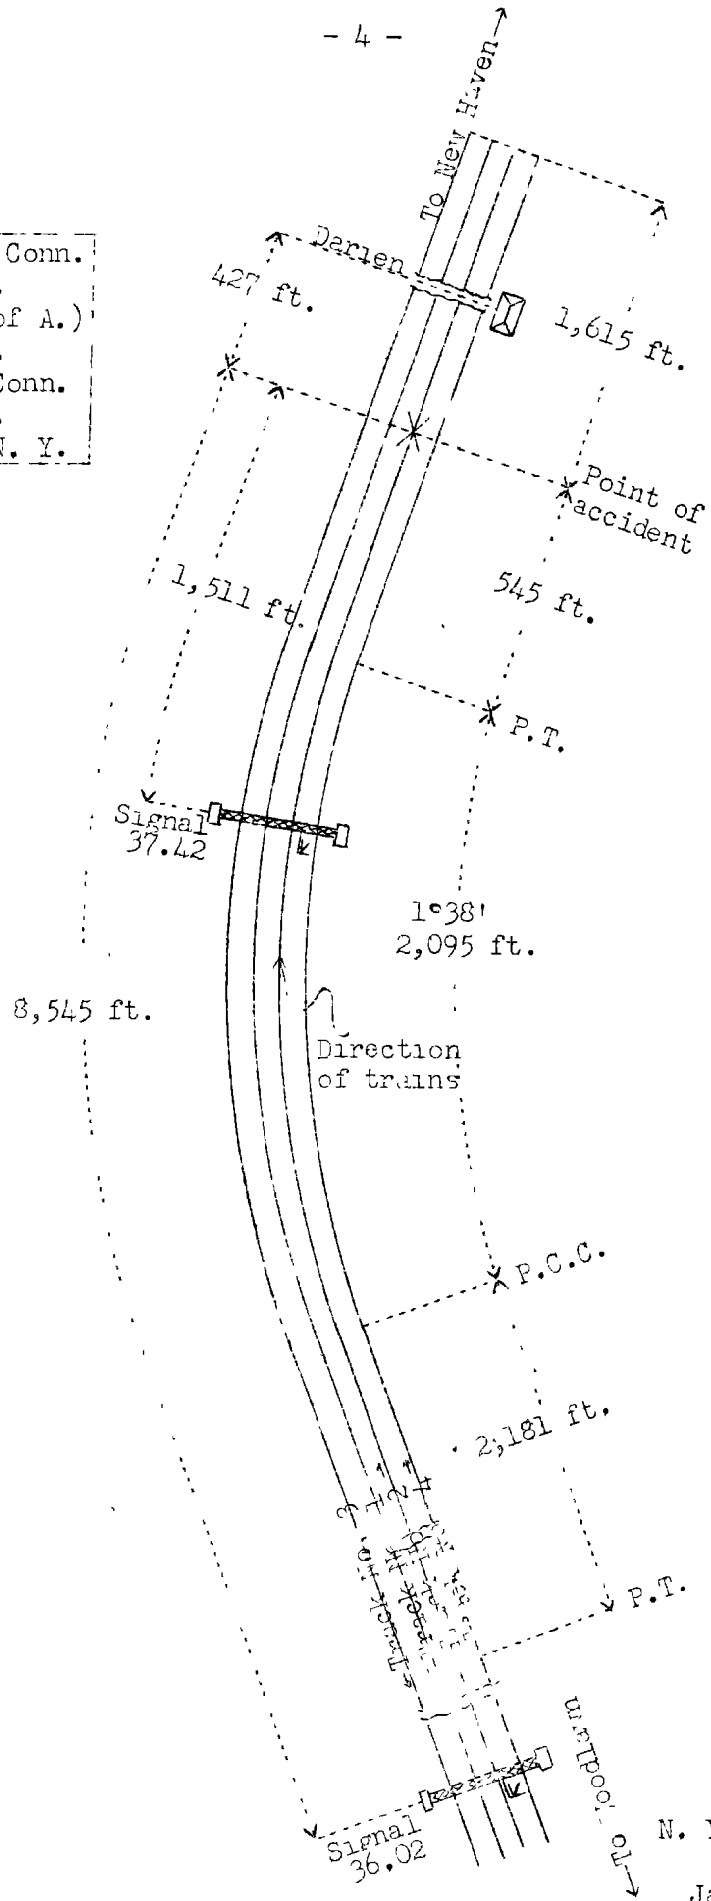
Inv. No. 2763
 N. Y., N. H. & H. R.R.
 Darien, Conn.
 January 14, 1944

- o New Haven, Conn.
34.54 mi.
- X Darien (P. of A.)
4.69 mi.
- o Stamford, Conn.
21.29 mi.
- o Woodlawn, N. Y.

Location of Accident and Method of Operation
