INVESTIGATION NO. 2774
THE PENNSYLVANIA RAILROAD COMPANY
REPORT IN RE ACCIDENT
NEAR ROXTON, PA., ON
FEBRUARY 13, 1944

Accident near Roxton, Pa., on February 13, 1944, caused by failure properly to control the speed of the following train in accordance with signal indications.

Inv. No. 2774
 Pennsylvania Railroad
 Roxton, Pa.
 February 13, 1944

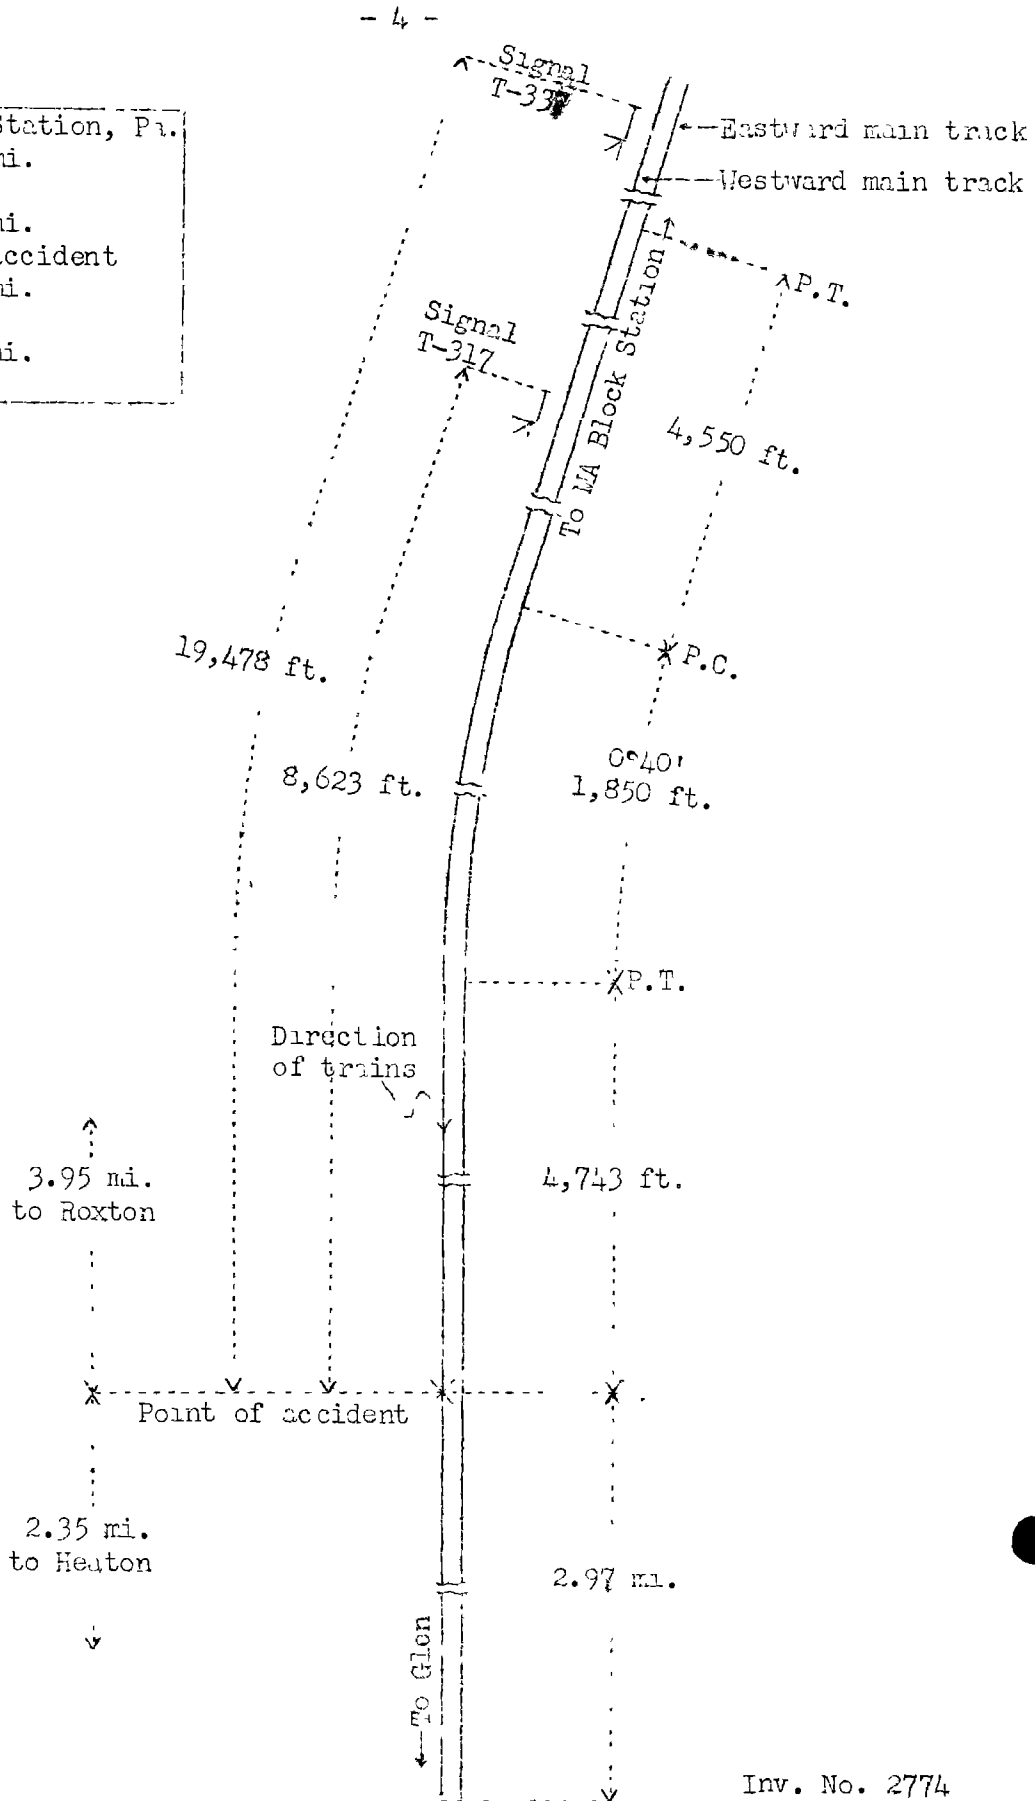
- o MA Block Station, Pa. 7.50 mi.
- o Roxton 3.95 mi.
- X Point of accident 2.35 mi.
- o Heaton 27.50 mi.
- o Glen, Pa.

Location of Accident and Method of Operation
