INVESTIGATION NO. 2784  
THE CHICAGO & EASTERN ILLINOIS RAILROAD COMPANY  
REPORT IN RE ACCIDENT  
AT BOURBON, ILL., ON  
MARCH 15, 1944

Accident at Bourbon, Ill., on March 15, 1944, caused by failure properly to control speed of the following train in accordance with signal indication and flagging signals.

Inv. No. 2784  
 Chicago & Eastern Illinois Railroad  
 Bourbon, Ill.  
 March 15, 1944

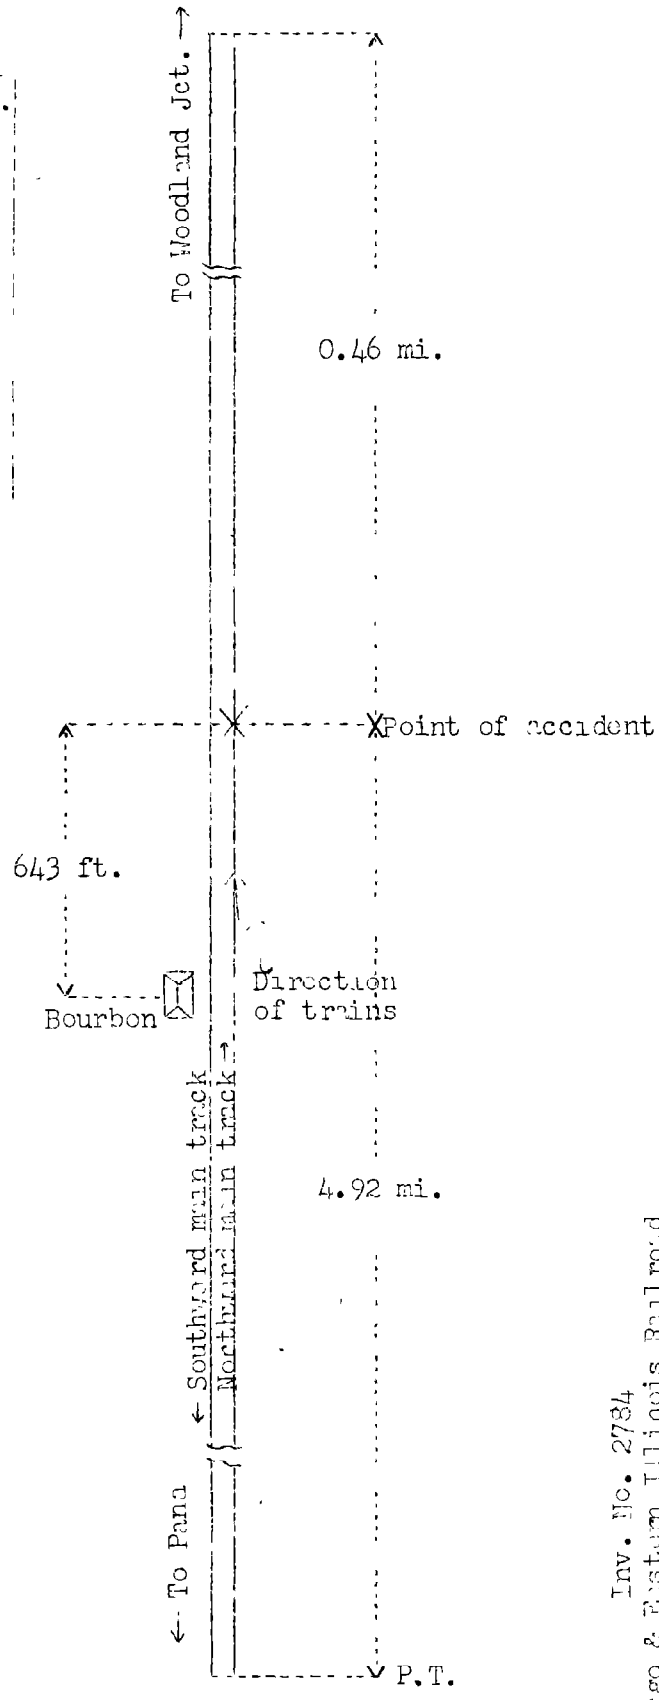
- o Woodland Jct., Ill. 62.2 mi.
- o Villa Grove Jct. 3.7 mi.
- o T. Y. Tower 5.9 mi.
- X Bourbon (P. of A.) 5.3 mi.
- o Arthur 20.8 mi.
- o Findlay Jct. 19.6 mi.
- o Pana, Ill.

Location of Accident and Method of Operation

Under the manual-block indication which No. 62 received at Arthur, this train was required to be so operated that it could be stopped at any point within the distance of the range of vision between Arthur and T. Y. Tower, 5.3 miles and 5.9 miles, respectively, south and north of Bourbon. The explosion of two torpedoes 1,500 feet south of the point of accident required the speed of No. 62 to be controlled in such manner throughout the next mile that it could be stopped within the distance of the range of vision. The burning fusee about 600 feet to the rear of the preceding train required No. 62 to be stopped short of the fusee and, after the fusee was extinguished, this train was required to proceed in such manner that it could be stopped within the distance of the range of vision. In addition, the flagman of the preceding train was giving stop signals. If the following train had been operated in accordance with these requirements, the accident would have been prevented.
