INVESTIGATION NO. 2947
THE NEW YORK CENTRAL RAILROAD COMPANY
REPORT IN RE ACCIDENT
NEAR TERRE COUPEE, IND., ON
NOVEMBER 16, 1945

Railroad: New York Central

Location: Terre Coupee, Ind.

Kind of accident: Derailment and collision

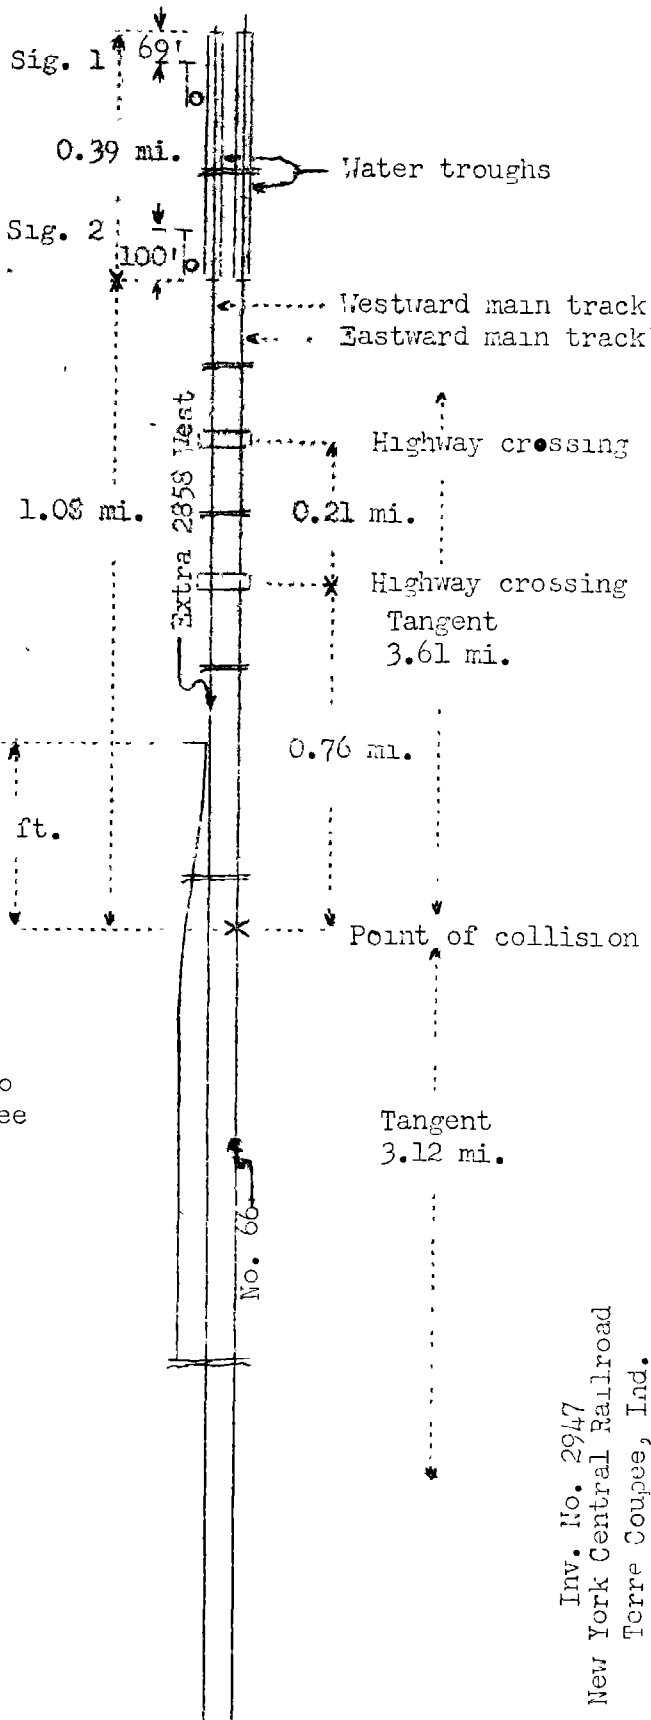
Inv. No. 2947
 New York Central Railroad
 Terre Coupee, Ind.
 November 16, 1945

Location of Accident and Method of Operation
