INVESTIGATION NO. 2957
CHICAGO GREAT WESTERN RAILWAY COMPANY
REPORT IN RE ACCIDENT
NEAR CARROLL, IOWA, ON
DECEMBER 14, 1945

Railroad: Chicago Great Western
Date: December 14, 1945
Location: Carroll, Iowa
Kind of accident: Head-end collision
Trains involved: Freight : Engine
Train numbers: 84 : Extra 737 West
Engine numbers: 757 : 737
Consist: 37 cars, caboose : Engine
Estimated speed: 40 m. p. h. : 30 m. p. h.
Operation: Timetable and train orders
Track: Single; 1^o curve; 0.79 percent
descending grade eastward
Weather: Cloudy
Time: 5:25 p. m.
Casualties: 4 killed; 2 injured
Cause: Failure to obey meet order

Accident near Carroll, Iowa, on December 14, 1945, caused
by failure to obey a meet order.

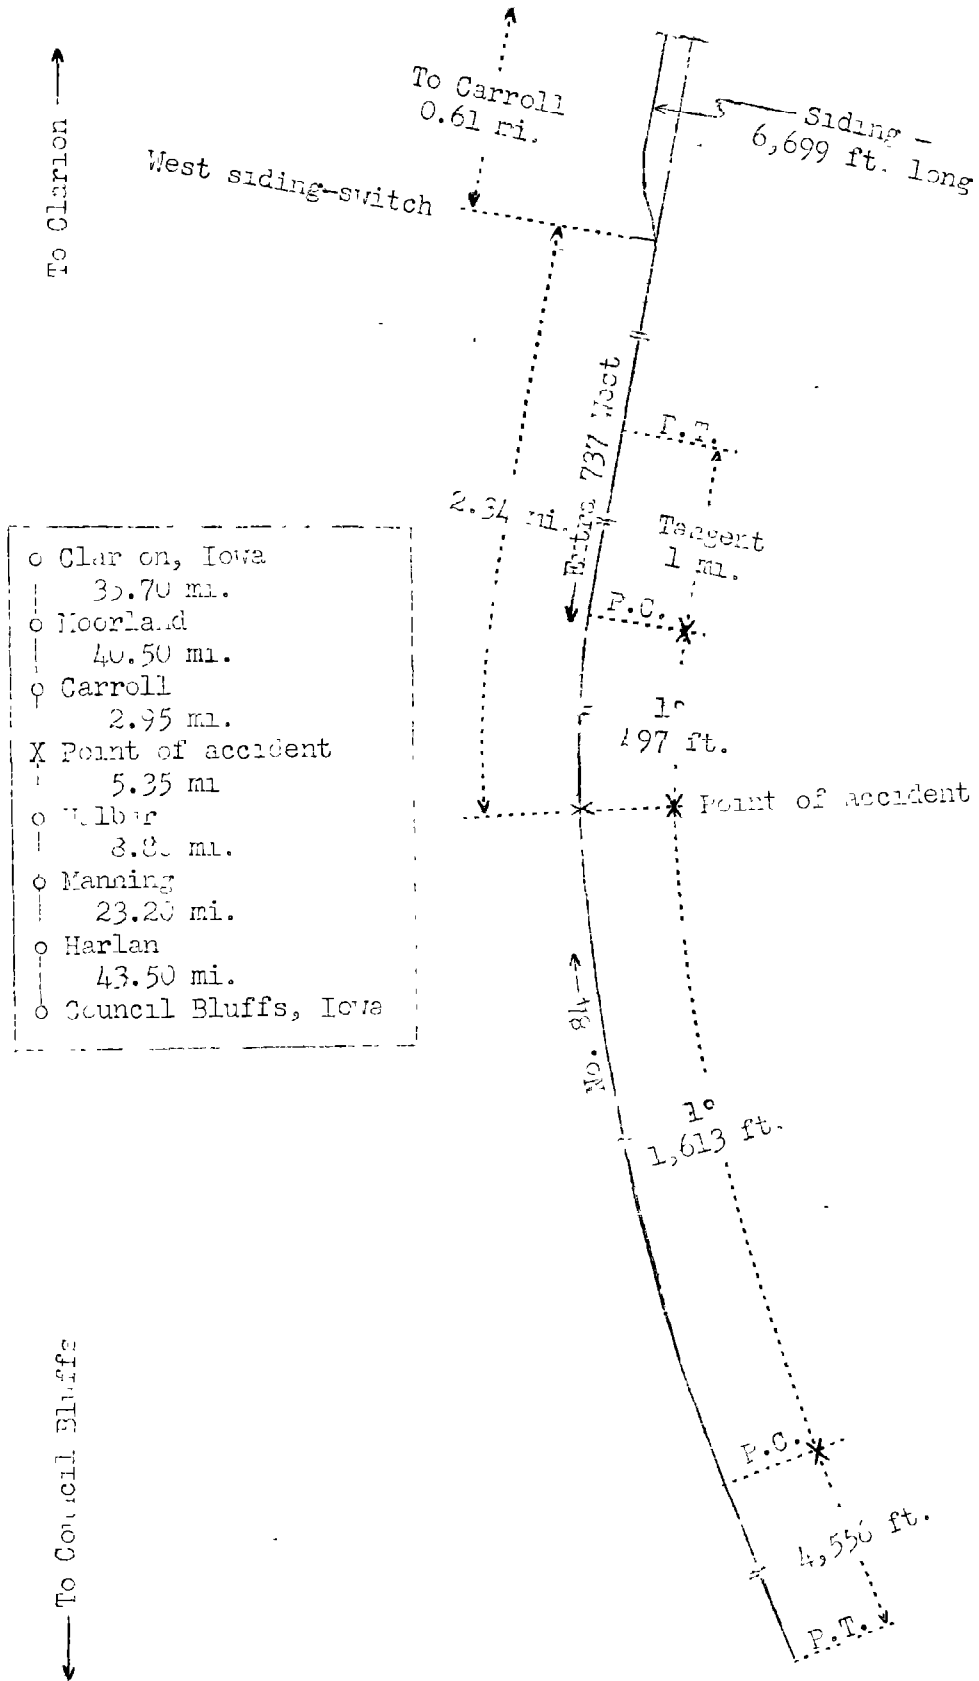
Inv. No. 2957
 Chicago Great Western Railway
 Carroll, Iowa
 December 14, 1945

- o Clarion, Iowa 35.70 mi.
- o Moorland 40.50 mi.
- o Carroll 2.95 mi.
- X Point of accident 5.35 mi.
- o Mulber 8.80 mi.
- o Manning 23.20 mi.
- o Harlan 43.50 mi.
- o Council Bluffs, Iowa

This accident occurred on that part of the Minnesota Division extending between Council Bluffs and Clarion, Iowa, 160 miles, a single-track line over which trains are operated by timetable and train orders. There is no block system in use. At Carroll, 83.8 miles east of Council Bluffs, a siding 6,699 feet in length parallels the main track on the north. The west switch of this siding is 3,222 feet west of the station. The accident occurred on the main track 2.34 miles west of the west siding-switch at Carroll. From the west there is a tangent 4,556 feet in length, which is followed by a 1° curve to the right 1,615 feet to the point of accident and 497 feet eastward. From the east there is a tangent about 1 mile in length, which is followed by the curve on which the accident occurred. The grade is 0.78 percent descending eastward.
