INVESTIGATION NO. 2982  
ERIE RAILROAD COMPANY  
REPORT IN RE ACCIDENT  
AT HAMMOND, IND., CN  
APRIL 4, 1946

Accident at Hammond, Ind., on April 4, 1946, caused by a loose wheel moving outward on its wheel seat, and by derailed passenger-equipment cars striking an engine standing on an adjacent track.

Inv. No. 2952  
 Erie Railroad  
 Hammond, Ind.  
 April 4, 1946

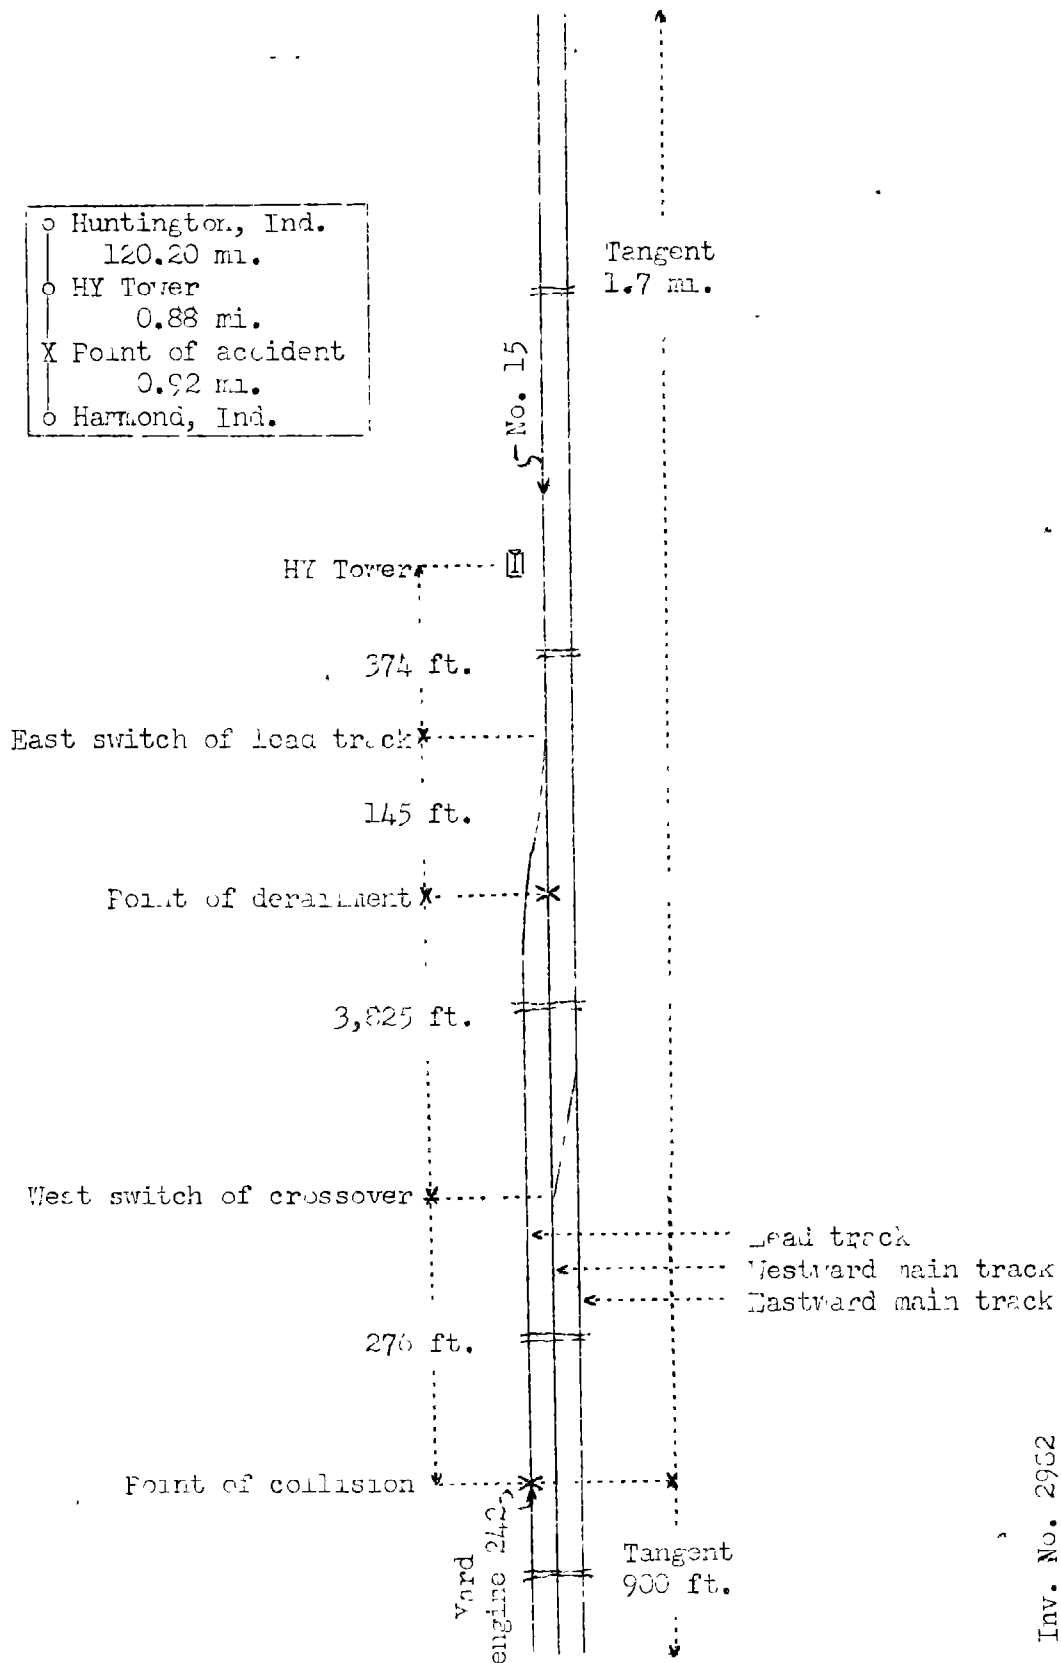
- Huntington, Ind. 120.20 mi.
- HY Tower 0.88 mi.
- X Point of accident 0.92 mi.
- Hammond, Ind.

Location of Accident and Method of Operation
