INVESTIGATION NO. 3093
THE PENNSYLVANIA RAILROAD COMPANY
REPORT IN RE ACCIDENT
AT COLUMBIA CITY, IND., ON
APRIL 7, 1947

Railroad: Pennsylvania
Date: April 7, 1947
Location: Columbia City, Ind.
Kind of accident: Derailment
Train involved: Passenger
Train number: 54
Engine number: 5514
Consist: 15 cars
Estimated speed: 55 m. p. h.
Operation: Movements with current of traffic by signal indications; movements against current of traffic by train orders and manual-block system; interlocking limits
Tracks: Double; tangent; 0.31 percent descending grade eastward
Weather: Clear
Time: 12:27 a. m.
Casualties: 10 injured
Cause: Train entering crossover at high rate of speed

Accident at Columbia City, Ind., on April 7, 1947, caused
by a train entering a crossover at a high rate of
speed.

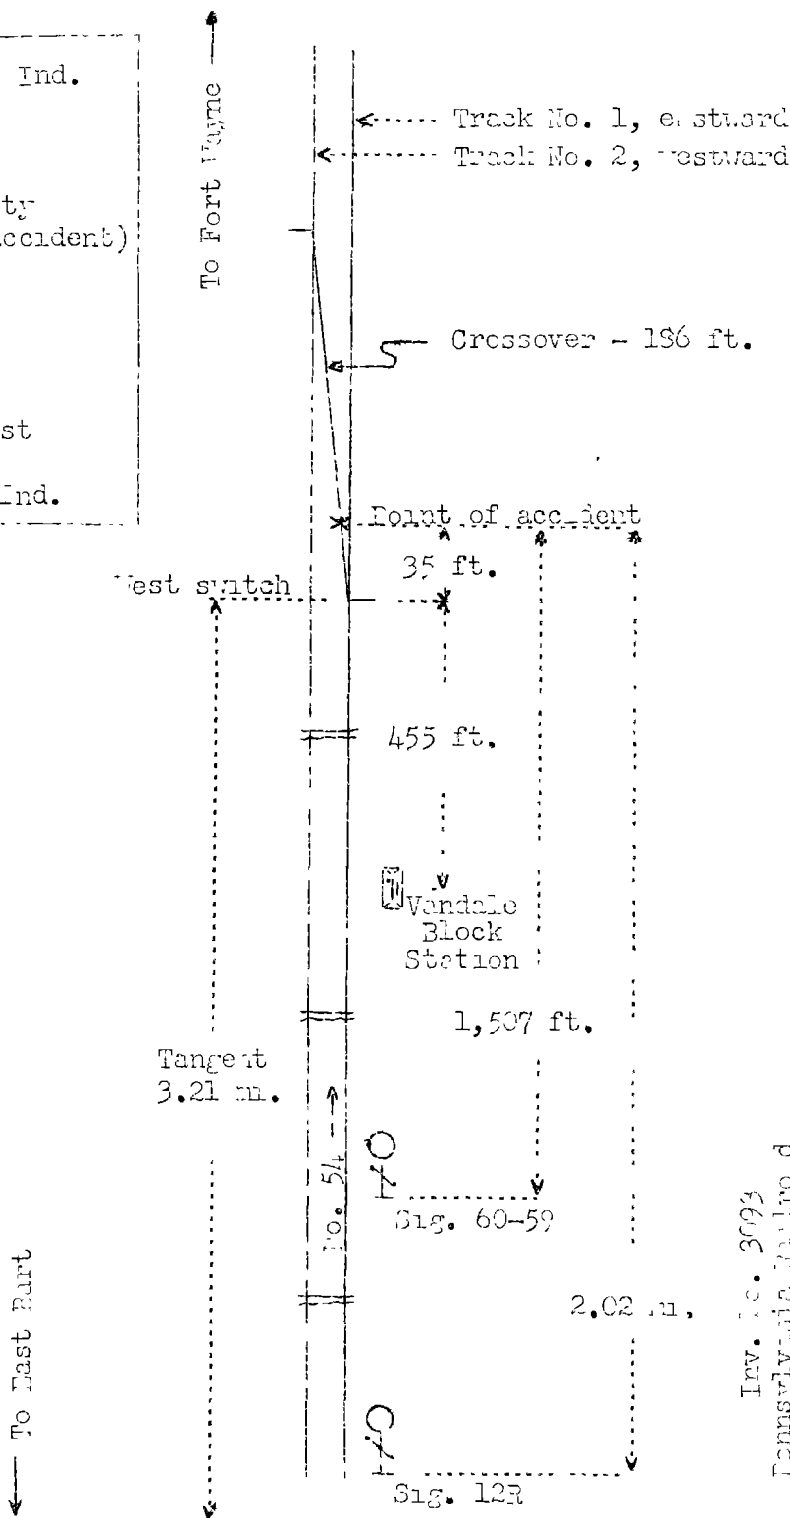
Inv. No. 3093
 Pennsylvania Railroad
 Columbia City, Ind.
 April 7, 1917

- o Fort Wayne, Ind. 1.4 mi.
- o Junction 17.5 mi.
- X Columbia City (Point of accident) 0.6 mi.
- o Vandale 19.3 mi.
- o Warsaw 74.0 mi.
- o Division Post 0.1 mi.
- o East Bart, Ind.

Location of Accident and Method of Operation
