INTERSTATE COMMERCE COMMISSION
WASHINGTON

INVESTIGATION NO. 3120
CHICAGO, BURLINGTON & QUINCY RAILROAD COMPANY
AND
ILLINOIS CENTRAL RAILROAD COMPANY
REPORT IN RE ACCIDENT
NEAR LITCHFIELD, ILL., ON
AUGUST 6, 1947

Inv. No. 3120
 Chicago, Burlington & Quincy Railroad
 and
 Illinois Central Railroad
 Litchfield, Ill.
 August 6, 1947

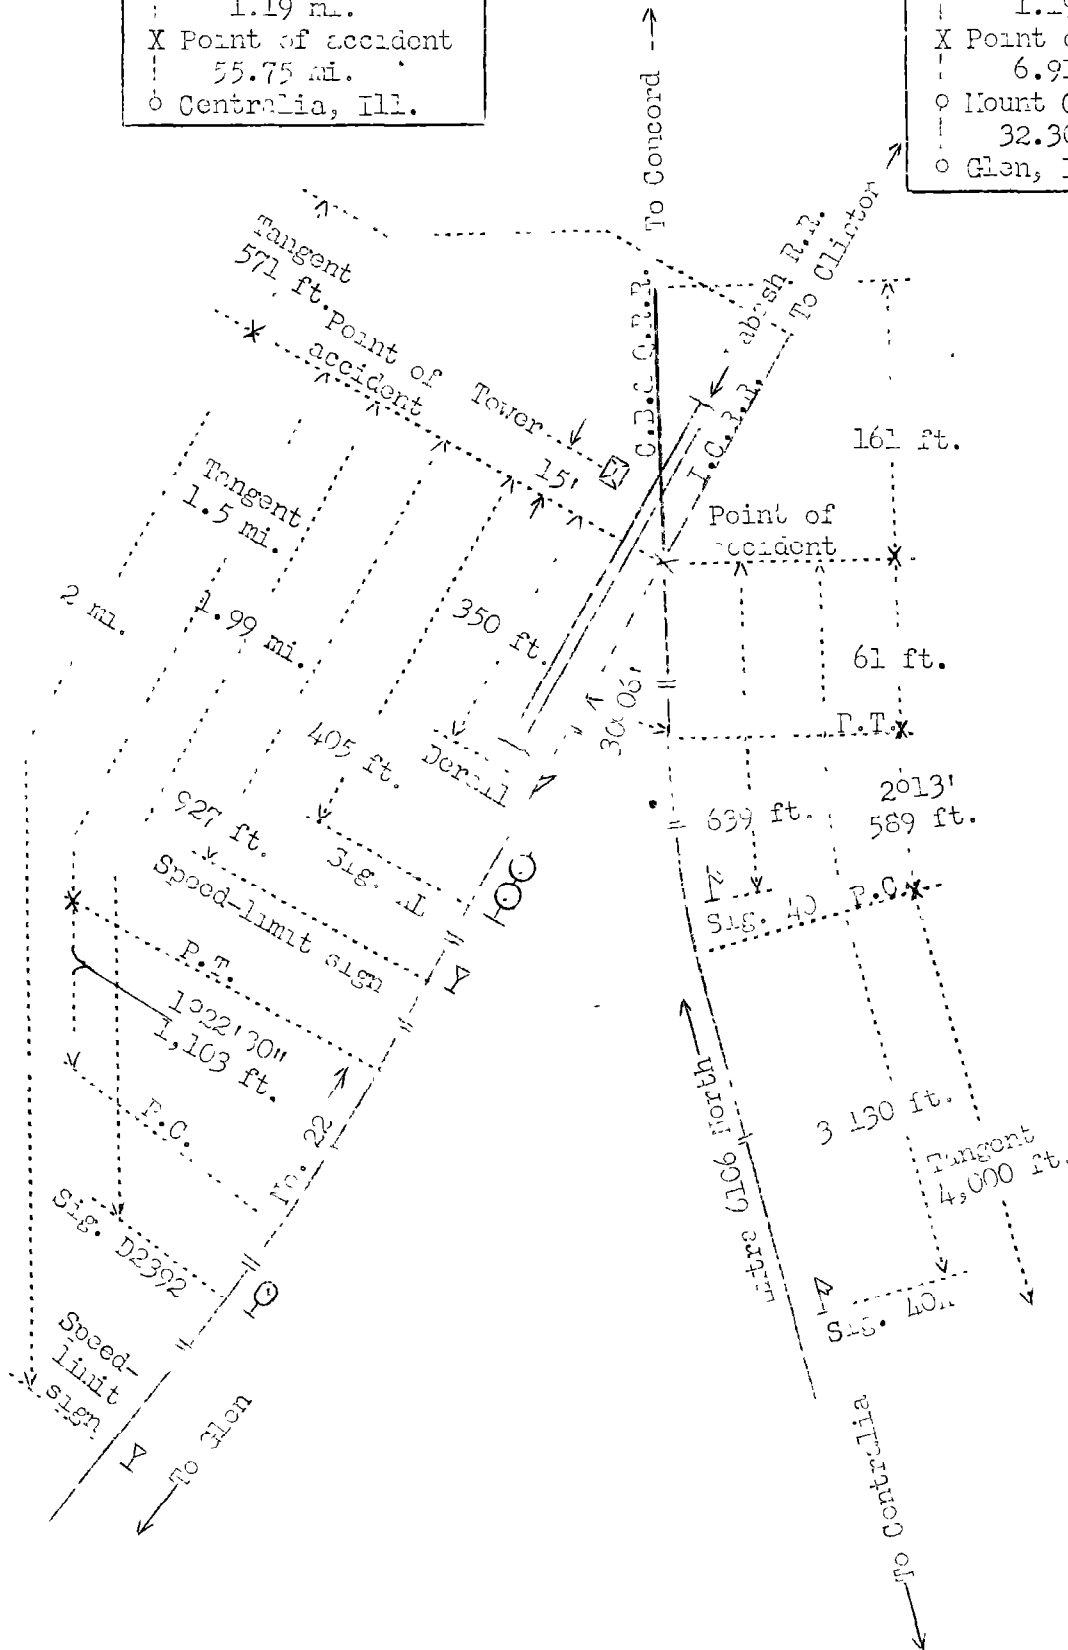
- o Concord, Ill. 63.28 mi.
- o Litchfield 1.19 mi.
- X Point of accident 55.75 mi.
- o Centralia, Ill.

- o Clinton, Ill. 87.40 mi.
- o Litchfield 1.19 mi.
- X Point of accident 6.92 mi.
- o Mount Olive 32.30 mi.
- o Glen, Ill.
