INVESTIGATION NO. 3145
ELGIN, JOLIET & EASTERN RAILWAY COMPANY
REPORT IN RE ACCIDENT
NEAR EOLA, ILL., ON
NOVEMBER 23, 1947

Accident near Eola, Ill., on November 23, 1947, caused
by a train being erroneously reported into clear.

Inv. No. 31145
 Elgin, Joliet & Eastern Railway
 Eola, Ill.
 November 23, 1947

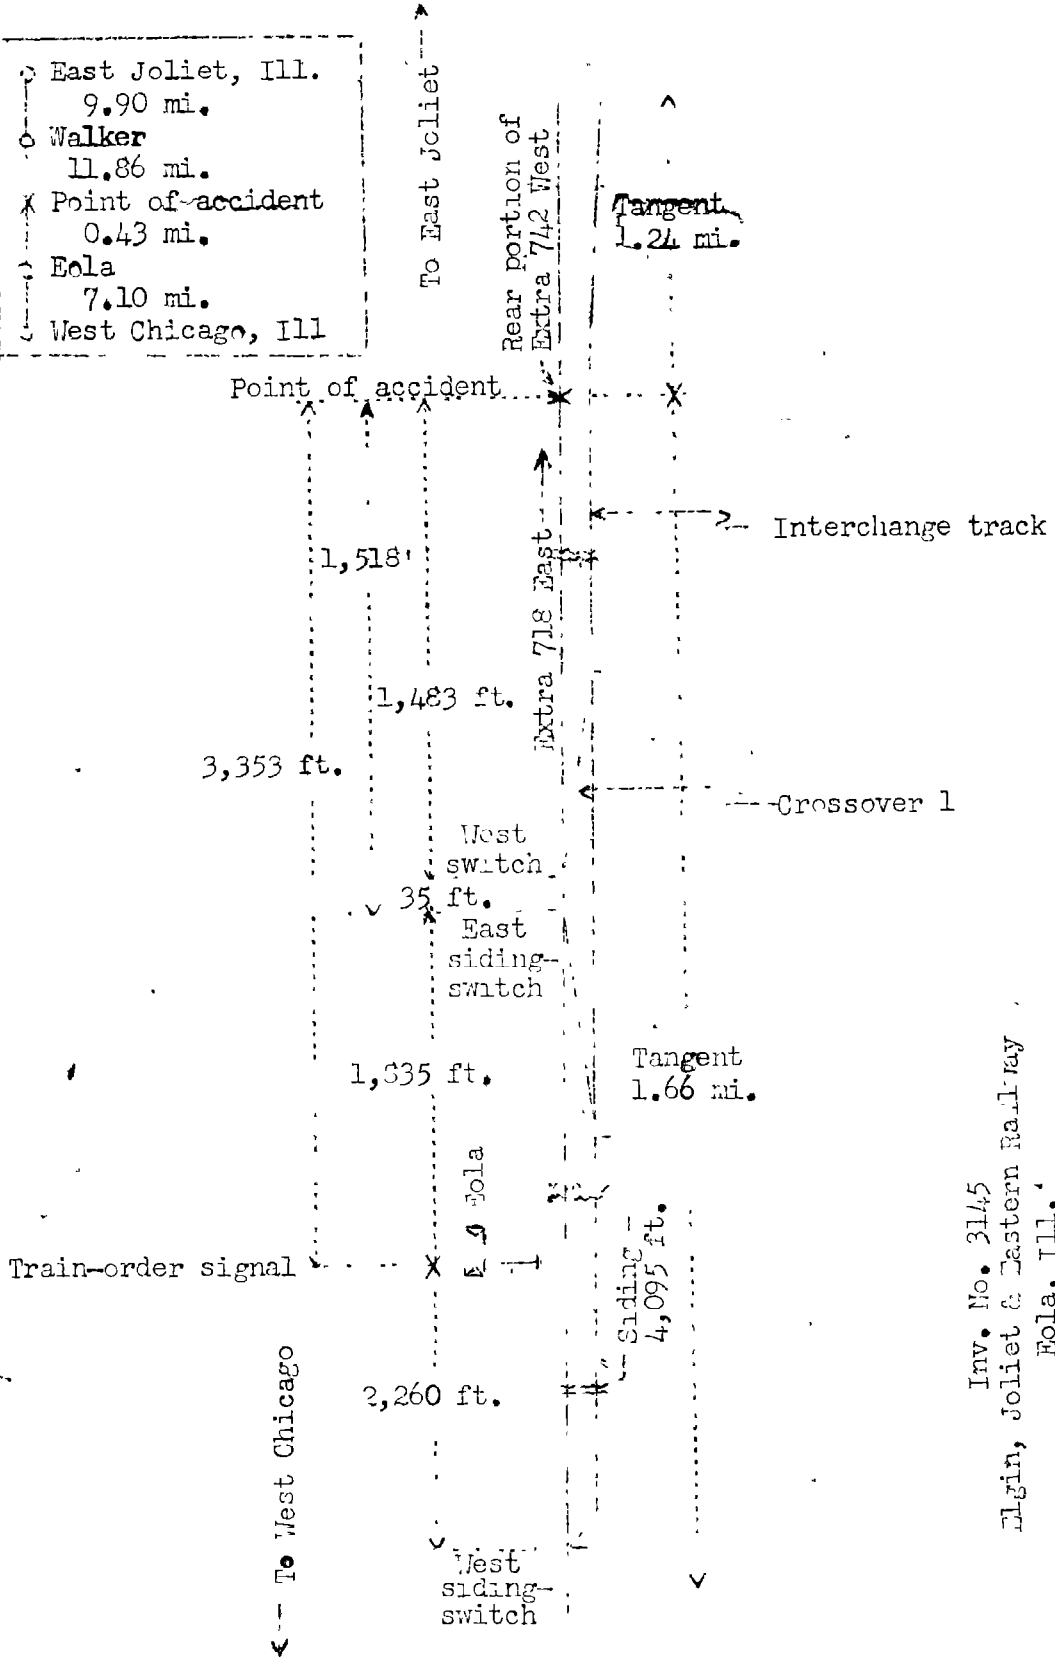
- East Joliet, Ill. 9.90 mi.
- Walker 11.86 mi.
- ✕ Point of accident 0.43 mi.
- Eola 7.10 mi.
- West Chicago, Ill

Location of Accident and Method of Operation

Extra 742 West, a west-bound freight train consisting of engine 742, 30 cars and a caboose, departed from Walker, 12.29 miles east of Eola, at 4:22 p. m., and stopped immediately east of the east siding-switch at Eola at 4:50 p. m. About 2 minutes later, when this train started to enter the siding at the east switch the front coupler of the twenty-ninth car failed and the train became separated at a point 1,518 feet east of the east siding-switch. The first twenty-eight cars were then moved to the siding, and the rear two cars and the caboose remained on the main track. The engine was detached from the front portion of the train, entered the main track at the west siding-switch, moved eastward to crossover 1, thence through the crossover to the interchange track. About 5:25 p. m., the west end of the rear portion of Extra 742 West was struck by Extra 718 East.
