INVESTIGATION NO. 3148
THE NEW YORK CENTRAL RAILROAD COMPANY
REPORT IN RE ACCIDENT
AT AUBURN, IND., ON
DECEMBER 21, 1947

Accident at Auburn, Ind., on December 21, 1947, caused
by failure to operate train in accordance with
an interlocking signal indication.

Inv. No. 3148
 New York Central Railroad
 Auburn, Ind.
 December 21, 1947

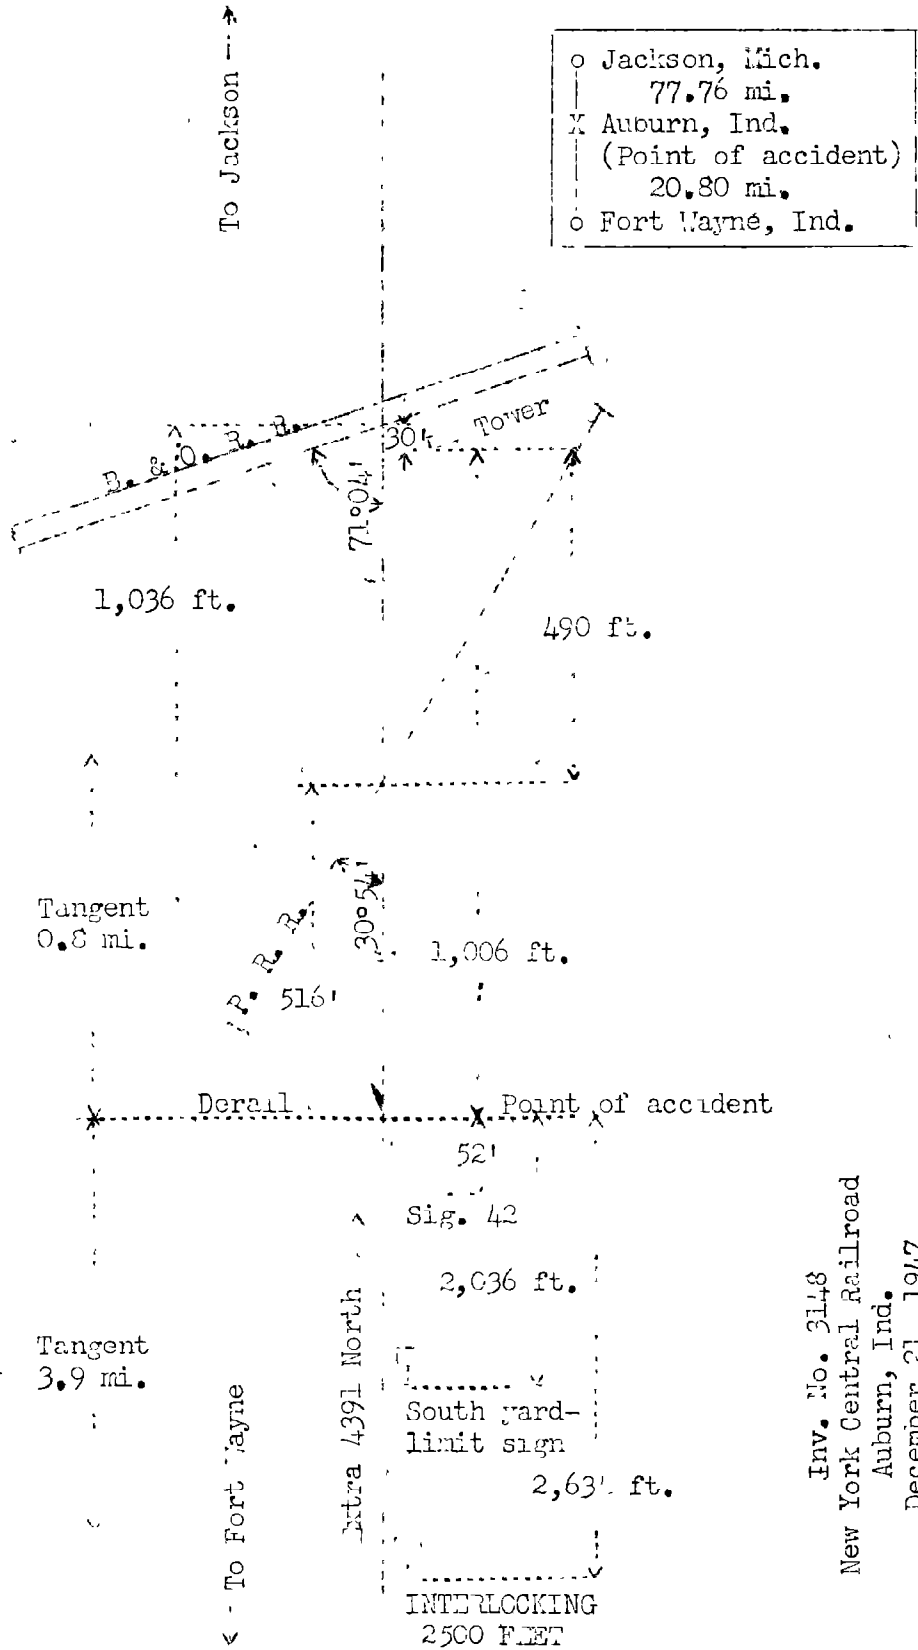
o Jackson, Mich.
 77.76 mi.
 X Auburn, Ind.
 (Point of accident)
 20.80 mi.
 o Fort Wayne, Ind.

This accident occurred on that part of the Toledo Division extending between Fort Wayne, Ind., and Jackson, Mich., 98.56 miles, a single-track line, over which trains are operated by timetable and train orders. There is no block system in use. Within yard and interlocking limits at Auburn, 20.8 miles north of Fort Wayne, this line intersects a single-track line of the Pennsylvania Railroad and a double-track line of the Baltimore and Ohio Railroad. The N.Y.C. main track extends north and south, and the P.R.R. and B. & O. main tracks extend northeast and southwest. The crossings are protected by interlocking signals. The N.Y.C. main track and the P.R.R. main track intersect at an angle of 30°54', at a point 490 feet south of the tower, and the N.Y.C. main track and the B. & O. main tracks intersect at an angle of 71°04', at a point 30 feet north of the tower, which is located in the southeast angle of the N.Y.C.-B. & O. crossing. The accident occurred within interlocking limits on the N.Y.C. main track at derail 44, a split-switch type derail located on the west rail and 1,006 feet south of the tower. The N.Y.C. main track is tangent throughout a distance of 3.9 miles immediately south of the point of accident and 0.8 mile northward. The grade for north-bound trains is, successively, 0.47 percent ascending 1,000 feet, 0.36 percent descending 1,300 feet and 0.28 percent ascending 788 feet to the point of accident and 112 feet northward.
