INVESTIGATION NO. 3165  
CHICAGO, MILWAUKEE, ST. PAUL AND PACIFIC  
RAILROAD COMPANY  
REPORT IN RE ACCIDENT  
AT STURTEVANT, WIS., ON  
FEBRUARY 11, 1948

Kind of accident: Head-end collision

Accident at Sturtevant, Wis., on February 11, 1948,  
caused by failure to obey an interlocking  
signal indication.

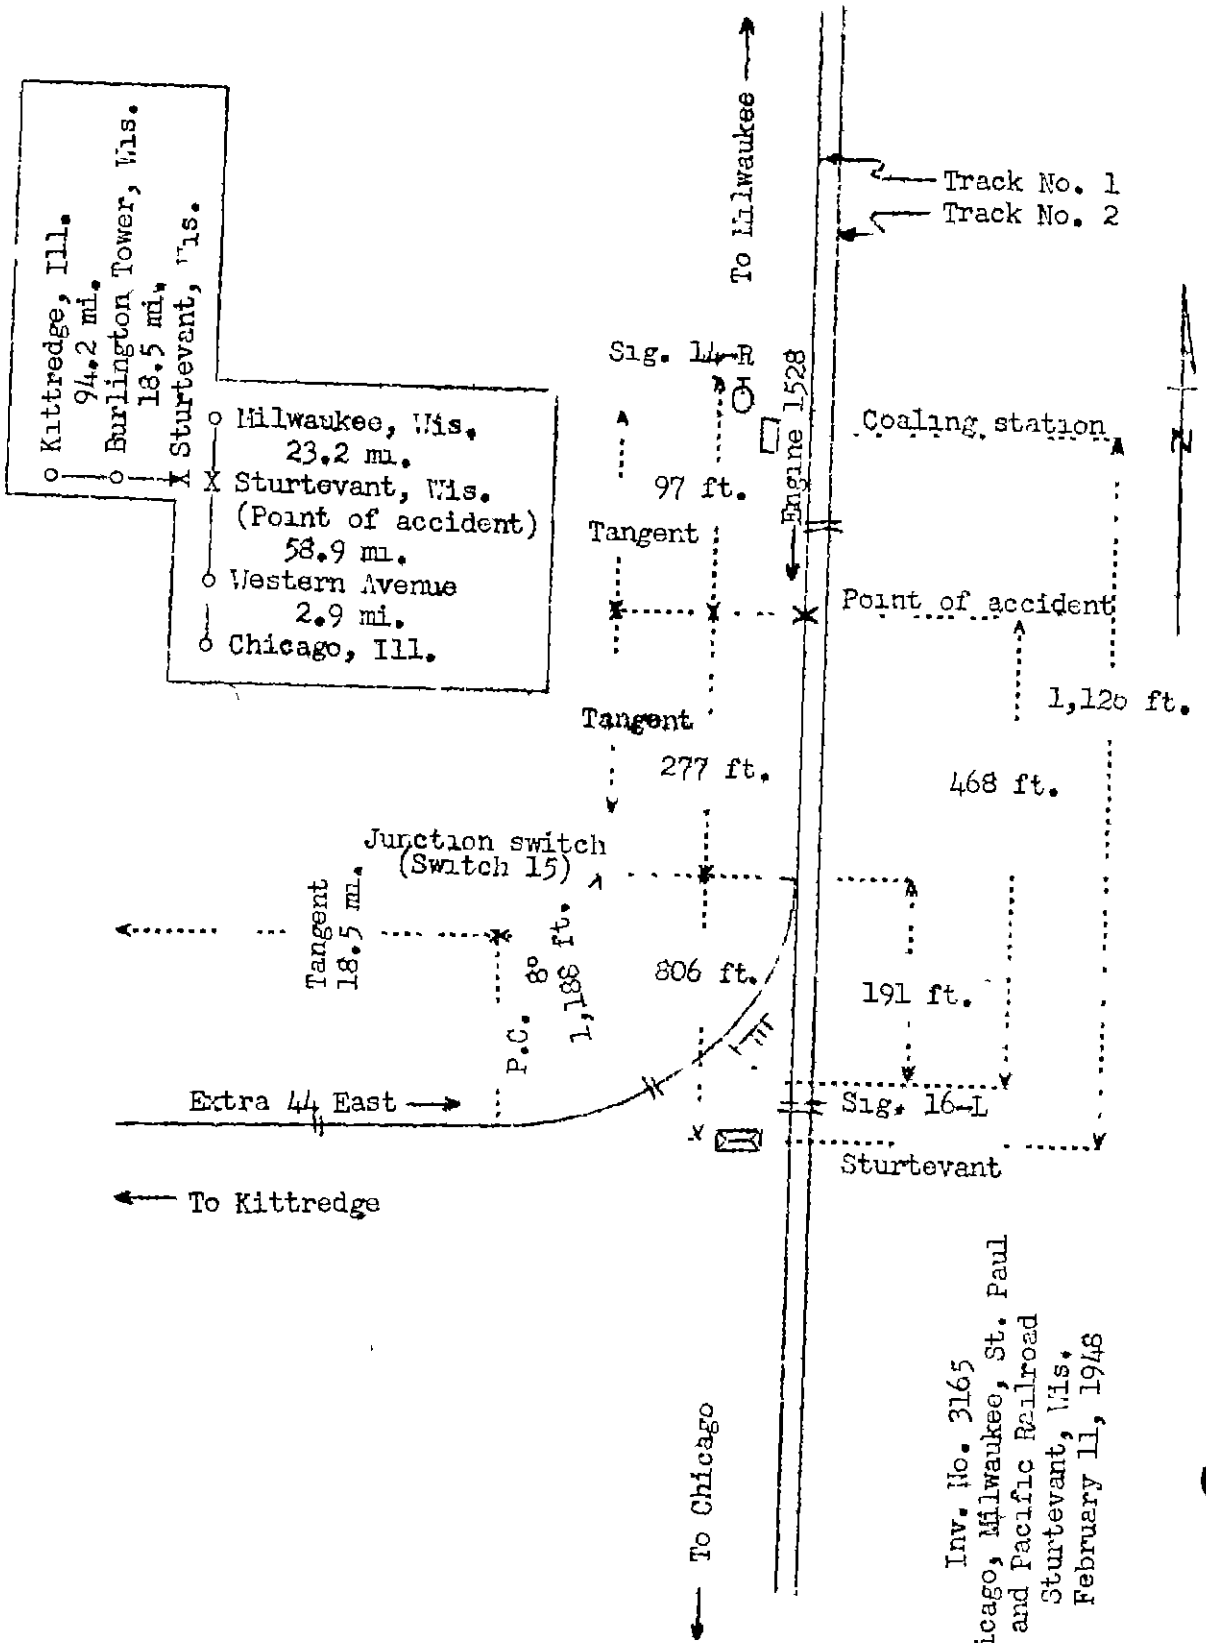
Kittredge, Ill.  
 94.2 mi.  
 Burlington Tower, Wis.  
 18.5 mi.  
 Sturtevant, Wis.

Milwaukee, Wis.  
 23.2 mi.  
 Sturtevant, Wis.  
 (Point of accident)  
 58.9 mi.  
 Western Avenue  
 2.9 mi.  
 Chicago, Ill.
