INVESTIGATION NO. 3267  
THE NEW YORK CENTRAL RAILROAD COMPANY  
REPORT IN RE ACCIDENT  
NEAR PHILADELPHIA, N. Y., ON  
JULY 22, 1949

Accident near Philadelphia, N. Y., on July 22, 1949,  
caused by a train being admitted under clear-  
block authority to a block occupied by an  
opposing track motor-car.

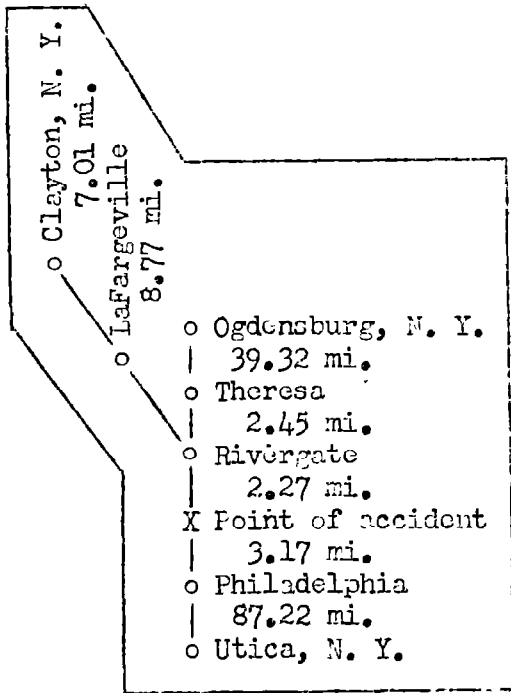
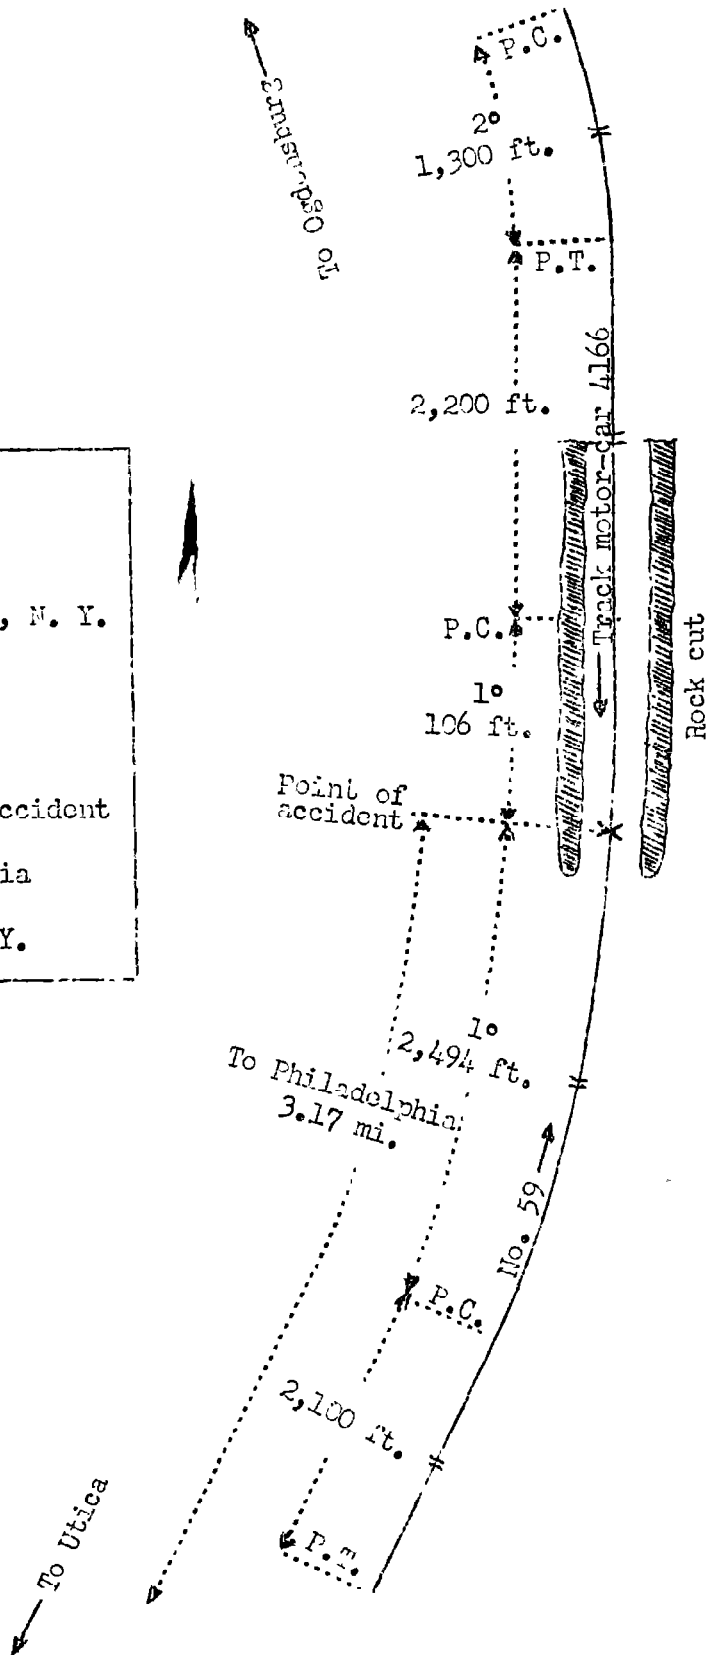
Inv. No. 3267  
 New York Central Railroad  
 Philadelphia, N. Y.  
 July 22, 1949

Location of Accident and Method of Operation
