REPORT No. 3612  
ILLINOIS TERMINAL RAILROAD COMPANY  
IN RE ACCIDENT  
AT REUTERS, ILL., ON  
FEBRUARY 3, 1955

Accident at Reuters, Ill., on February 3, 1955, caused by improper handling of a train order and failure properly to control the speed of a train moving within yard limits.

Report No. 3612  
 Illinois Terminal Railroad  
 Reuters, Ill.  
 February 3, 1955

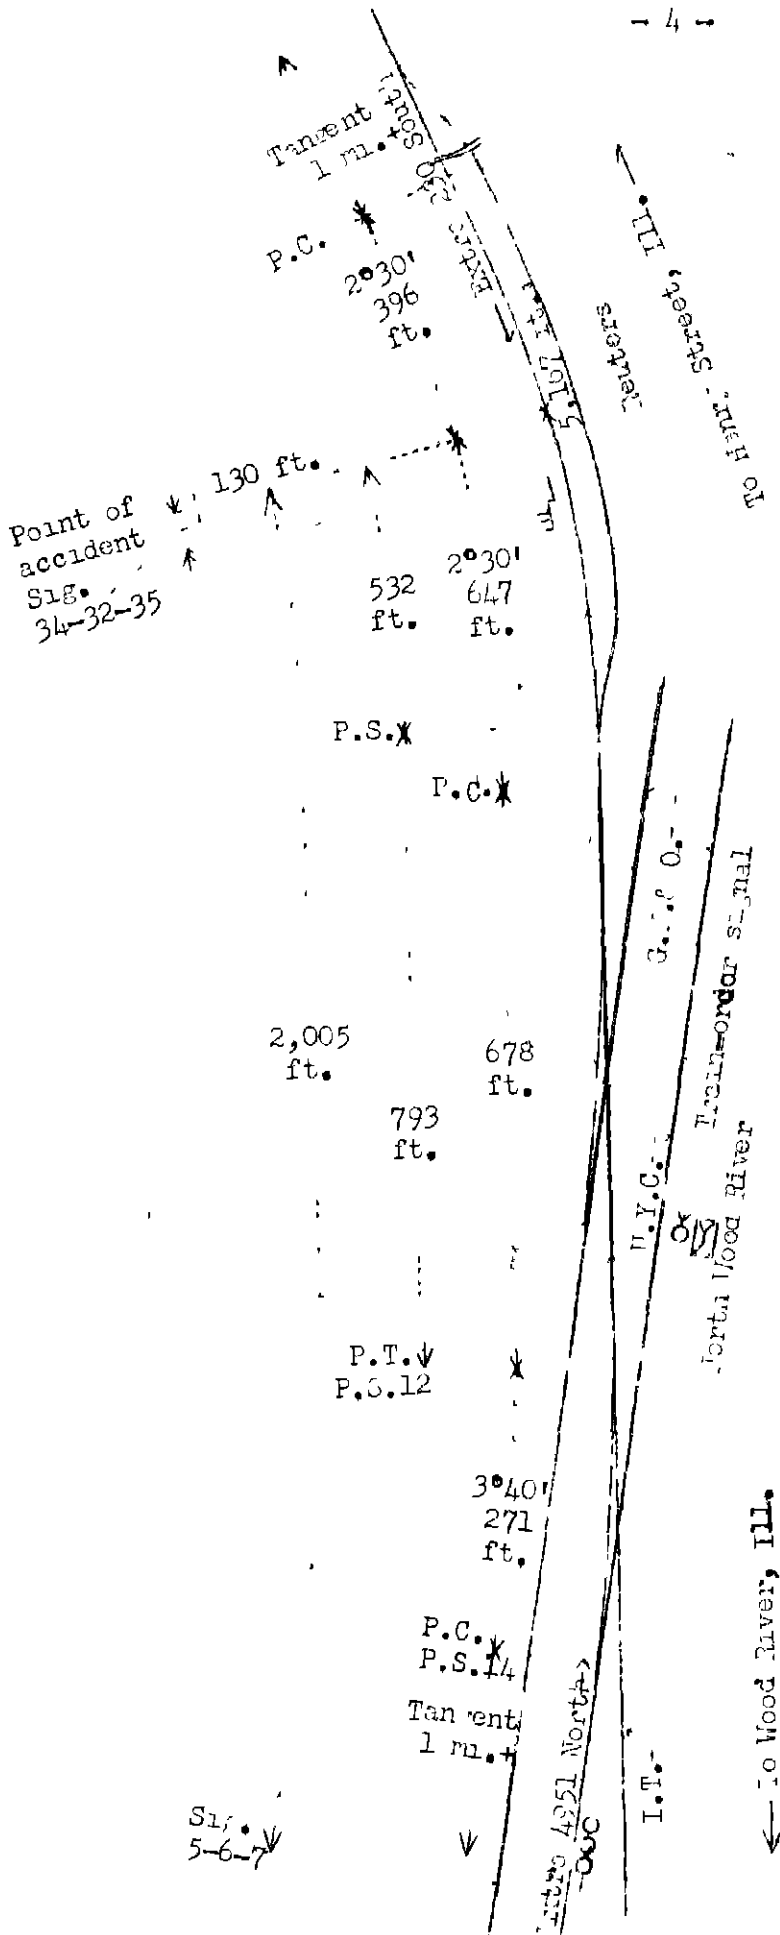
- West Alton, Mo.      ↗
- 2.8 mi. Alton, M.I.B. & B.      ↗
- Henry Street, Ill.      ✕
- 1.3 mi.
- Federal
- 2.4 mi.
- ✕ Reuters
- (Point of accident) I.T.
- 1.0 mi.
- North Wood River
- 0.2 mi.
- Wood River, Ill.      ↘
