INTERSTATE COMMERCE COMMISSION
WASHINGTON

REPORT NO. 3685

CHICAGO, MILWAUKEE, ST. PAUL AND PACIFIC
RAILROAD COMPANY

AT DUPLAINVILLE, WIS., ON

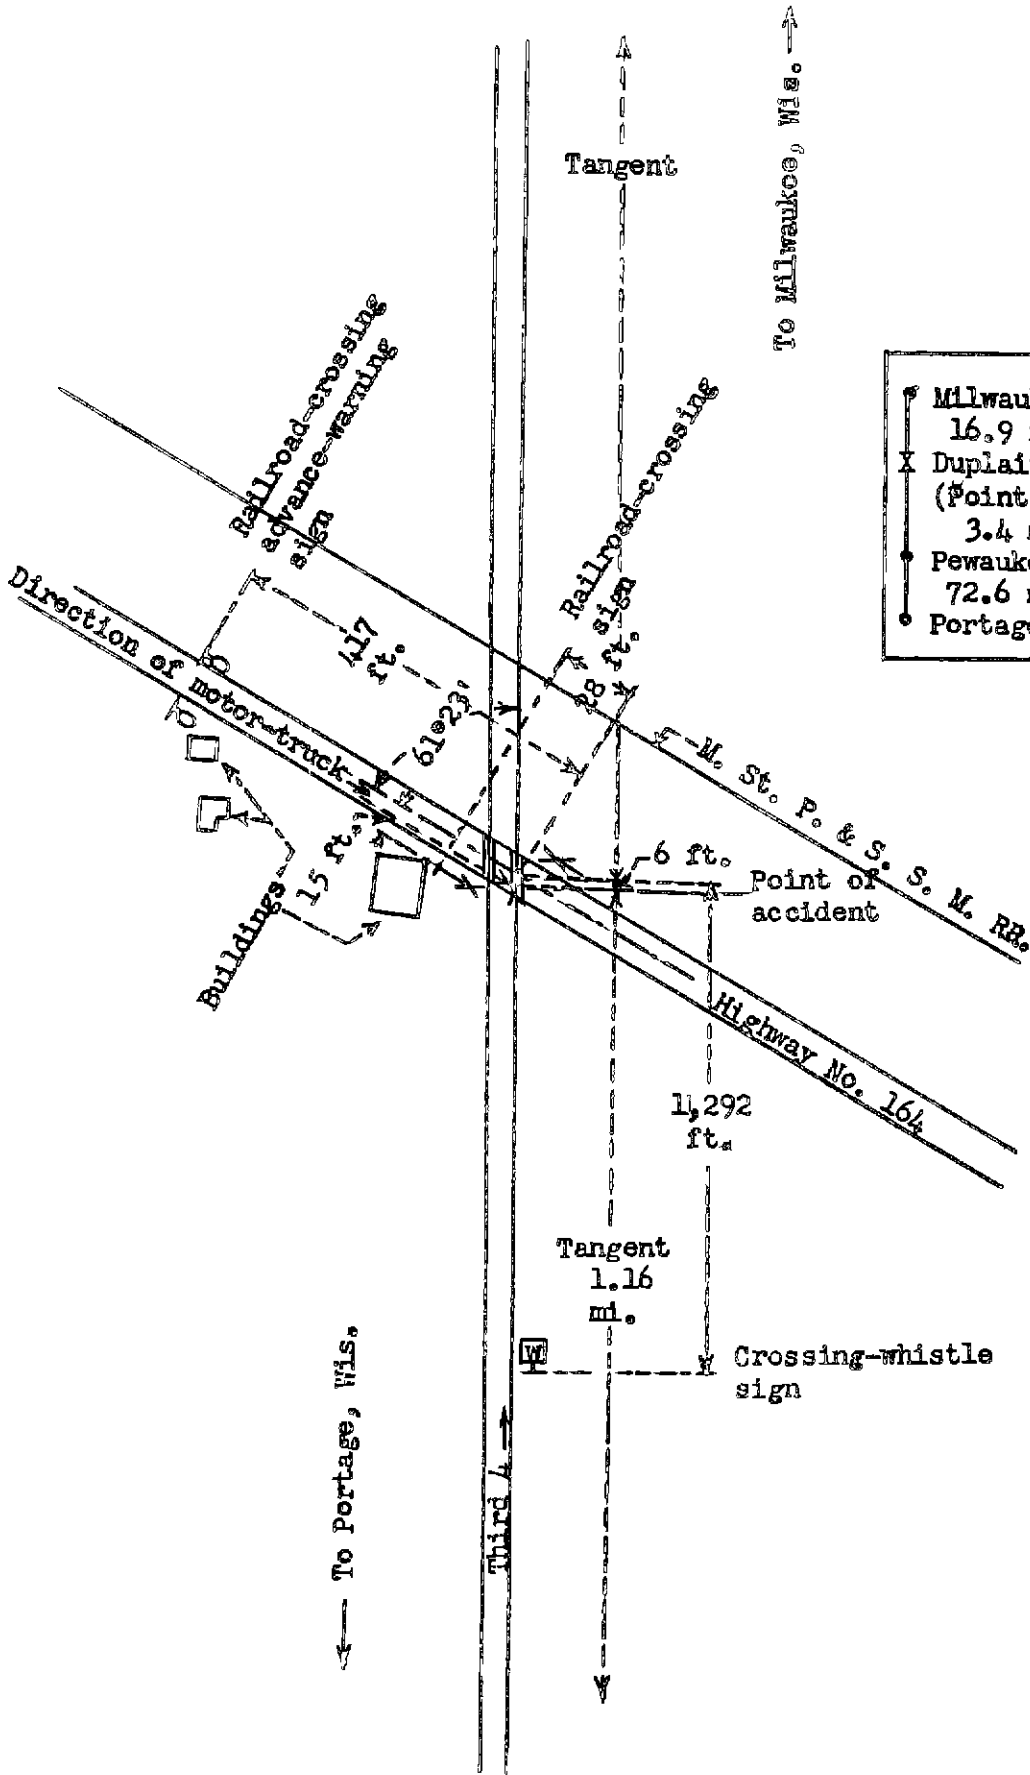
Report No. 3685
 Chicago, Milwaukee, St. Paul and Pacific Railroad
 Duplainville, Wis.
 May 7, 1956

•	Milwaukee, Wis.
	16.9 mi.
X	Duplainville (Point of accident)
	3.4 mi.
•	Pewaukee
	72.6 mi.
•	Portage, Wis.
