RAILROAD ACCIDENT INVESTIGATION

Report No 3813

CHICAGO, MILWAUKEE, ST PAUL AND PACIFIC RAILROAD COMPANY

ELKHART LAKE, WIS

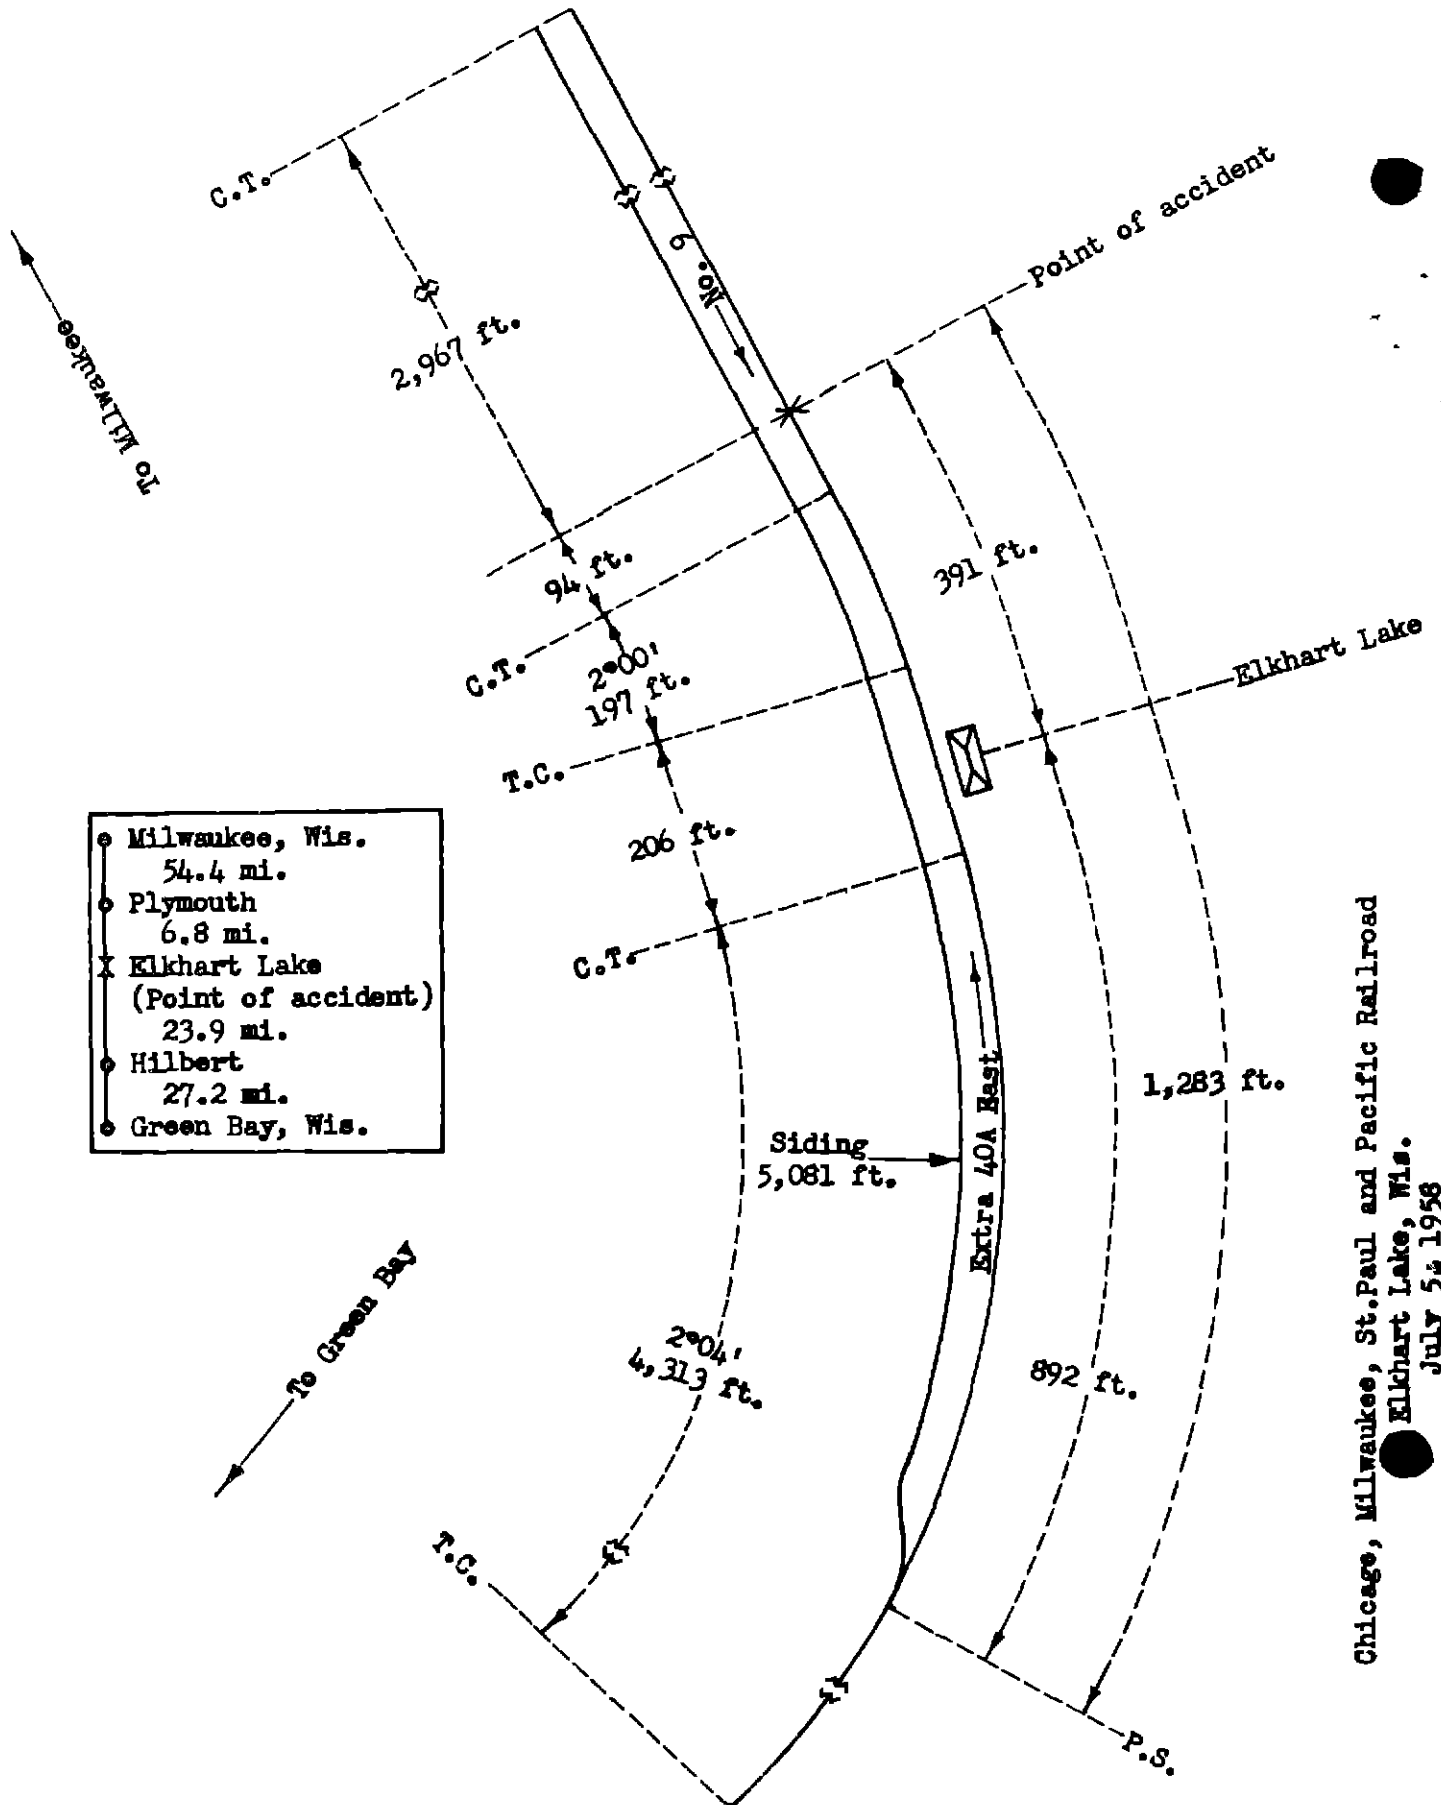
Chicago, Milwaukee, St. Paul and Pacific Railroad
 Elkhart Lake, Wis.
 July 5th 1958

- Milwaukee, Wis. 54.4 mi.
- Plymouth 6.8 mi.
- ✕ Elkhart Lake (Point of accident) 23.9 mi.
- Hilbert 27.2 mi.
- Green Bay, Wis.

→ To Green Bay

This accident occurred on that part of the Milwaukee Division extending between Milwaukee and Greer Bay, Wis., 112.3 miles. In the vicinity of the point of accident this is a single-track line over which trains are operated by timetable, train orders, and a manual block system. At Elkhart Lake, 61.2 miles west of Milwaukee, a siding 5,081 feet in length parallels the main track on the north. The west switch of the siding is located 892 feet west of the station. The accident occurred on the main track at a point 1,283 feet east of the west siding switch and 391 feet east of the station. From the west there are, in succession, a 2°04' curve to the left 4,313 feet in length, a tangent 206 feet, a 2° curve to the left 197 feet, and a tangent 94 feet to point of accident. From the east there is a tangent 2,967 feet in length to the point of accident. The grade from the west is, successively, 0.33 percent ascending for 1,618 feet, and level 81 feet to point of accident and 419 feet eastward.
