SIGNAL PROTECTION FOR WASHOUTS

A PRACTICAL demonstration of the protection which automatic signals give for washouts was recently reported from East Chattanooga, Tenn., on the Southern. Heavy rains and high water caused a fill on the eastbound main line just east of an interlocking plant

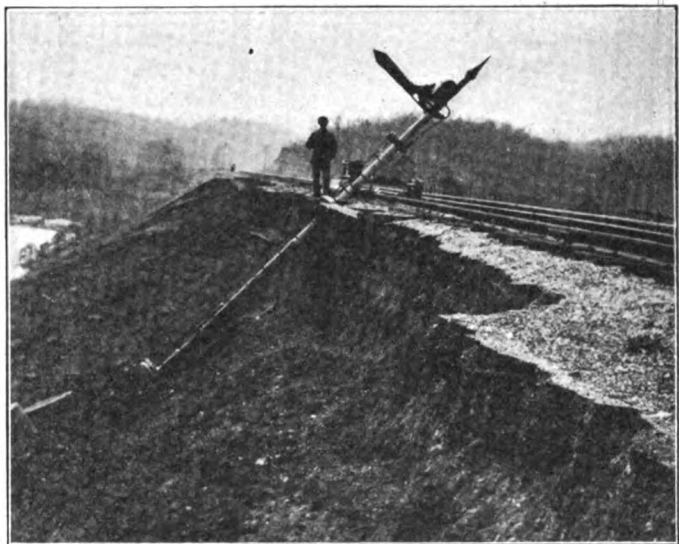
Washed Out Signal Doing Its Best to Protect the Track

to give way for a distance of about 500 ft. Automatic signal No. 2362, located at the scene of the trouble, slid half-way down the fill. This movement of the signal caused the home signal in the interlocking plant to indicate "stop." Two eastbound passenger trains were due at this point shortly after the fill gave way, and when the operator of the interlocking plant notified J. T. Brown, signal maintainer, that the home signal had been thrown to danger by some unknown cause, he refused to permit trains to be carded by the home signal until he could go over the track to locate the trouble. He went forward promptly and found signal 2362 in the position indicated in the illustration. In spite of the washout, it was still standing guard over the tracks, the upper portion of the pole inclining over the tracks with the signal blade in the stop position. The part played by these signals and the judgment shown by the maintainer very probably averted an accident in this case.
