The Illuminated Track Diagram, the Track Layout and the New Tower

THE old mechanical interlocking layout at the crossing of the Southern with the Chesapeake & Ohio at Charlottesville, Va., has been replaced by an all-electric machine for controlling the enlarged track and signal facilities at that point. The old plant consisted of a Johnson type machine having a 16-lever locking frame controlling 16 functions and 2 order boards with a crank leadout housed in a two-story frame structure. The new plant was installed by the General Railway Signal Company and was placed in service on February 27.

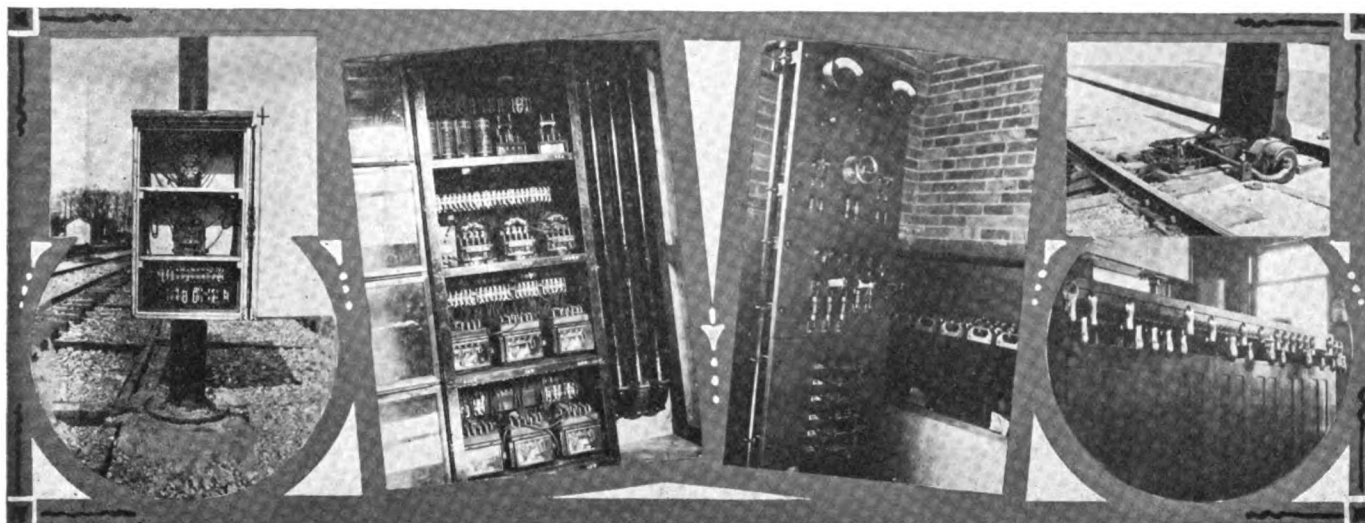
Instrument Case with Relay and Transformer

Relay Case in Tower

Charging Panel and Batteries

There are six track sections on the plant, requiring alternating current for the operation of Model 2 Form A, a. c. track relays. All of the track circuits are within home signal limits and are supplied with energy at 110-volt 60-cycle single-phase through type K transformers, which are regulated by means of resistance units having
