Locking Arrangement for Movable Point Crossing Frogs*

System Installed on the Central of Argentine Insures Safety With Minimum Apparatus

By J. Parsons

Assistant Engineer for Signals and Telegraphs, Central of Argentine, Buenos Aires

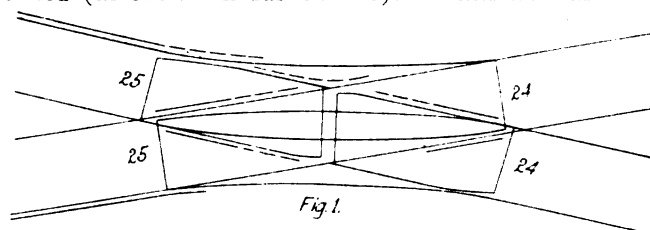
Fig. 1.

In Fig. 1, for example, points No. 25 control the crossing, the original bars (shown in full line) have been extended (as shown in dashed line). Points 24 was made

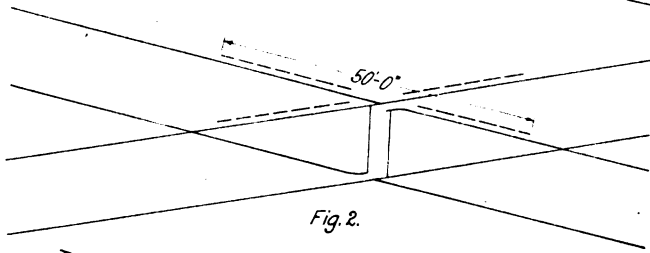
Fig. 2.

Figure 2 shows a crossing without slips operated by points on the other track. In this case two complete new bars had to be installed and operated by the gear operating the crossing.

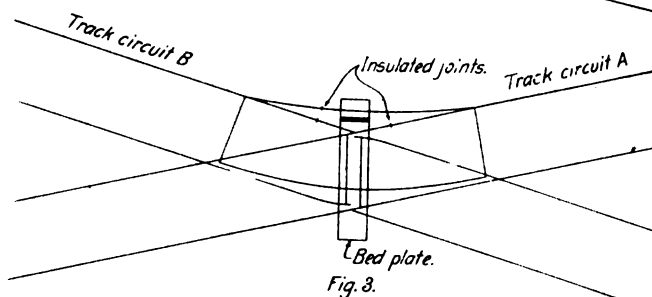
Fig. 3.

A short length including the crossing was cut out from the track circuit. When fixing the movable crossings, two, three or even four tracks were affected; but as the track circuits are single rail a.c. and not carried through the crossings, it was possible by insulating the bed plates, as shown in Figs. 3 and 4, and moving the insulated joint to one side of the center of the crossing, to cut out the whole of the center part of the crossing, using it as a return, and thus avoiding the trouble of insulated joints at the heel of the switch tongues.

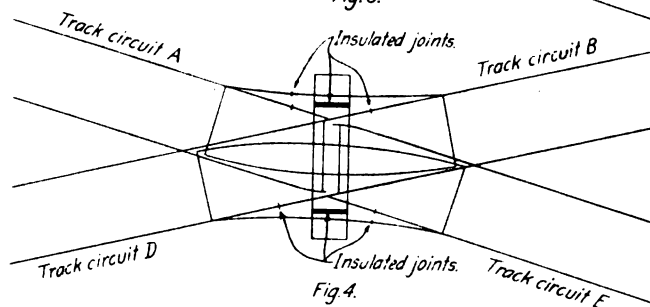
Fig. 4.

Track Diagram of Bars and Insulation
