# C. & O. Installs Signaling With Train Control

## New Equipment Expedites Movement of Traffic at Sidings and Eliminates Unnecessary Stops

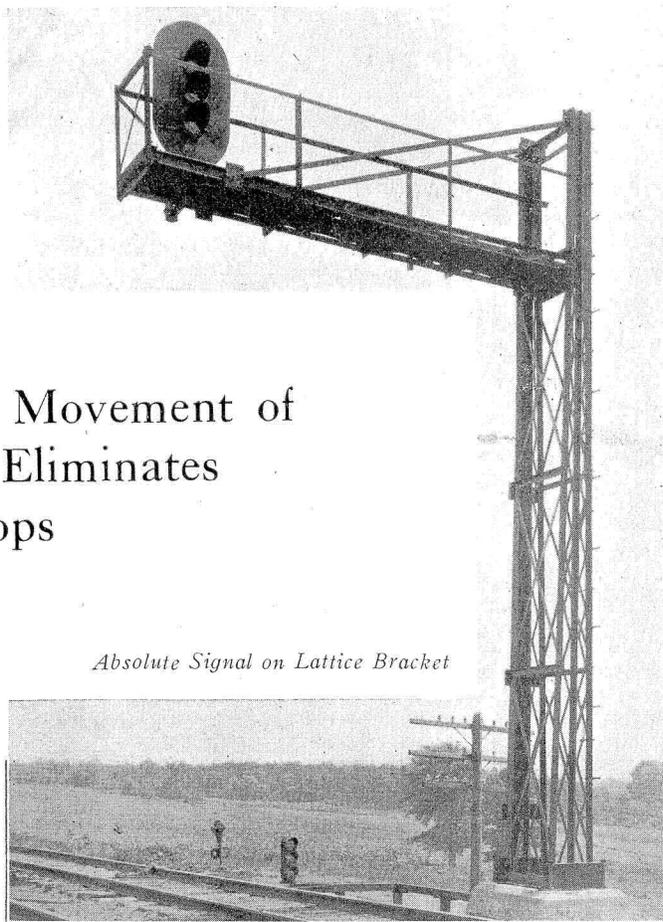
*Absolute Signal on Lattice Bracket*

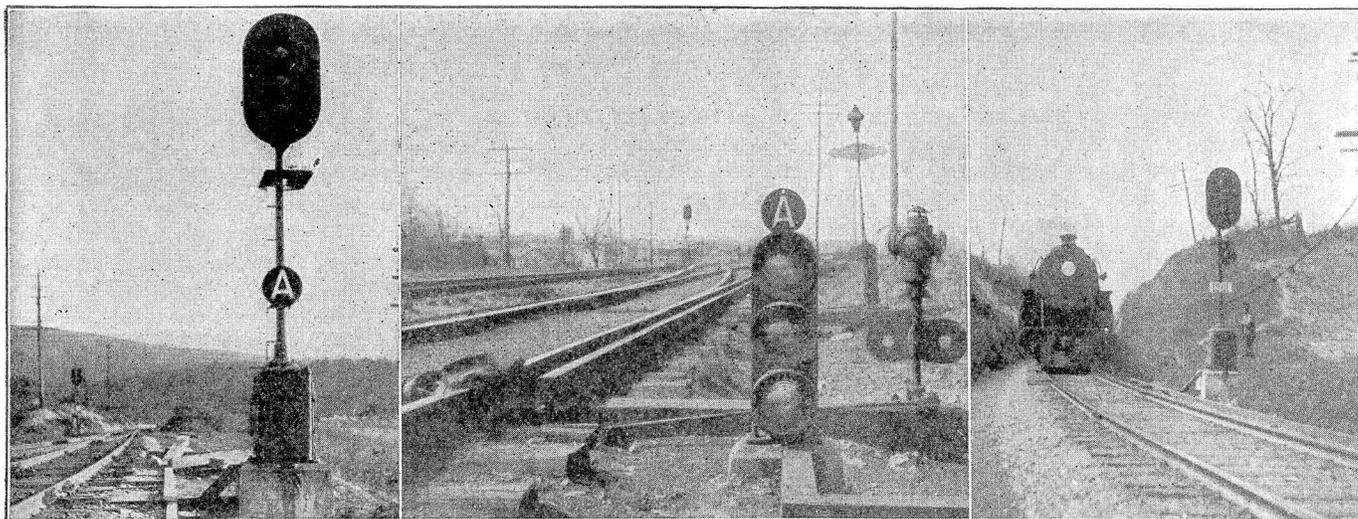
Fig. 1. Absolute Head-Block Signal

Fig. 2. Absolute Dwarf Signal

Fig. 3. Permissive Signal

The absolute signals, either high-mast, bracket, or dwarf, are designated by a sign showing the letter "A" without any number (see Fig. 1 and 2) and are located at passing points, at the entrance to a block, and at tunnels. The permissive signals, either high-mast or bracket, are located at intermediate points (i. e.,) between stations, and are designated by number plates (see Fig. 3). All signal indications are given by colored lights arranged in a vertical row. On the high signals the indications are as follows:

Absolute dwarf signals, as shown in Fig. 2, are located at clearance points at the ends of passing sidings at

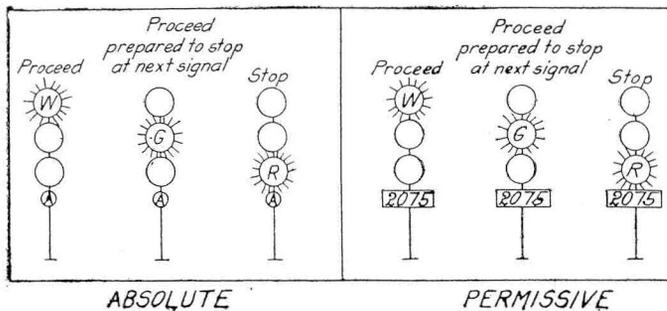
Fig. 4. Names and Aspects of Light Signal Indications

Top light .....	White	Proceed.
Second light .....	Green	Proceed with caution.
Third light .....	Red	Stop.
Fourth light (displayed with red light only).....	Amber	Proceed under Rule B-1.

Top light .....	White	Proceed.
Second light .....	Green	Proceed with caution.
Third light .....	Purple	Stop.

The several aspects are shown in sketches in Fig. 4. The rules governing train movements under these signal indications are as follows:

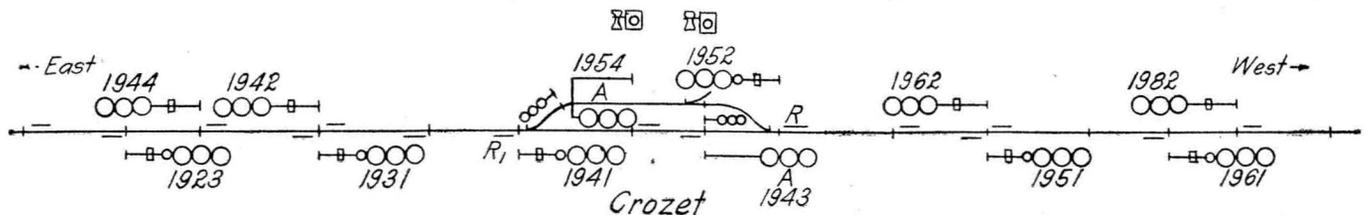
Fig. 5. Typical Track and Signal Layout at Siding

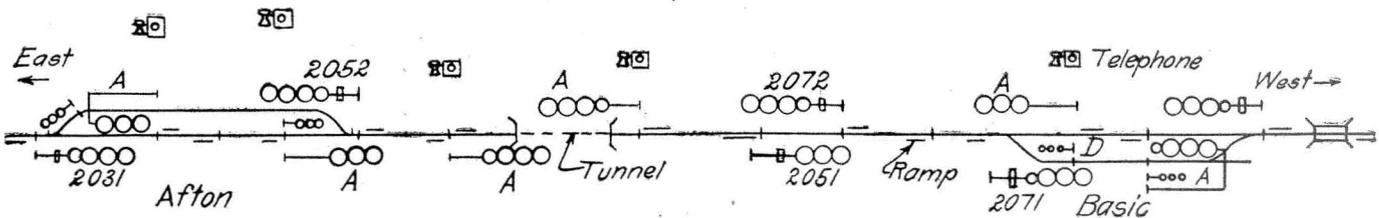
Fig. 6. Typical Signal Layout Between Sidings Including Tunnel Protection

For example, assume that train E is on the siding at Basic, Va., Fig. 6, waiting for a westbound train W to pass, then both the eastbound head block absolute signal A and the absolute dwarf signal D give the absolute "Stop" indication. Both the high signal A and the dwarf D are located opposite the point of clearance for the siding. Therefore, there is no room for doubt on the part of the engineman as to where he must hold his train. Another advantage of this layout is that if westbound train W makes a station stop, train E can proceed east in the meantime on the clear indication of the dwarf signal which indicates "Proceed" as soon as the rear of westbound train W passes signal A. This movement of train E out of the siding is protected against any back-up move of train W by the signal A.

Ordinarily the signals between sidings are permissive signals (see Rule B), however, the signals at the entrance of the tunnels are absolute signals, i. e., they have no number but have the marker A the same as the head block signals. Referring to rule A, it may be seen that such a signal cannot be passed without permission from the chief dispatcher or under flag protection. The purpose of requiring an absolute stop at the tunnel entrance is to prevent two trains from being in the tunnel at one time, or even for following moves. Referring to Fig. 6, it may be seen that after a proceeding train has actually cleared the tunnel, that there is no reason why signal A at the tunnel should not then be treated as any other intermediate permissive signal to allow the second train to proceed at minimum speed. Therefore, an amber light is added below the regular signal, which is illuminated in addition to the red indication as soon as the preceding

at Basic, while westbound train W had been approaching, then train W would have found the permissive signal 2071 giving the "Restricted Speed" indication. Under this condition the westbound train W would have been permitted to proceed into the passing track without coming to a full stop at the signal 2071. (See Rule B-1).

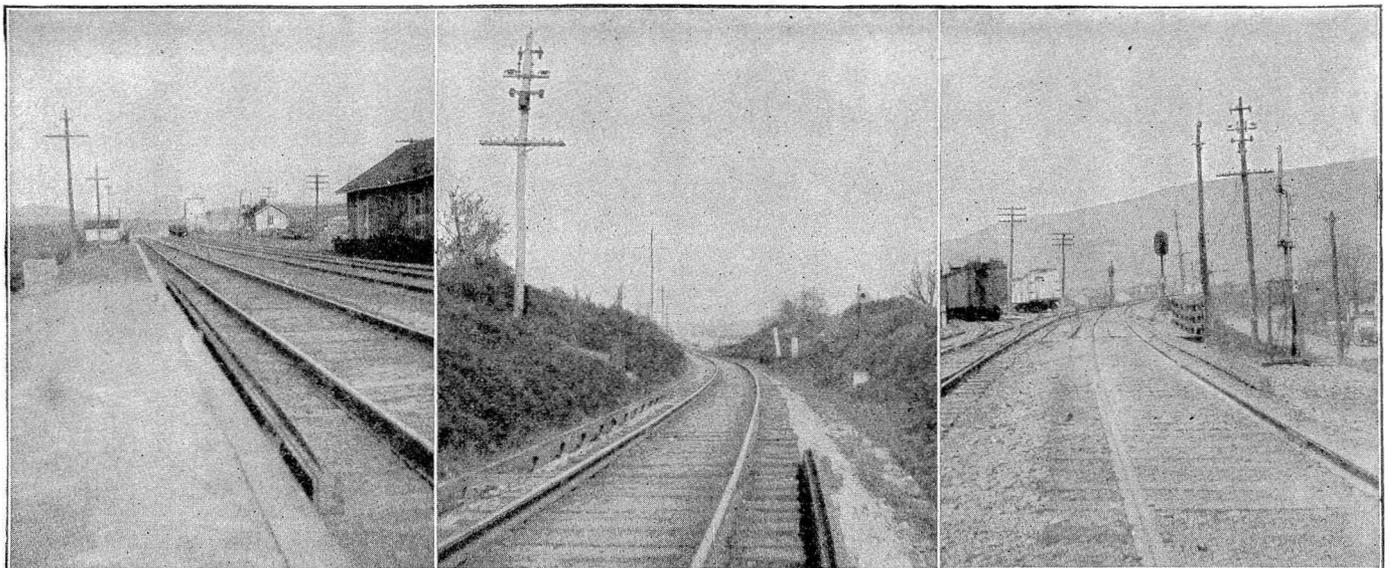
Fig. 7. Ramp Located Along Platform    Fig. 8. Intermediate Ramp Location    Fig. 9. Absolute Signal and Ramp Location

At any point where a ramp is located between signals it is distinguished by a special marker as shown in Fig. 8. The ramp marker consists of a standard R. S. A. cast iron electric lamp case with No. 18 gage sheet metal background, 18 in. in diameter, on an R. S. A. adjustable lamp bracket, the whole being supported on a standard cable post. The background is painted white and serves as the marker. It is illuminated at night by reflected light. The reflection is obtained by placing a small disc directly in front of the lens and about 6 in. away. The side of the small disc toward the engineman is painted black and the side toward the lamp white, to assist in the reflection of light on the large disc. The engineman is shielded from all direct light from the lamp and observes only the large white disc with the black spot in the center both day and night. If the first train clears the block before the second train reaches the intermediate ramp, energy is supplied to this ramp so as to operate the control equipment on the locomotive in such a way as to remove the minimum speed control restriction.

High tension choke coils were made up of 23 turns of No. 10 hard drawn rubber covered wire, the turns being 5 in. in diameter. A 0.75 kv.a. oil cooled line transformer 6,600 volt to 110 volt was located at each signal location. Typical pole line construction is shown in Fig. 8. All signal cables and conductors between signals and instrument cases is No. 14 solid copper rubber covered single conductor. Track wires are No. 9 solid rubber covered. All insulated wire on this installation is Okonite.

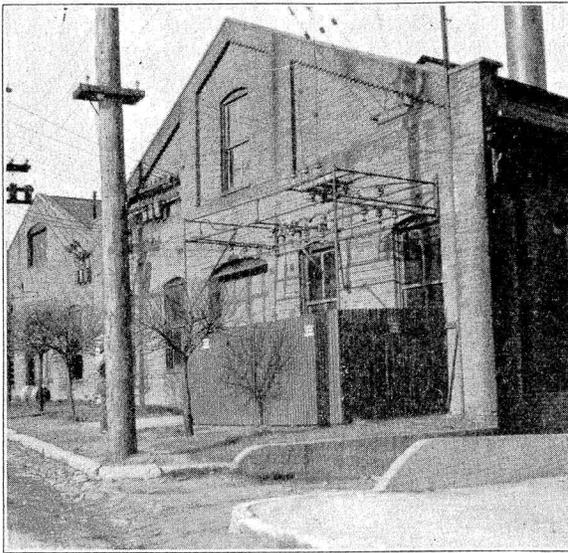
Fig. 13. Open Air Substation Outside Powerhouse at Staunton
