## Dispatcher Signaling System Operates Through Sleet Storm

**A** HEAVY sleet storm in northwestern Ohio on March 29 and 30, broke down hundreds of telegraph poles along the railways in that area, including over 600 poles on the New York Central's 40-mile installation of the centralized dispatching system extending from Berwick to Stanley. In spite of the loss of these poles no delays to trains resulted on this line because of any shortcomings of the dispatching system, notwithstanding the fact that all other communication and facilities for directing train movements were out of commission. This storm subjected the dispatcher signaling system, installed

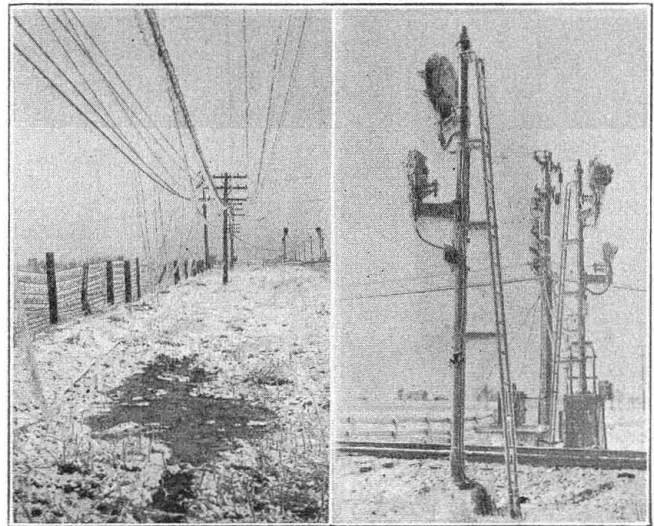
Ice-covered cables, line wires and signals

last summer by the General Railway Signal Company, to an operating test beyond anything anticipated at the time of its installation. All control wires are carried in Hazard steel-armored cable which did not break the circuit continuity at any point, despite the pole line failure.\*
