# Pennsylvania Installs an Interlocking Without Derails

*33-lever electro-pneumatic plant handles crossings*

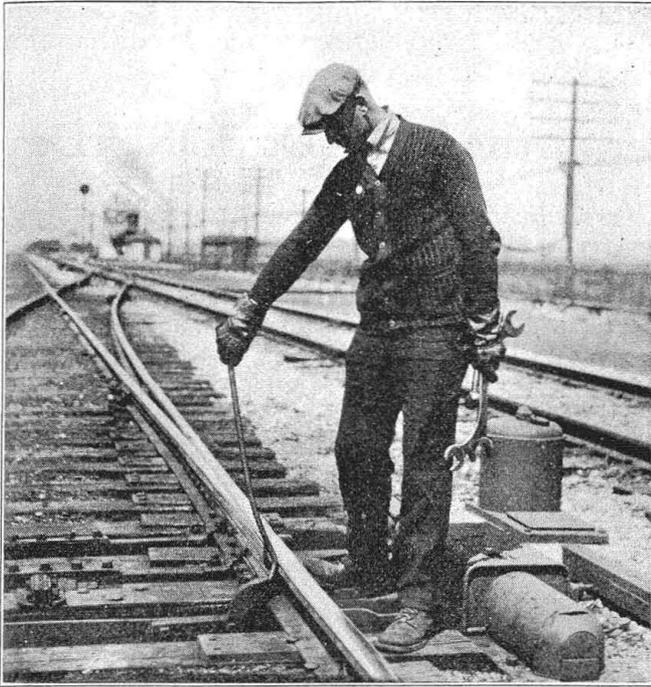
R. J. Walimire, maintainer, testing the adjustment of a switch

power failure air can be supplied by a locomotive, a special connection being provided for this purpose. Air for operating the electro-pneumatic switches is supplied through a two-inch iron pipe line, supported on concrete

foundations about 10 ft. apart. The cross runs to the switches are 0.75-in. galvanized pipe.
