Pennsylvania Installs

Interlocking at Lancaster, Pa.

Electro-pneumatic plant with wires distributed in lead cable—Relay cabinets in tower are made of asbestos

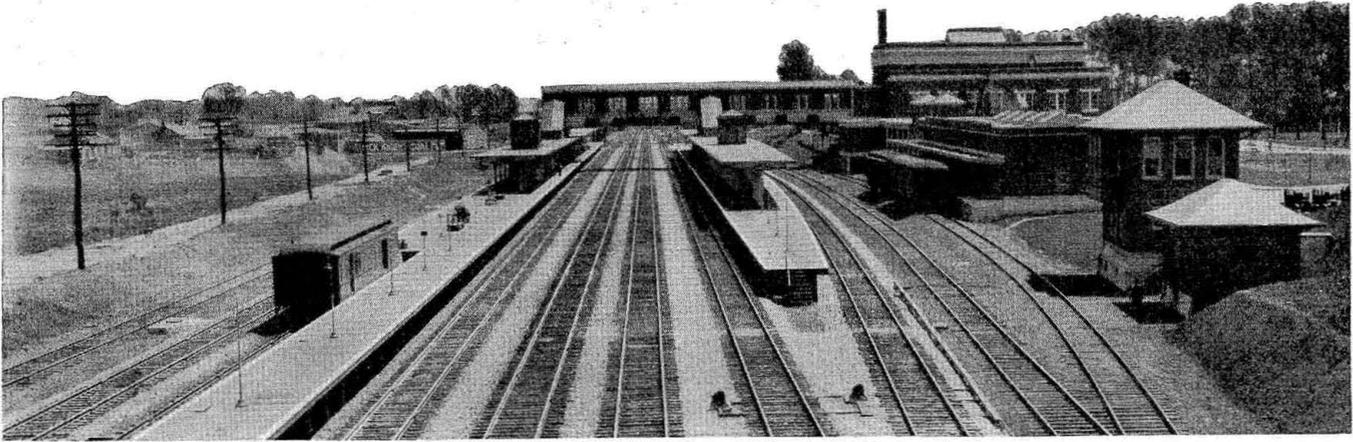
View looking east through station, tower at right
