Wabash Tests Automatic Train Control with Cab-Lights

Test installation on 11 miles of track and with two locomotives equipped proves satisfactory

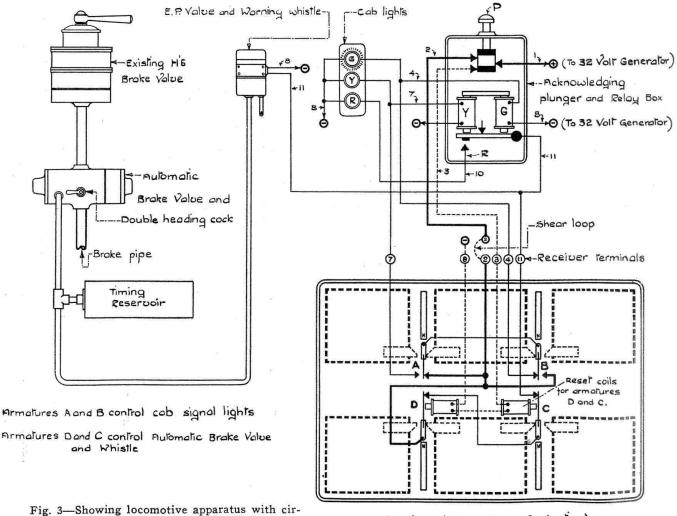
cuits set up for green indication

The locomotive equipment requires but little explanation. Referring to Fig. 3, the mode of operation is as follows: In the normal position set for a green cab indication, all of the armatures are at the "IN" position. When set for caution, a yellow cab indication, as shown in Fig. 4, all armatures "OUT," after passing Binductor, but C and D are restored by acknowledgment to the "IN" position (to avoid a brake application). When set for zero, the armatures are deflected either to the right or to the left, giving an "out of phase" condition which breaks down all circuits. Armatures C and

Referring to Fig. 3 the positive lead I and 2 is normally connected to the receiver armatures A, B and D, but is cut off when the acknowledger P is operated, which diverts this circuit through the reset coils on armatures D and C. If P is held down more than four seconds an automatic brake application will occur.

When all the armatures are "IN" as shown in Fig. 3,

the green cab lights are illuminated through lead 4. The coil G of the relay is also energized. The E-P valve is energized only when armatures D and C are IN, (trace circuit through lead 11). When armatures A, B are "OUT," as shown in Fig. 4, the yellow cab lights are illuminated. The coil Y is energized through lead 7. When A and B are "out of phase," the red cab light appears, but only after D and C are restored to the "IN" position after acknowledgment. Contact R is closed only when coils Y and G are de-energized.

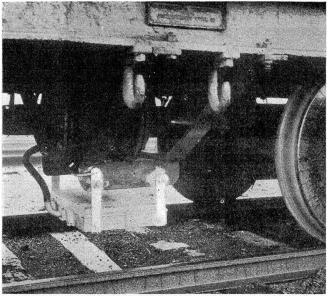
The receiver is mounted under the tender

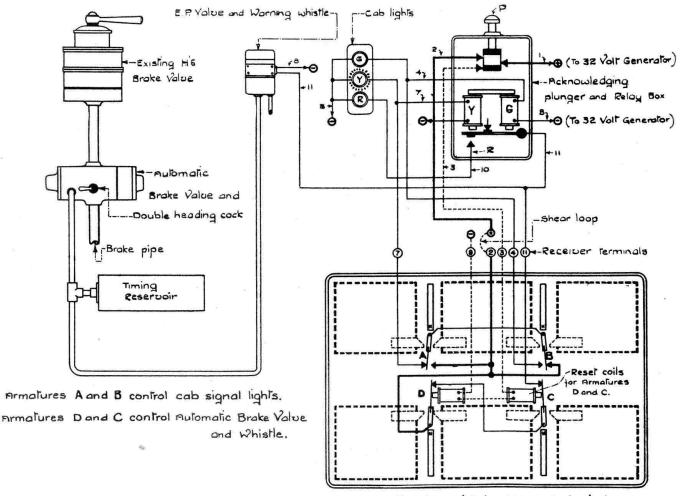
Fig. 4-Showing locomotive apparatus with circuits set up for yellow indication

Receiver (giving Yellow Indication)

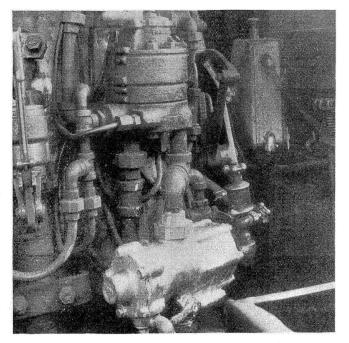
The train control brake valve below regular engineman's valve—Note acknowledger at right

heading cock is installed in the brake pipe under the engineman's automatic brake valve, where it replaces the double-heading cock. This valve is designed to accomplish the following: To initiate an automatic brake application at service rate of reduction in brake pipe pressure; to provide a double-heading cock in lieu of the ordinary double-heading cock displaced, and to permit of a manual emergency application of the brakes to be made with the engineman's automatic brake valve, while the double-heading cock is closed, or while an automatic application is in progress.
