## Railway Signaling

# Automatic Interlocking Replaces Mechanical Plant

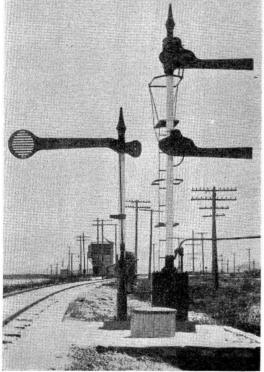
Home signal on the Great Western

Since the speed over the crossing is limited by bulletin to 20 m.p.h., operative distant signals were not required. The home signals on the Great Western operate to two positions, Stop and Caution, and are designated Chicago Great Western and Chicago & North Western effect total net return of 23 per cent on investment of \$10,500 —Smash-boards required—Circuits utilize interlocking relays for directional control

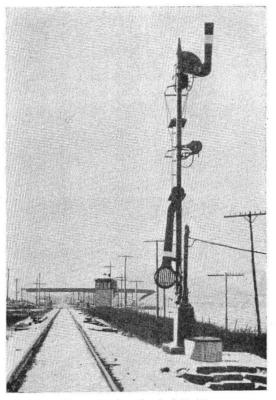
Home signal on the C. & N. W.

as such by an auxiliary blade fixed in the Stop position. On the North Western the home signals operate to two positions, Stop and Clear, and carry lunar white marker lights. The distant signals on the latter road carry yellow marker lights. Home signals are located approximately 580 ft. from the crossing, with the distant signals 2,550 to 3,000 ft. in the approach to the home signals.
