D. & R. G. W. Completes the Signaling of Its Main Line

Five-year program includes 722 miles of automatic block signals and two C. T. C. installations. Excellent performance report – Five-year records on a-c. floating system show operating cost for electric current to be 85 cents per mile per month

By B. W. Molis

Signal Engineer, Denver & Rio Grande Western, Denver, Colo.

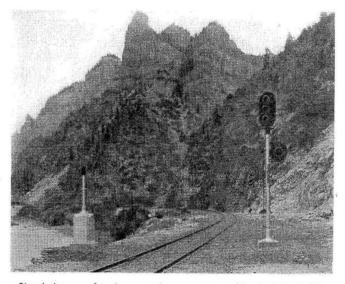
Signals insure safety in mountainous country on the D. & R. G. W.

All of the signals are the G. R. S. Type-D color-light type. The single-track control circuits are the regular absolute permissive block type, and the power is supplied by the a-c. floating system, using a 550-volt power supply line. To preclude interruptions or "winking lights" due to the high-speed, light-engine movements prevalent in the mountainous territory, thermal relays are used. The thermal relay is so arranged that, after the circuit is closed, a time interval elapses before the control relay picks up. On account of the adverse mountain grades encountered, grade signals were installed, the circuits for which are so arranged that the grade-signal indication is displayed only for following movements.
