Signaling of New Terminal

Illinois Terminal Railroad installs interesting automatic signal arrangement in new subway and underground terminal in St. Louis

By John Leisenring

Assistant Chief Engineer, Illinois Terminal Railroad, Springfield, Ill.

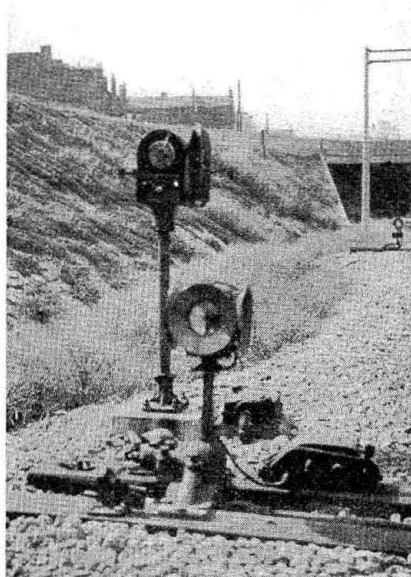
Switch indicator and time-element release at switch

Where required, switch indicators were installed at certain switches, as shown on the plan, and at some of these switches where a time delay is necessary, a clock-work time release mechanism is provided.
