Electric Interlocking on the B. & O.

Plant installed at temporary end of four-track may remain for many years

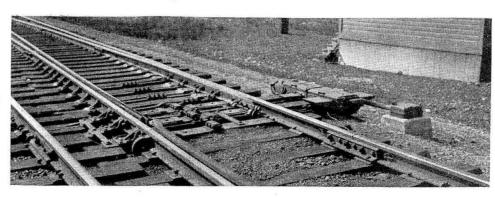
The switch layouts are well equipped with insulated gage plates and rail braces

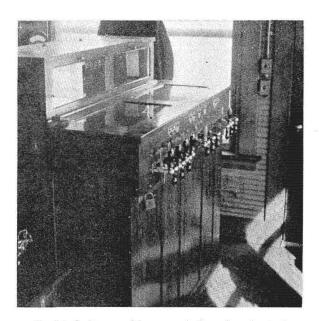
The interlocking machine was rebuilt and modernized

The interlocking machine was equipped with individual polar cross-protection relays, and forced-drop

electric locks, thus modernizing it in these respects. Mounted above each signal lever is a set of two small lamps and a pushbutton. The green lamp at the left is lighted when the signal controlled by the lever is at clear. The white lamp at the right is the approach annunciator which is lighted at the same time as the approach bell rings. The pushbutton is for the control of the call-on feature of the signal, the signal lever must be reversed and this button pushed to get the call-on aspect. Above each switch lever there is a small white lamp which is lighted when the track circuit is occupied, with the route lined, and the signal lever reversed. In other words, this lamp shows that the route is lined up and locked. The entire interlocking machine was, of course, rewired.
